Terrain awareness warning system alert involving Eurocopter BK 117C-2, VH-SYB

near Crookwell, New South Wales | 21 October 2016

ATSB Transport Safety Report
Aviation Occurrence Investigation
AO-2016-160
Final – 6 November 2018

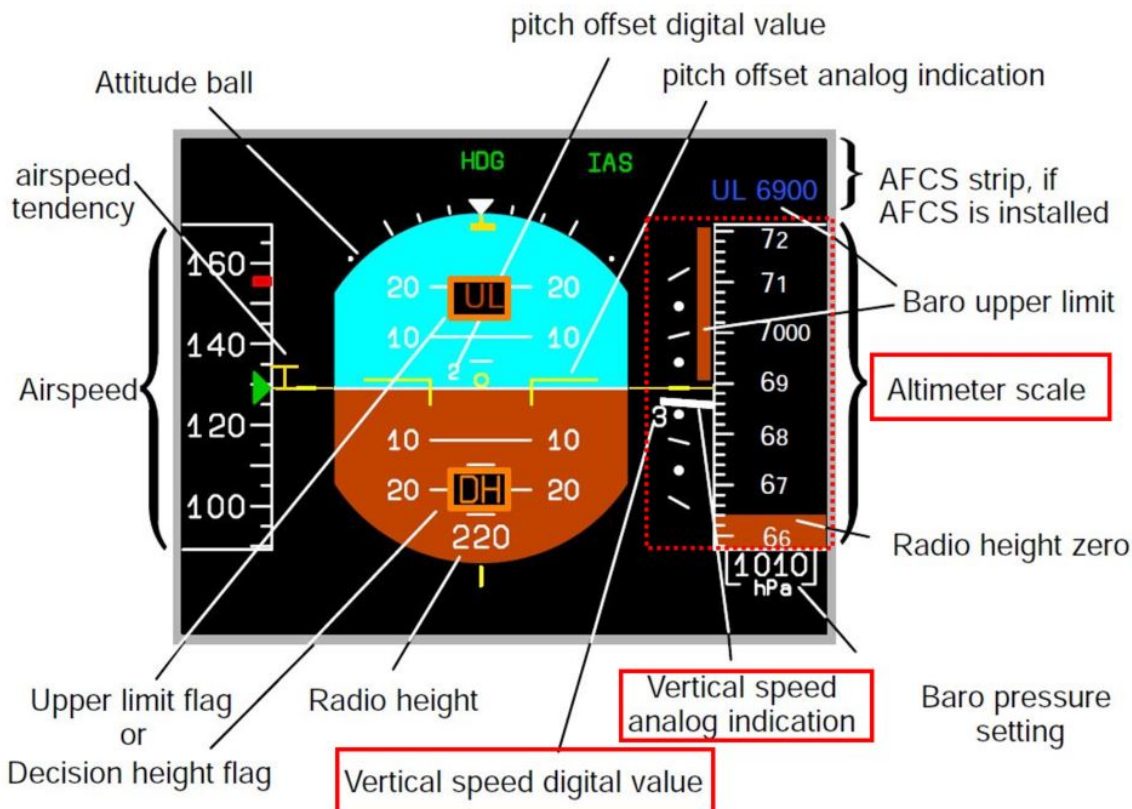
Figure 3: VH-SYB's primary flight display

The BK 117 C-2 flight manual noted a limitation of the accuracy of the VSI, which stated:

Vertical speed indication may be unreliable in gusty conditions and at airspeeds around 30 kt during fast transition from hover flight into steep descent and from level flight to hover during rapid pull up's.

As noted in *Departure from Crookwell*, the ACM recalled seeing the VSI indicate a rate of descent of 3,000 ft/minute at the time of the EGPWS alert. She also recalled seeing a rate of climb of 2,900 ft/minute during the initial unusual attitude recovery. The ACM stated she read these figures from the digital VSI display.
