Derailment of freight train WG713

Denman, New South Wales | 19 January 2016

ATSB Transport Safety Report
Rail Occurrence Investigation
RO-2016-001
Final – 22 March 2019

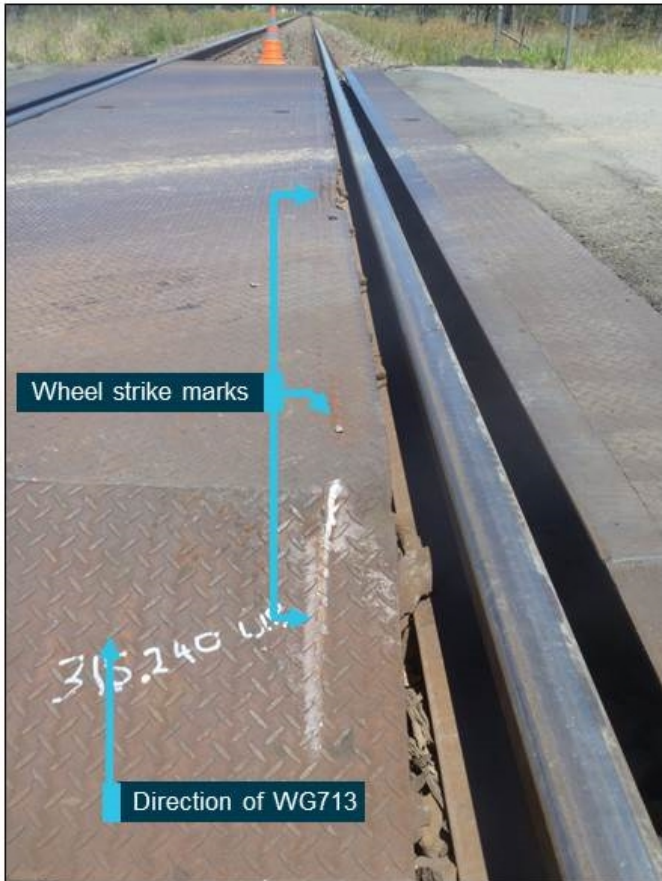
Figure 2: Wheel strike marks on Rosemount Road level crossing road plate

The steel crossing plate of the Rosemount Road level crossing, 690 m away from the derailment location, displayed damage consistent with rail wheels striking and running over the crossing (see Figure 2). The wheel strike marks indicate a direction of travel back onto the rail track and no damage was evident after the level crossing. This indicated that a combination of the tensile draft longitudinal forces and the wheel striking the road crossing plate elevated the wheel flange sufficiently to assist re-railing the train.

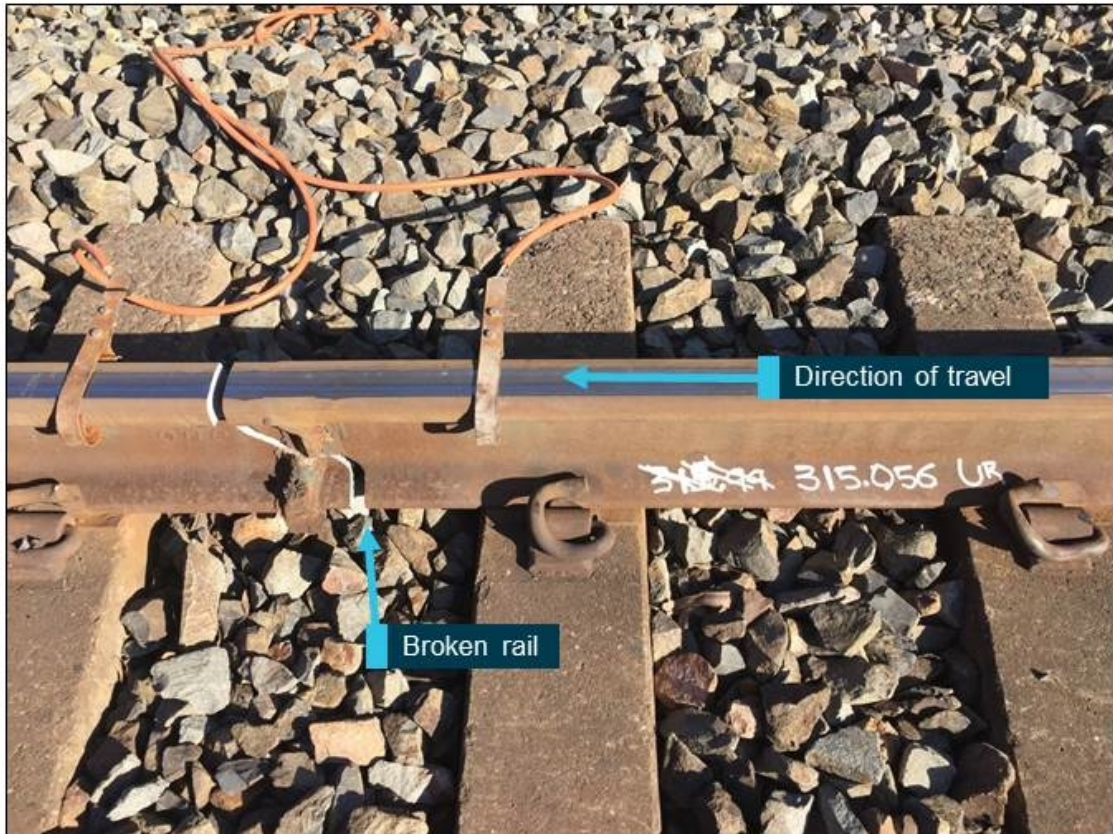
As the wheels ran in a derailed state, they impacted the track fastenings and the foot of the rail. A number of rail welded joints, sleepers and fasteners were damaged by the derailed wheels on both rails. The Up rail at 315.056 km suffered a full cross-section break at an aluminothemic weld joint (see Figure 3). The rail break subsequently broke the track circuit which triggered a signal failure to occur. At 0400 the Network Control Officer (NCO) located at the Australian Rail Track Corporation's (ARTC) Network Control Centre North (NCCN) was alerted to the problem after the train had cleared the section. The train crew were unaware that the train had derailed and continued onto their destination.

Figure 3: Broken Up rail at 315.056 due to weld being struck by WG713’s derailed wheel

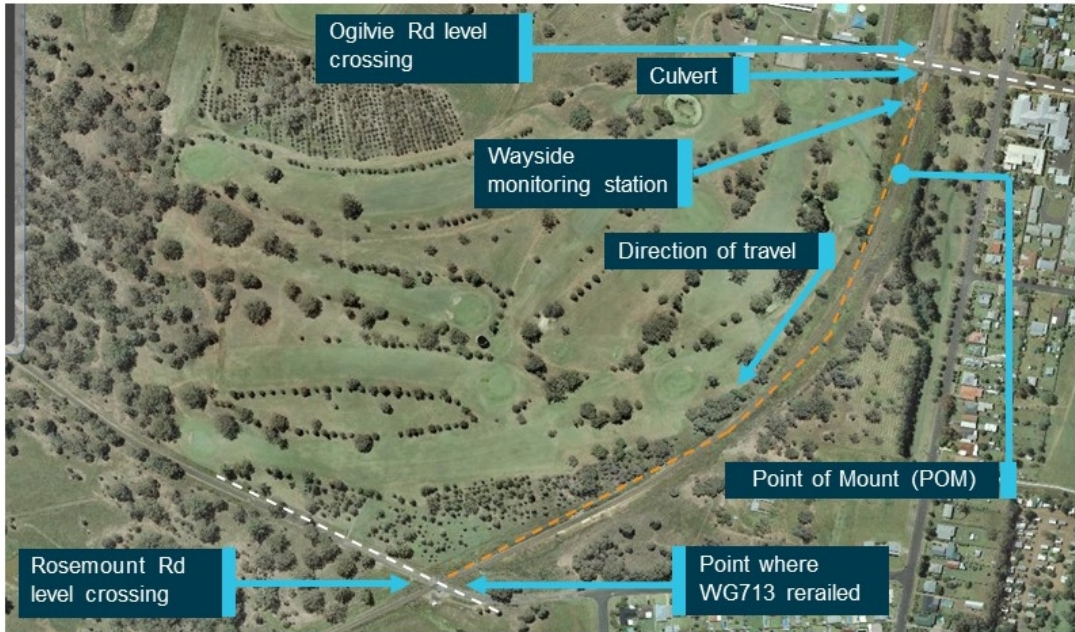
Figure 6: Incident location aerial view

On 19 January 2016, the defective area had deteriorated to a point where the 64th wagon of train WG713 likely could not negotiate the defective area and derailed then re-railed at the Rosemount Rd level crossing (see Figure 6).

The derailment occurred approximately five metres after the transition (highest superelevation in the curve) for a 600 m radius curve in an area with a known problematic formation (see Figure 6). The normal line speed at the incident location was 85 km/h for freight trains and 110 km/h for passenger trains. A TSR of 40 km/h was imposed on 12 January 2016 due to an identified top defect and two days later, the track geometry recording car identified five twist defects in the area. This deterioration was likely a result of the track settling due to a displaced formation.

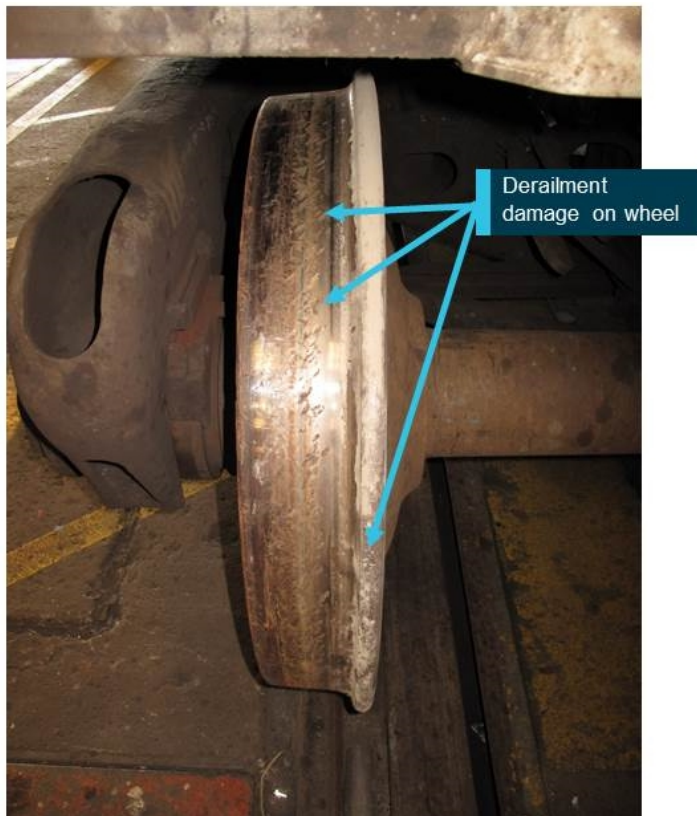
Upon inspection of the wagons of train WG713, the ATSB identified wheel damage on the leading bogie of the 64th wagon. The wheel damage observed was consistent with damage typically found as a result of a wheel having operated in a derailed state for a period of time (see Figure 7).

Figure 7: Wheel damage (all four wheels displayed similar damage)

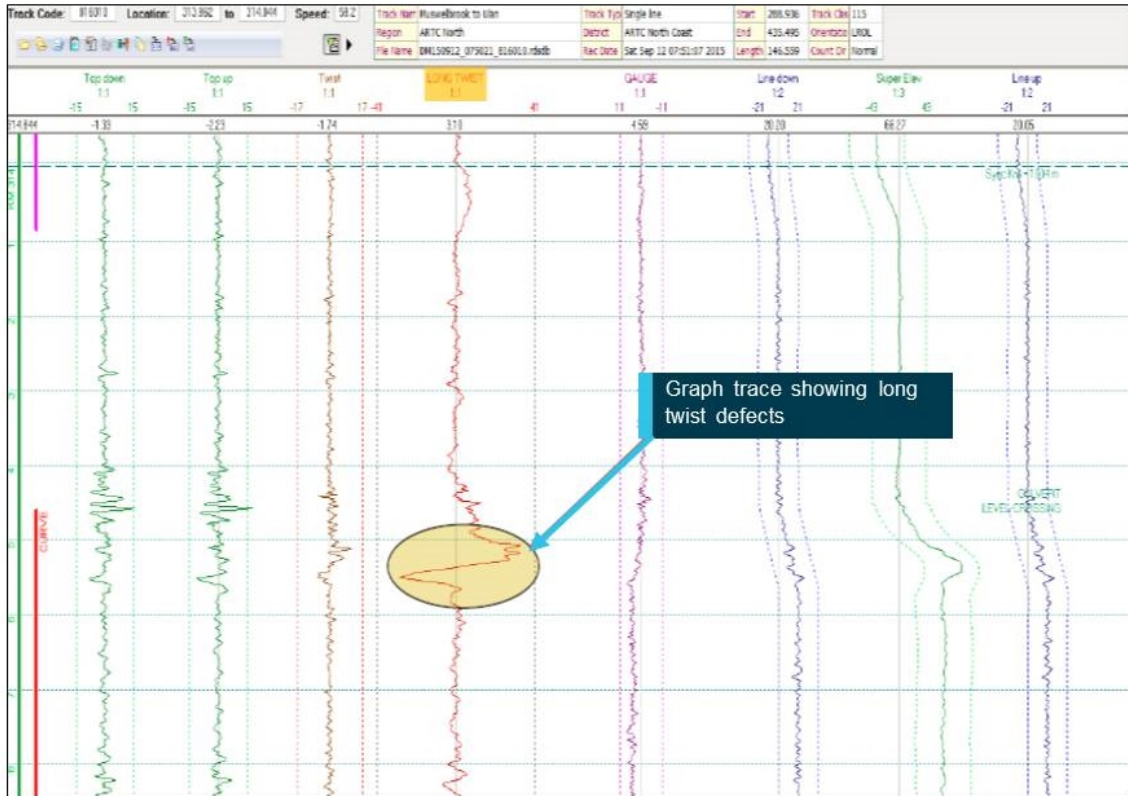
Figure 8: Track geometry recording car's graph 12 September 2015

On 12 September 2015, a routine track geometry recording car inspection identified a P1 long twist defect and top loss in both rails in the vicinity of the shear key at 314.523 km (see Figure 8). The track was again tamped and the defects were repaired on 7 October 2015.

The ATSB found that, three weeks after the installation of the shear key, a P1 long twist defect was identified in the vicinity at 314.523 km. This was probably due to soft fill and water moving into the backfill voids causing the track to settle and twist.

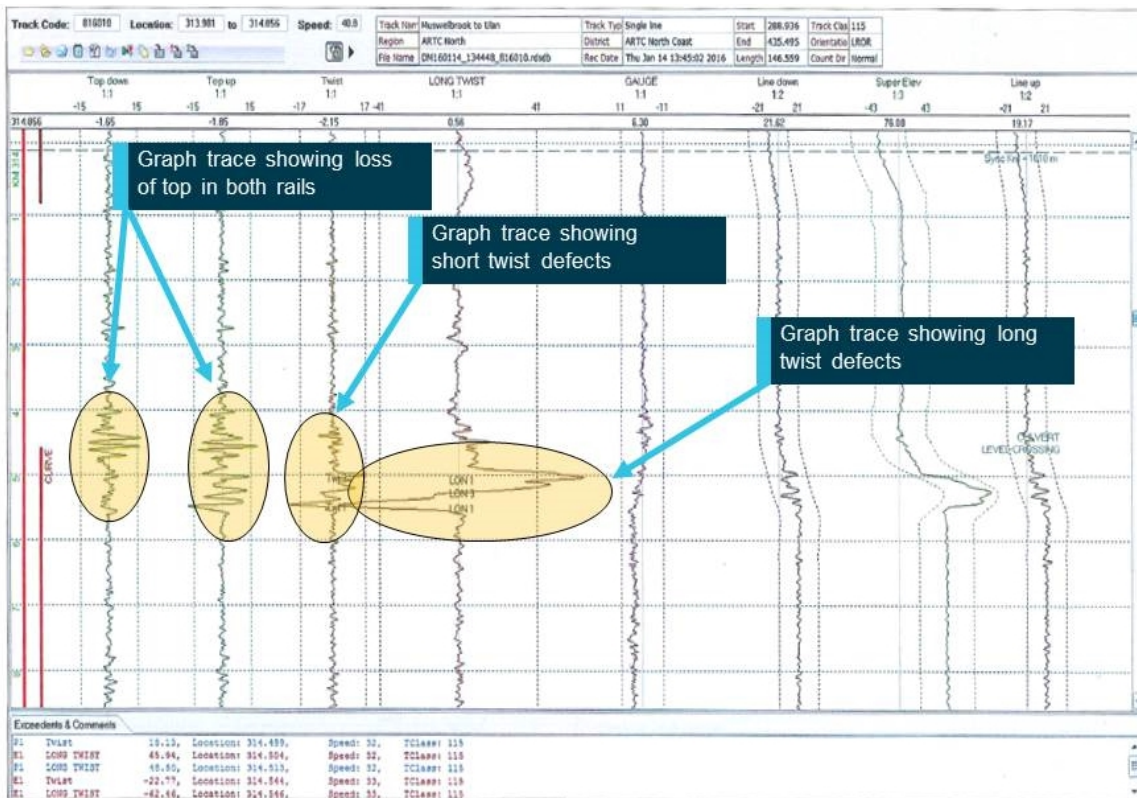
Figure 9: Track geometry recording car's graph 14 January 2016

- Top loss on both the Up and Down rail between 314.450 km – 314.550 km
- An Emergency 1 short twist defect at 314.544 km
- Two Emergency 1 long twist defects at 314.504 km and 314.546 km
- A Priority 1 short twist defect at 314.499 km
- A Priority 1 long twist defect at 314.513 km.

In response to the defects identified by the track geometry car, the 40 km/h TSR was reduced further to 20 km/h. The application of the 20 km/h TSR was in accordance with Section 5 - Table 5.5 of ARTC's COP and hence reduced the defective area's repair priority. The area was scheduled to be tamped (realigned) on 20 January 2016 to repair the identified defects.

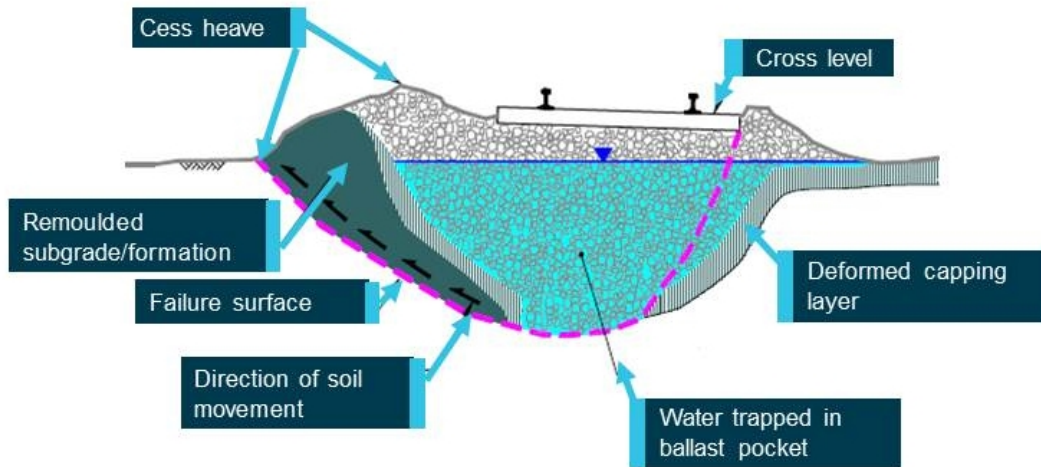
The geotechnical inspection was completed on 21 July 2015 by an ARTC geotechnical engineer. The inspection identified a weakened formation which was heaving towards the Up cess⁹ (see Figure 10). As an outcome, the geotechnical engineer recommended the track formation be reconditioned. This work was scheduled to be completed in the 2017/2018 Annual Maintenance Plan (AMP).

ARTC determined that the formation failure was due to a ballast pocket which had developed due to cumulative plastic strain¹³. It is likely that this was caused over time because of cyclic loading from normal train operations.

The ballast pocket would have prohibited water from draining away from the track as intended which likely contributed to the formation becoming saturated. This likely provided an environment for localised formation displacement under train loading (cumulative shear failure). As a consequence of this, it is likely that the formation displaced to a point where it was observed as heaving towards the Up cess which was identified by ARTC maintenance personnel on 20 May 2015 (see Figure 10).

Figure 10: Image depicting a ballast pocket caused by cumulative shear failure

1. A long-term solution to recondition the area by removing track panels, replacing the soft formation and reestablishing the capping layer/ballast depths
2. A short-term solution by installing a shear key which would remove the softened formation adjacent to the track and replace it with a stronger backfill.

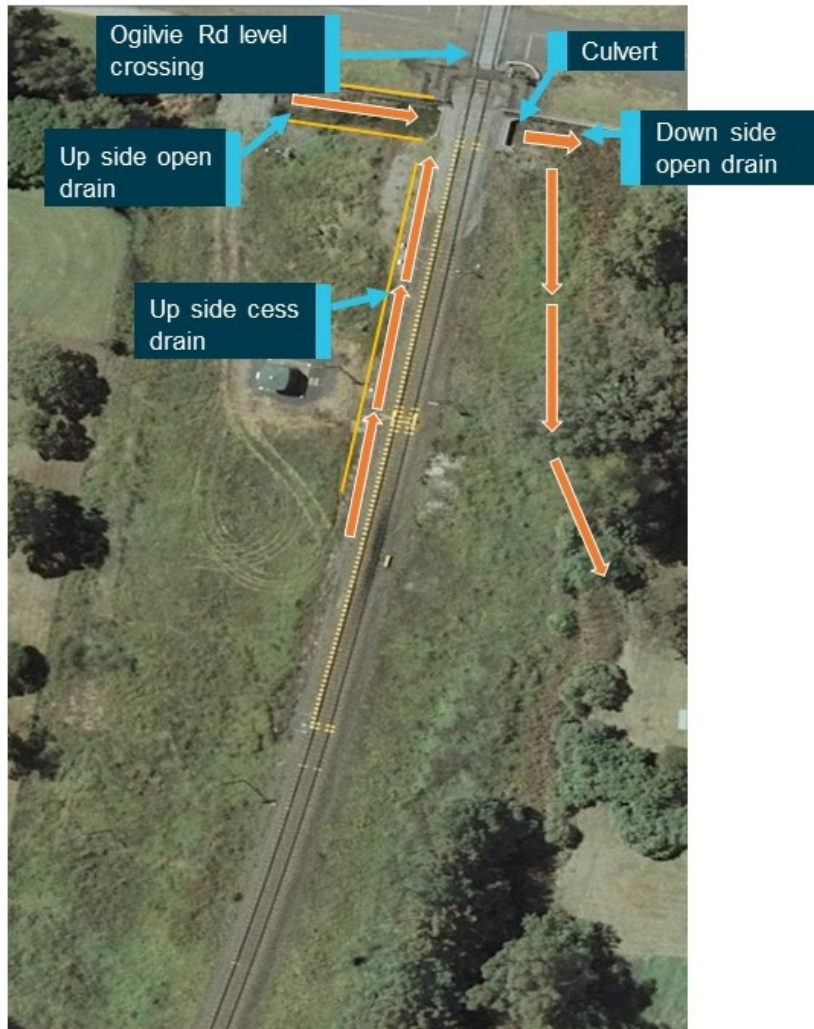
A cess drain was observed on the Up-side of the track. The cess drain was likely designed to direct water to an open drain adjacent to the Up-side culvert at 314.450 km. The culvert was likely designed to direct water from the Up side open drain to a connected open drain on the Down side. The culvert consisted of three 600-mm reinforced concrete pipes laid under the track from the Up side to the Down side. The Down-side open drain likely directed water away from the track (see Figure 11).

The ATSB observed that the Up-side cess drain was shallow and had a relatively flat gradient. Vegetation was also observed in both the Up and Down open drains, as well as the Up-side cess drain. The ATSB determined that the vegetation in the Up-side cess drain, its level gradient and shallow depth likely restricted drainage in rainy periods from the up slopes.

Figure 11: Drainage at incident location, orange arrows showing the expected flow of water

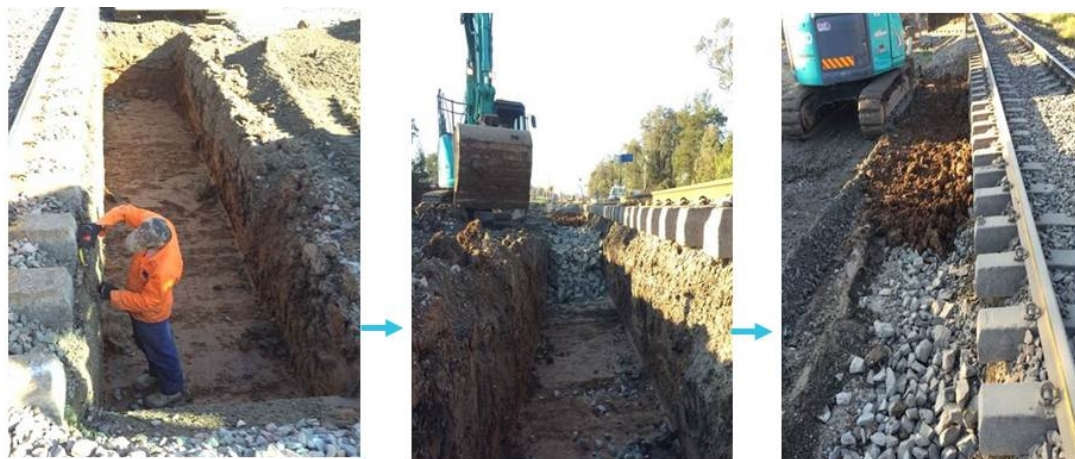
Figure 12: Shear key construction at Denman

ARTC advised that the shear key was installed on 21 August 2015 and was 25 m long, 1.2 m deep and 1.2 m wide. The backfill material used was clean, angular gabion rock of an aggregate size between 100 and 250 mm and no geo-fabric was used (see Figure 12).

The ATSB found that the actual shear key width was 20% less than the recommended width specified by the geotechnical engineer. This meant that the shear strength of the shear key would have been lower than what was specified by the geotechnical engineer. It was also identified that a cross-drain was not installed as per the geotechnical engineer's recommendation.

The use of large aggregate gabion rock as a backfill material likely introduced voids between the rock particles adjacent to the track. The absence of a geo-fabric and these voids likely provided a pathway for sludge (soft formation and water) to move into the voids. Without the shear key having any drainage capability, the water was likely trapped and contributed to degrade the track formation over time.
