# Safeworking irregularity involving Lookout Working

Near Tempe, New South Wales | 31 July 2017

**ATSB Transport Safety Report**  
Rail Occurrence Investigation  
RO-2017-009  
Final – 25 July 2019

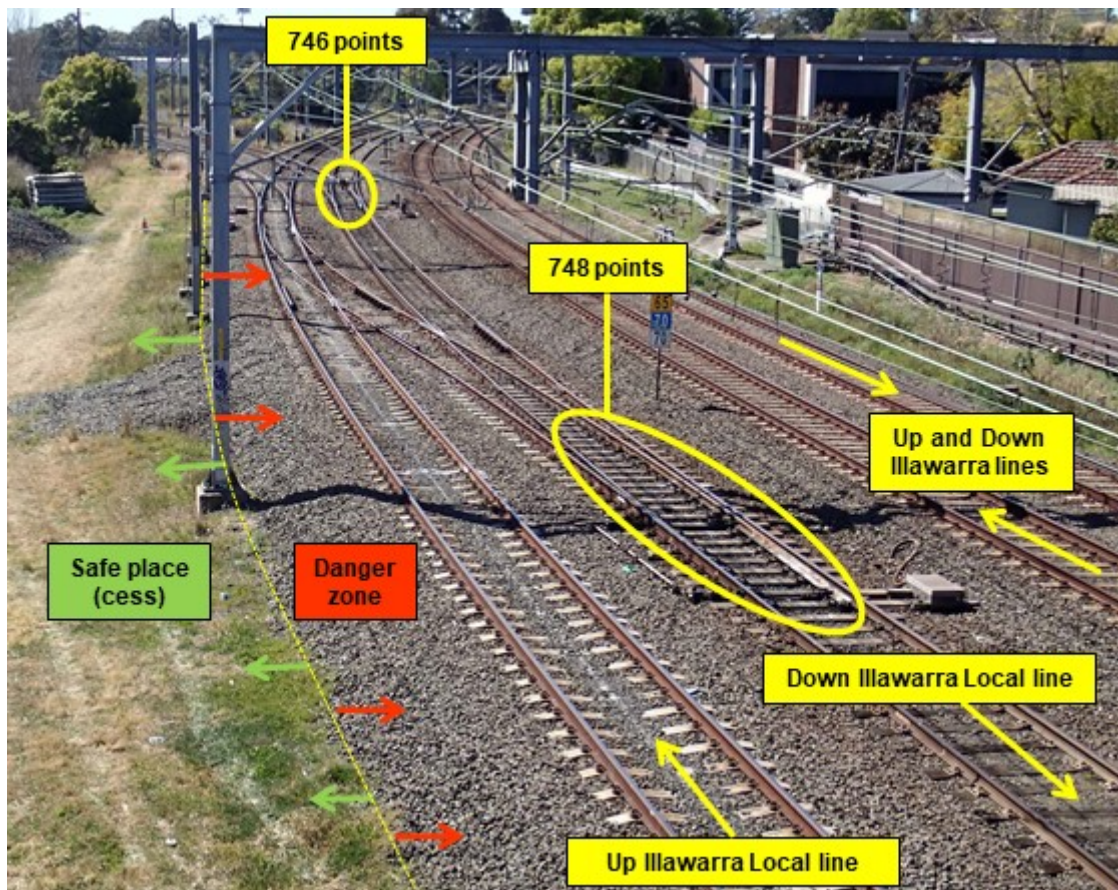
Figure 1: Incident location – Tempe, NSW

On the morning of 31 July 2017, a team of four Sydney Trains infrastructure maintainers from their Sydenham Network Base gathered to conduct a series of regular inspections and measurements at several points along the Up and Down Illawarra Main and Up and Down Illawarra Local lines, Tempe. The work involved four sets of points, with the incident occurring between 746 points and 748 points (see Figure 1).

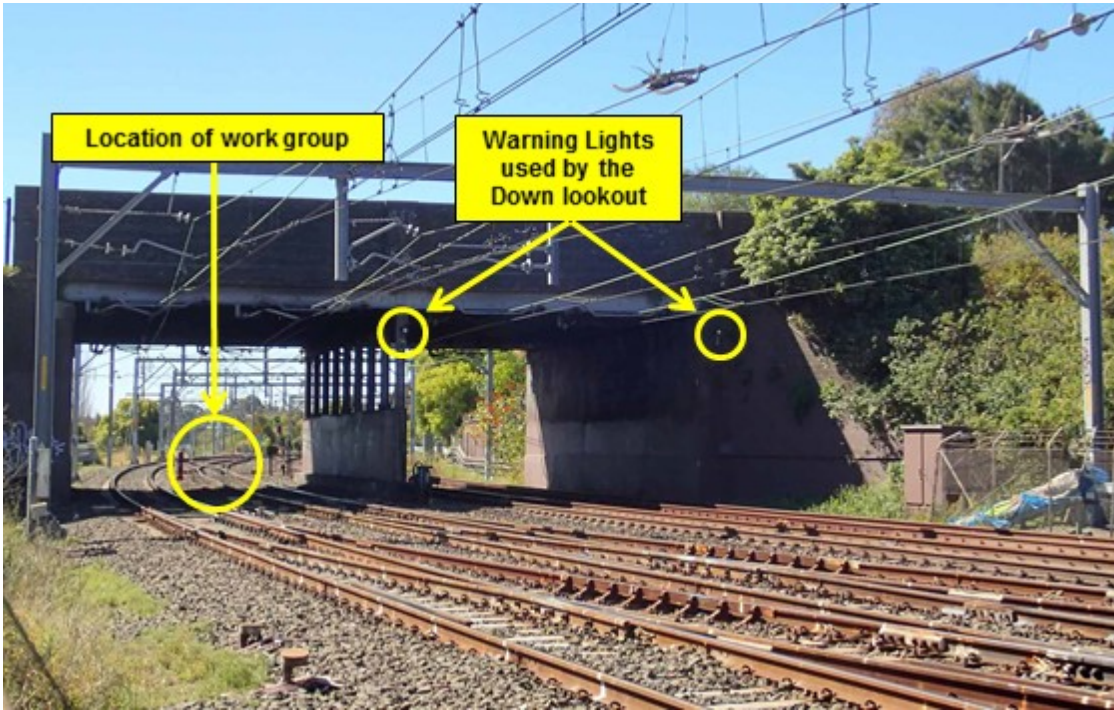
Figure 3: View from the position of the Down lookout

The distance of the work group at 746 points from the Up lookout was approximately 350 metres. The distance of the work group from the Down lookout from 746 points was approximately 170 metres. At these locations the Down lookout was within sighting distance of the work group, however, the sighting distance to the Up lookout was obstructed by the overhead bridge stanchions.

The Down lookout was on the Up side of the work group during the inspections of 746 and 748 points. It is possible the Down lookout's audible alarm coming from the Up side of the work group could have confused workers and delayed their evacuation from the danger zone. In most cases, Lookouts are on the extremities of the workgroup, so audible warnings from a lookout generally come from the direction the train is coming from.

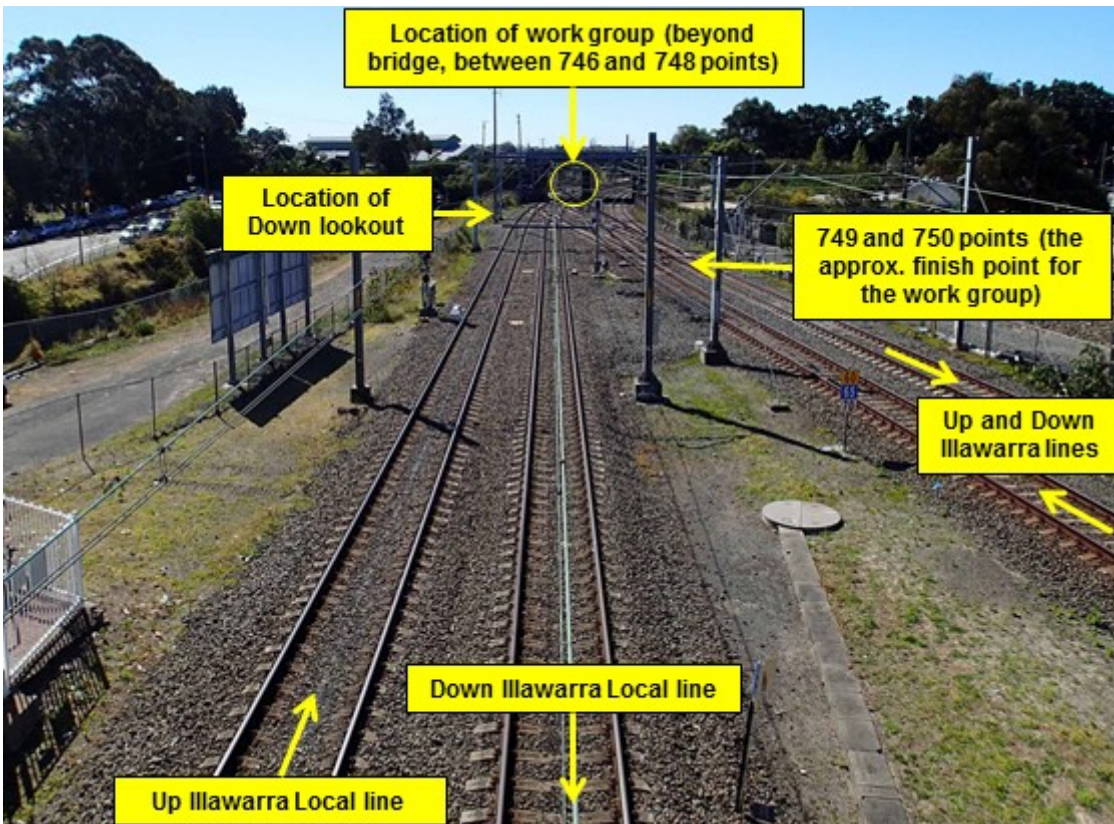
Figure 4: View from the position of the Up lookout, looking towards the work group

The location and distance of the Up lookout from the work group would have made it difficult for the work group to hear the audible warning devices during their first two point inspections of 746 points and 748 points (see Figure 4).

- The location and distance of the Up lookout from the work group may have made it difficult for the work group to hear the audible warning devices during their first two point inspections of 746 points and 748 points.

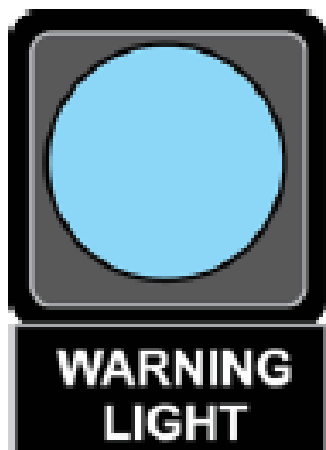
**Figure 5: Example of Warning light**

The warning lights used by the Down lookout were illuminated white with a configuration of the example warning light in Figure 5.

- **Warning lights were utilised at Tempe to overcome sighting hazards and justify the use of LOW. Warning lights rely on lookouts maintaining continuous observation and their use were not specifically referenced in the LOW Network Rules. [Safety issue].**

On 12 November 2017, Sydney Trains made changes to NPR 711 *Using Lookouts*<sup>5</sup>. Instructions mandated that warning lights must not be used to provide warning of approaching rail traffic when using lookouts. Further, this instruction applied to all tracks in the Sydney Trains Network unless specifically exempted in the Network Local Appendices.
