Grounding of *ABFC Roebuck Bay*

Henry Reef, Queensland | 30 September 2017

ATSB Transport Safety Report
Marine Occurrence Investigation
MO-2017-009
Final – 27 June 2019

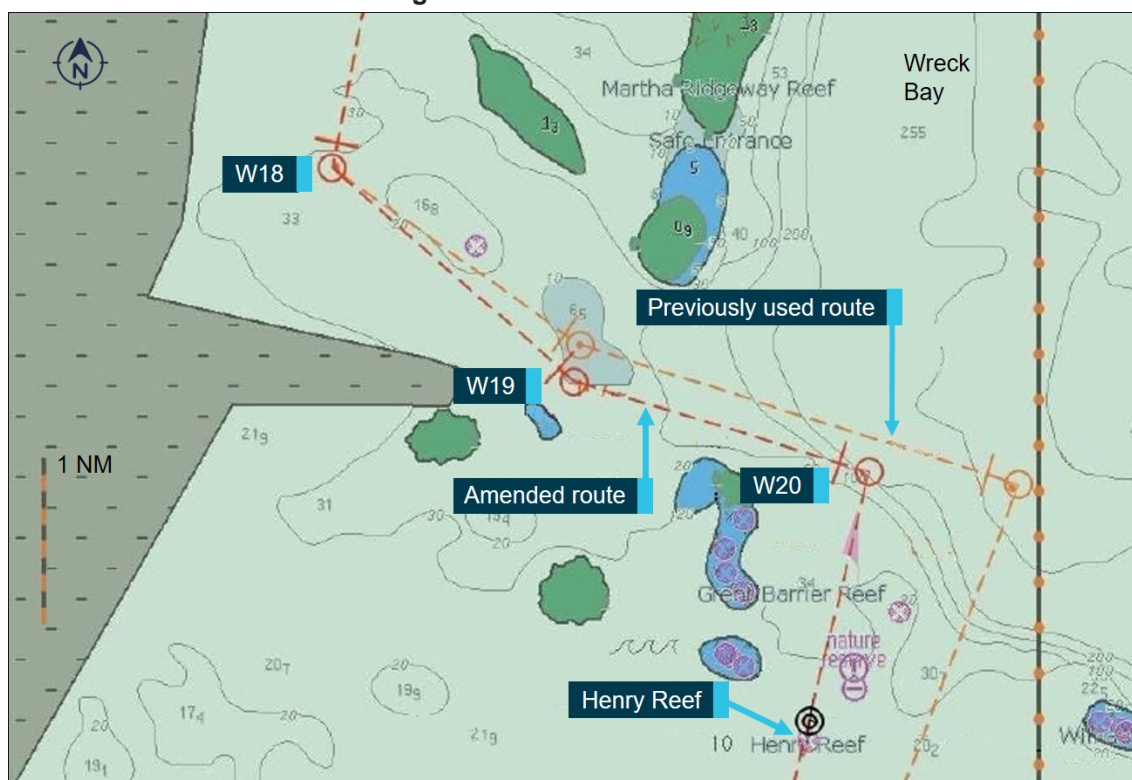
Figure 2: Image from *ABFC Roebuck Bay*'s ECDIS showing the section of the overall route with the amended route legs

When the master tried to save the amended route, the 'Errors' tab in the route tab folder of the ECDIS's 'Edit Route' menu turned yellow indicating an error in the route. The master advised the navigation officer of his desired amendments to the route and of the error encountered. The navigation officer reviewed the route's waypoint list in the ECDIS's route editor table and found the error to be an incorrect turn radius for one of the waypoints. The turn radius was amended, which cleared the error; the error tab reverted to its normal grey colour and changed to 'No Error'. The master and navigation officer then reviewed the amended route visually and saved it.

Image from ABFC Roebuck Bay's ECDIS display, taken after the grounding, showing the previously used route (orange) and the amended route (red) based on the changed waypoints, W19 and W20.

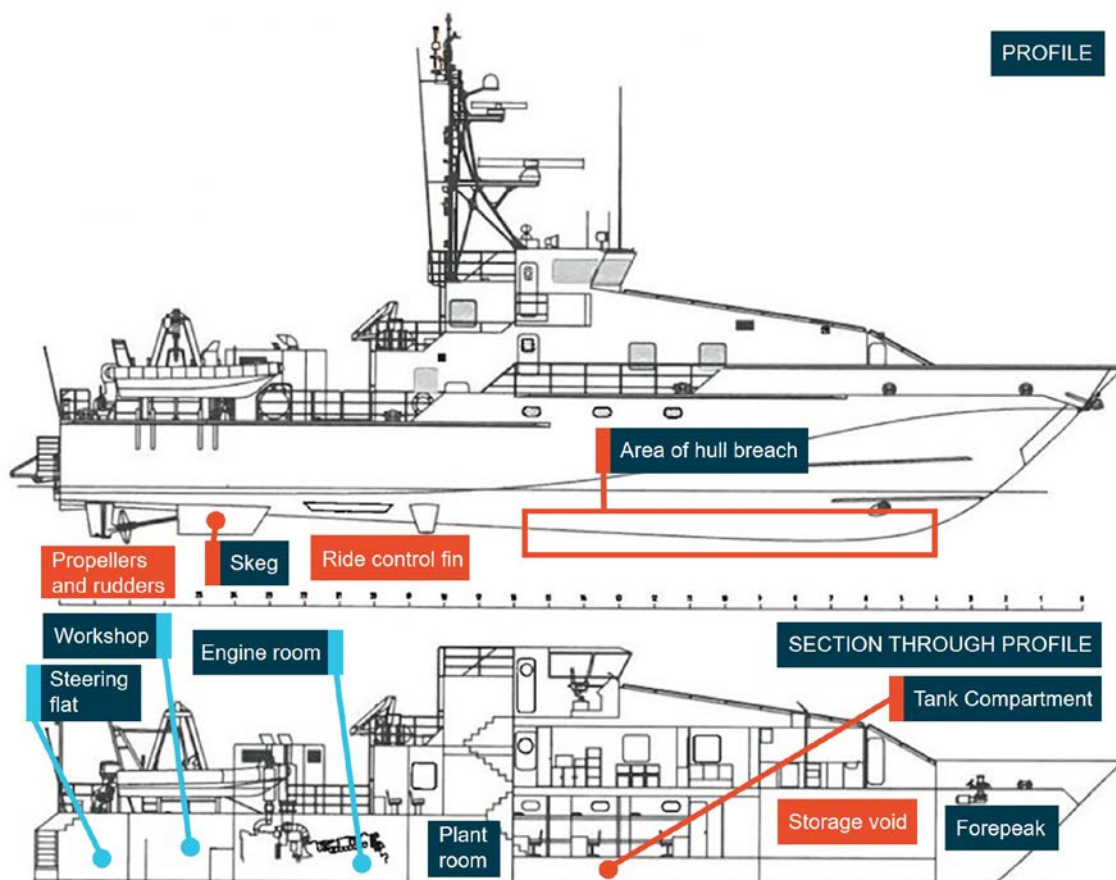
Figure 6: Section of general arrangement plan showing affected spaces

The master, who was in his cabin and was woken by the impact of the grounding, went to the bridge and activated the general emergency alarm. The cutter's crewmembers mustered and were all accounted for. They established that the cutter was aground on a reef and immediately began implementing damage control measures. Initial damage reports indicated that there was water ingress to the storage void space and the tank compartment immediately aft of it, while other spaces and compartments appeared to be intact (Figure 6).

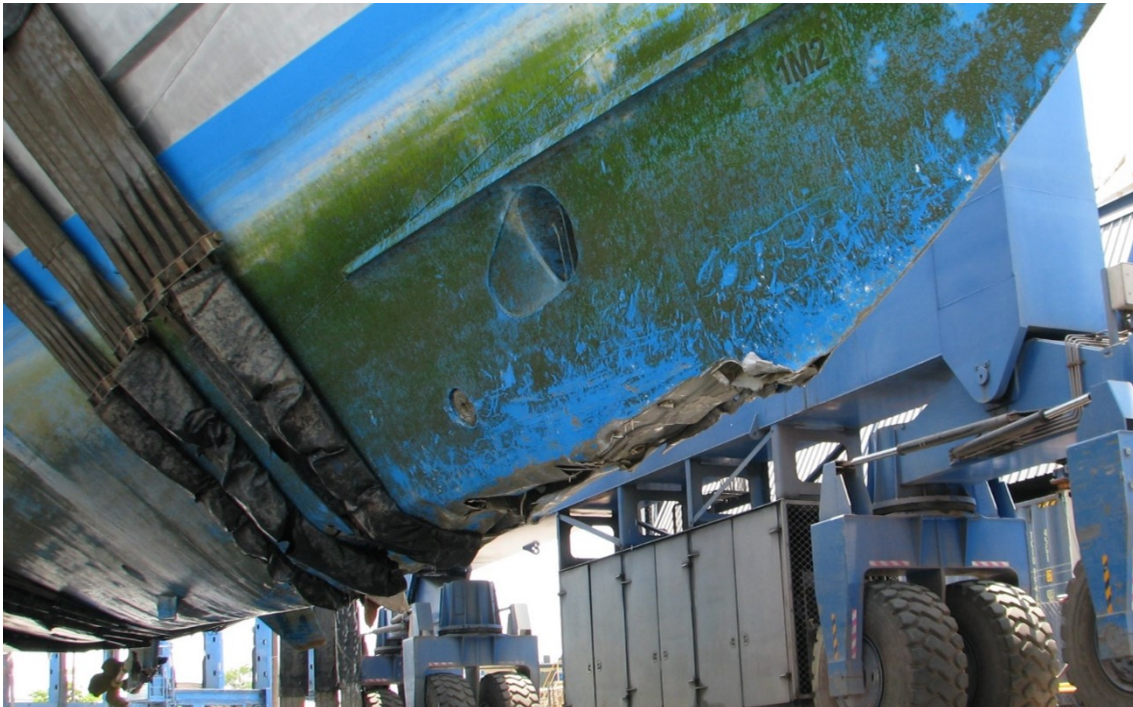
Figure 9: Damage to ABFC Roebuck Bay's keel

ABFC Roebuck Bay sustained substantial damage as a result of the grounding rendering the cutter unseaworthy. The storage void space and tank compartment (Figure 9) were both breached and flooded in way of the keel section with significant seawater damage to all electrical fittings in the two spaces.

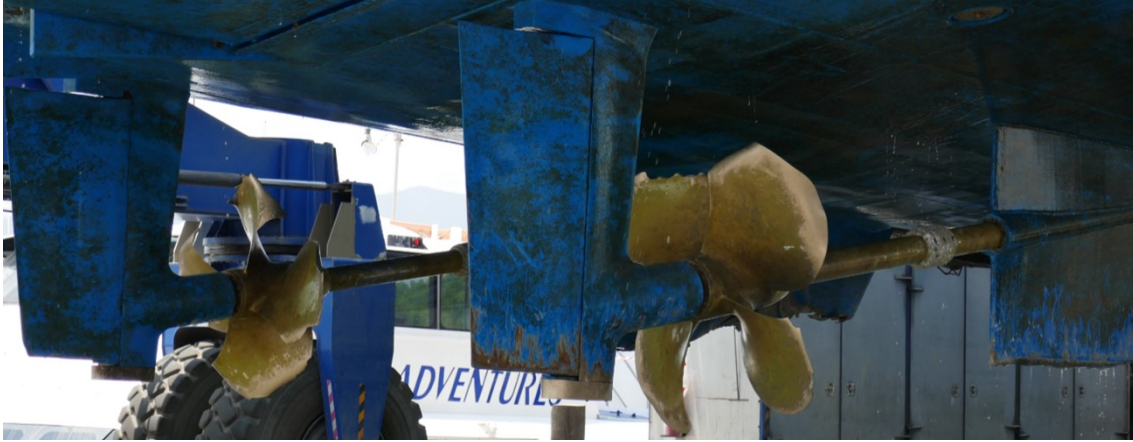
Figure 10: Damage to ABFC Roebuck Bay's propellers, rudders and skegs

Externally, the port and starboard ride control fins were found holed and bent. Similarly, the port and starboard skegs were found breached with a loss of watertight integrity and both stern tubes had sustained misalignments. The port and starboard propeller blades were also found to have

sustained extensive damage, especially to the blade tips, and both rudders showed minor deformation to the lower section of their trailing edges (Figure 10).¹⁶

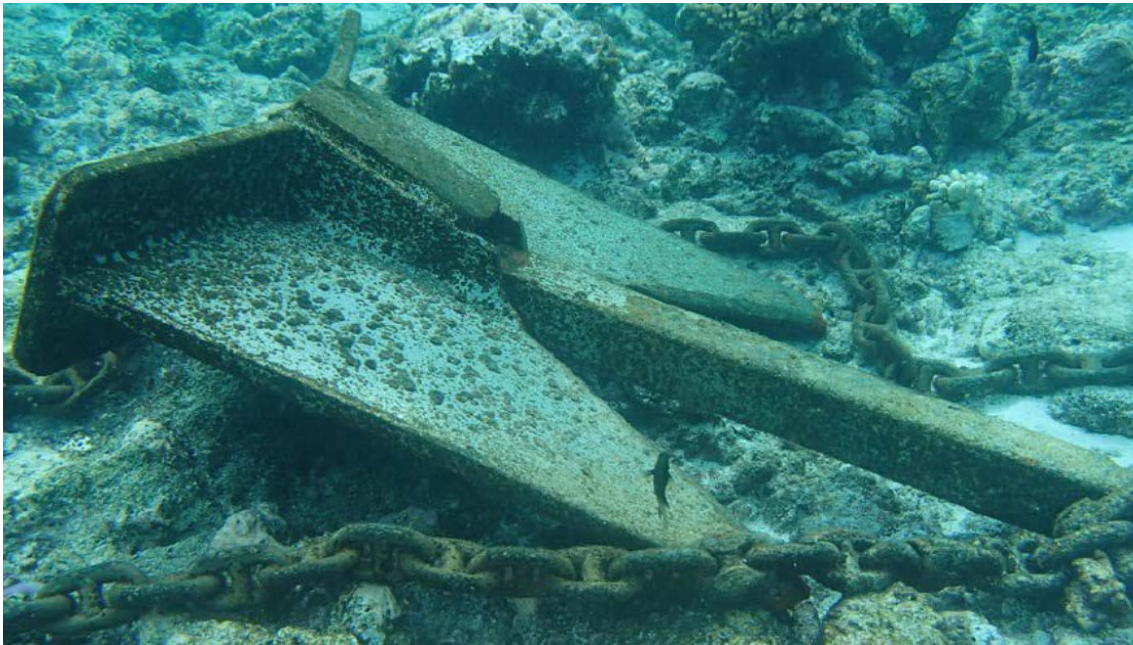
Figure 11: ABFC Roebuck Bay's anchor and chain on Henry Reef

In October 2017, officers from the Great Barrier Reef Marine Park Authority and Queensland Parks and Wildlife Service conducted a site assessment of Henry Reef. The assessment found that the maximum extent of physical reef damage occurred within an area of about 990 m² on the north-western aspect of Henry Reef.¹⁷ At the time of the assessment, ABFC Roebuck Bay's 184 kg anchor and about 150 m of anchor chain remained on the reef (Figure 11).

The assessment report concluded with recommendations to remove the anchor, chain and any other metal and anti-foul paint still on-site and to stabilise coral debris on the reef. In November

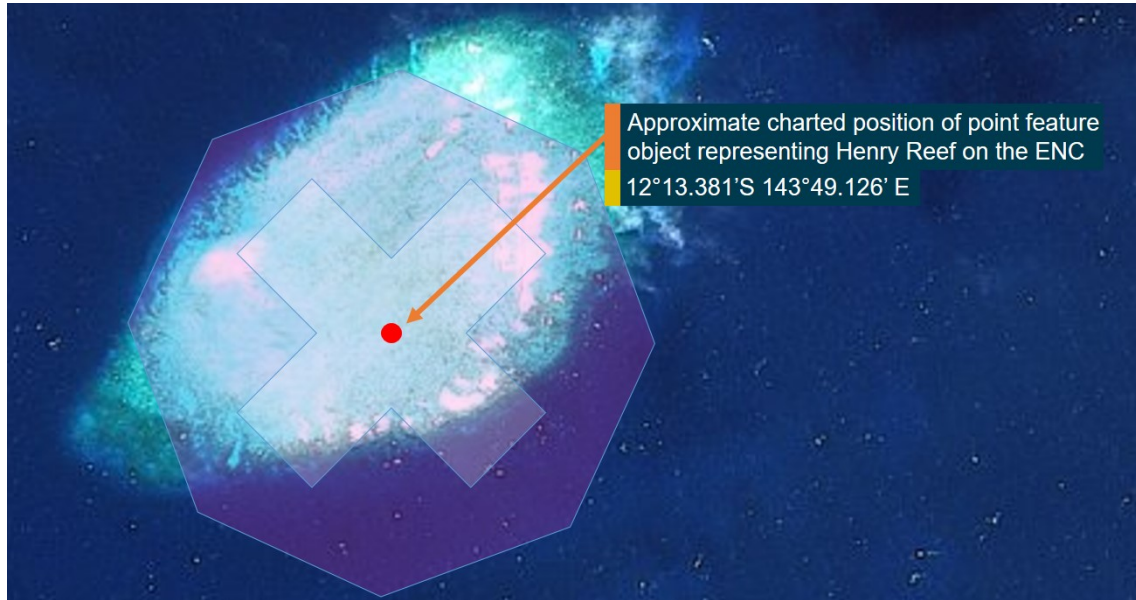
Figure 21: Charted position of Henry Reef point feature object on ENC

As a point feature, Henry Reef was charted in position 12° 13.381'S 143° 49.126'E on the ENC. Visually, this meant that the symbol representing Henry Reef would always be centred on this position (Figure 21). However, with regard to the ECDIS route checking functions (see *Point features and ECDIS safety checking functions*), the use of a point feature meant that the only

Image showing the charted 'point' position of Henry Reef as encoded in the ENC in relation to the actual reef. Note that the relative size of the isolated danger symbol to the reef is approximate only and that on the ECDIS display, the isolated danger symbol always displays at its standard size of about 7 mm regardless of scale.

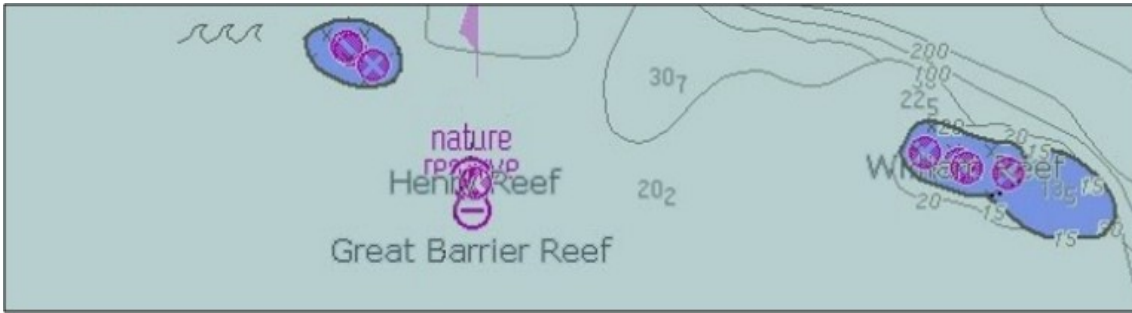
Figure 26: Image of ENC AU413143 displaying text and symbol overlap

Image shows ENC AU413143 centred on Henry Reef, at a scale of 1:40,000 on a VisionMaster FT ECDIS, demonstrating text and symbol overlap. Note that all text is on display as required by the Annex A - ECDIS start-up checklist. Source: Electrotech and ATSB

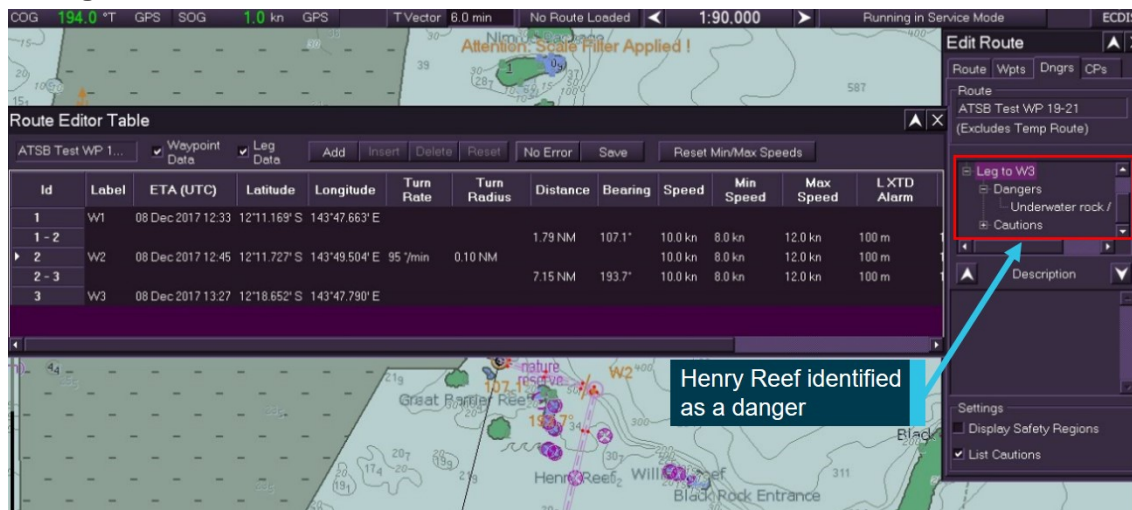
Figure 29: Danger identified on the amended route leg in the 'Edit Route' menu during testing

Image shows a danger (Henry Reef) identified by the ECDIS route dangers safety checking function on the amended route leg during ATSB testing. Note that the danger is not automatically highlighted on the chart and that the route validation function does not show any errors. Source: Electrotech and ATSB

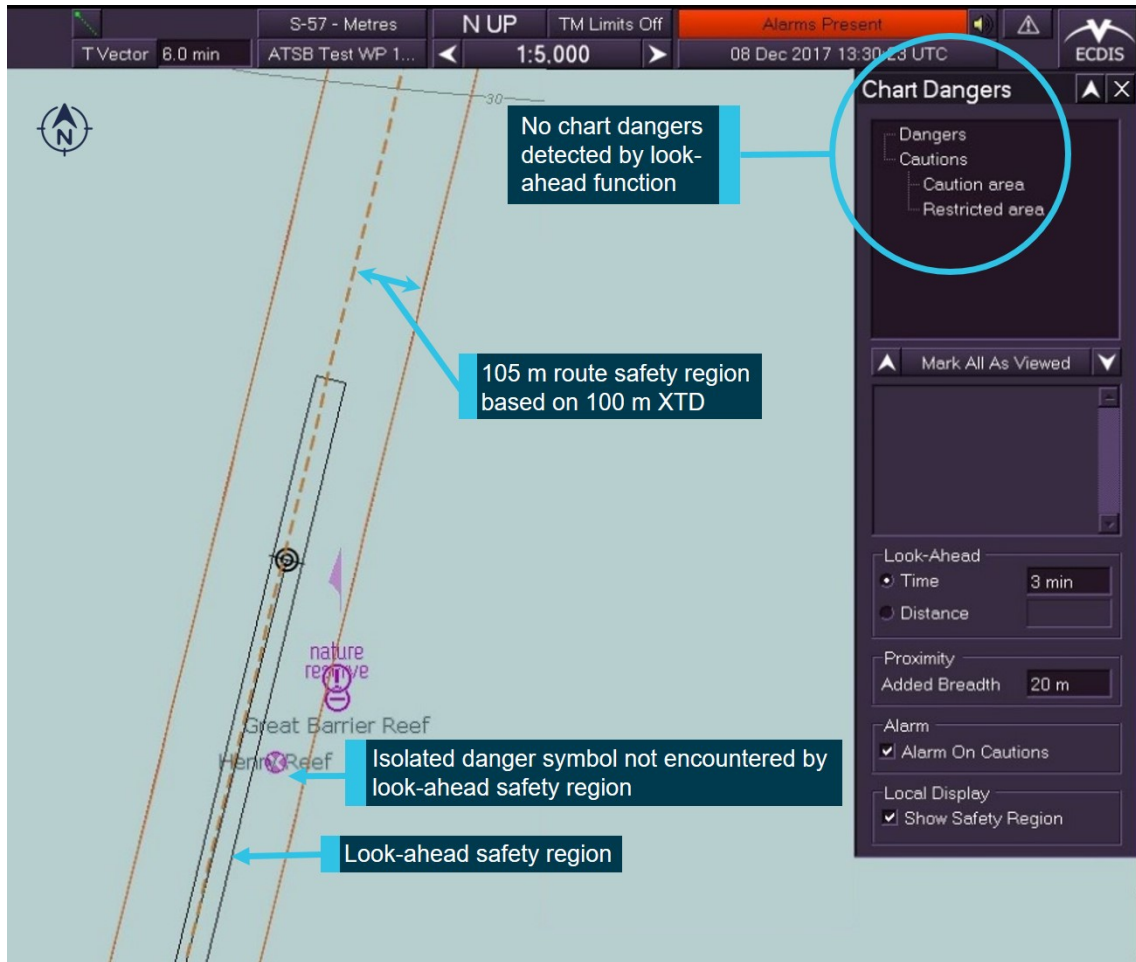
Figure 30: Image showing Henry Reef, undetected by the look-ahead function during testing

Image from ATSB testing showing Henry Reef going undetected by the ECDIS's look-ahead function when set up with a 20 m added breadth based on settings in the Annex A – ECDIS start-up checklist of the ABF work instructions.
 Source: Electrotech and ATSB

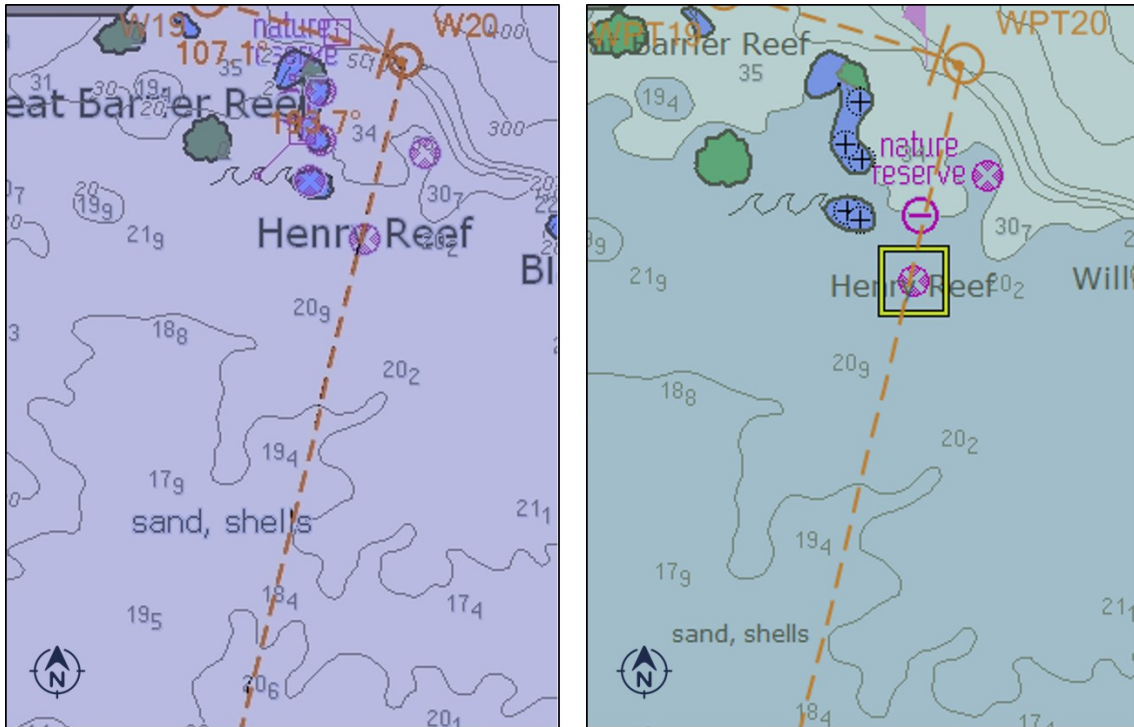
Figure 33: Images of ECDIS operating on PresLib 3.4 (left) and ECDIS updated to PresLib 4.0 showing indication highlight feature demonstrated on the amended route plan (right)

Image shows the amended route plan as it probably appeared on board ABFC Roebuck Bay (left) and as it might have appeared had the ECDIS been updated to PresLib 4.0 (right).

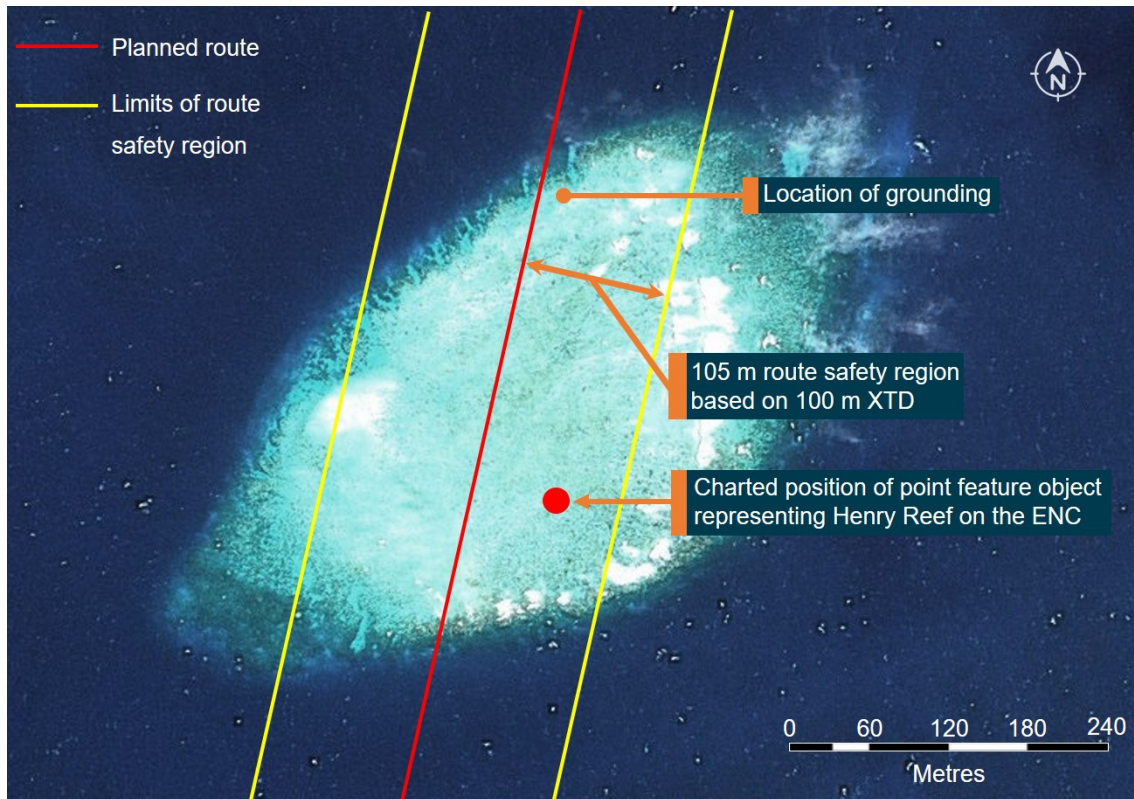
Figure 34: ABFC Roebuck Bay's planned route and route safety region

Figure showing ABFC Roebuck Bay's approximate planned route and the ECDIS route safety region based on a 100 m XTD in relation to the ENC's encoded position for Henry Reef. Note that the charted position of Henry Reef falls within the route safety region.
Source: DigitalGlobe, Esri, modified and annotated by the ATSB
