Undetected engine thrust reverser deactivation involving Airbus A320, VH-VQG

Gold Coast Airport, Queensland on 18 December 2017

ATSB Transport Safety Report
Aviation Occurrence Investigation
AO-2017-117
Final – 5 September 2019

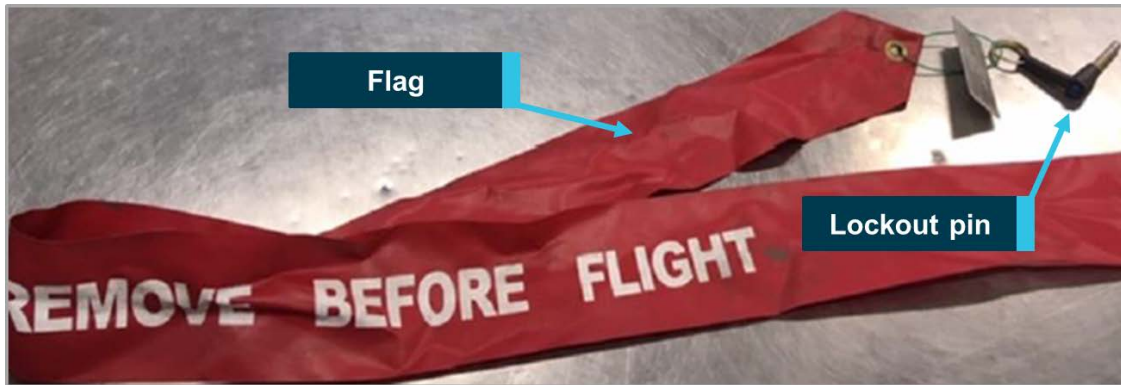
A couple of hours later, the engineers completed investigating the bleed air issue. By this time, it had started raining. Engineer 1 made a visual inspection around the engine in preparation to close the cowling. The available lighting had reduced as half the tarmac lights automatically turn off at midnight. Engineer 1 missed seeing the lockout pin and its 1 m long red warning flag, and closed

the cowling (Figure 1). The flag was shorter than those on the pins in the hangar tool store at Adelaide, which had been lengthened to 4 m after a previous incident to make them more obvious. Additionally, the stand that engineer 1 had used to install the pin, and which may have reminded him about it, had been removed for another task.

Figure 1: Photograph of a thrust reverser lockout pin and warning flag (non-reflective)

The red colour of the flag was also harder to see in the artificial lighting,⁴ and the flag was not fitted with reflective material. The lockout pin was located at the top of the engine, where its 1 m flag was not as conspicuous as other longer flags, which would have hung below the engine to the tarmac. Further, the stand used to install the pin, which might have served as a reminder, had been removed. The combination of these factors probably led to the pin not being removed.

- Lengthening all thrust reverser lockout pin flags to hang past the closed cowls. The pin will also have a warning notice attached for placement on the engine thrust reverser controls during maintenance.
- Focused audits on work practices for tooling and documenting maintenance activities.
- Reiterating the responsibilities of engineers to those involved in this incident.
