# Non-operation of level crossing protection

Colac, Victoria on 22 September 2018

**ATSB Transport Safety Report**  
Rail Occurrence Investigation  
RO-2018-015  
FINAL – 8 October 2019

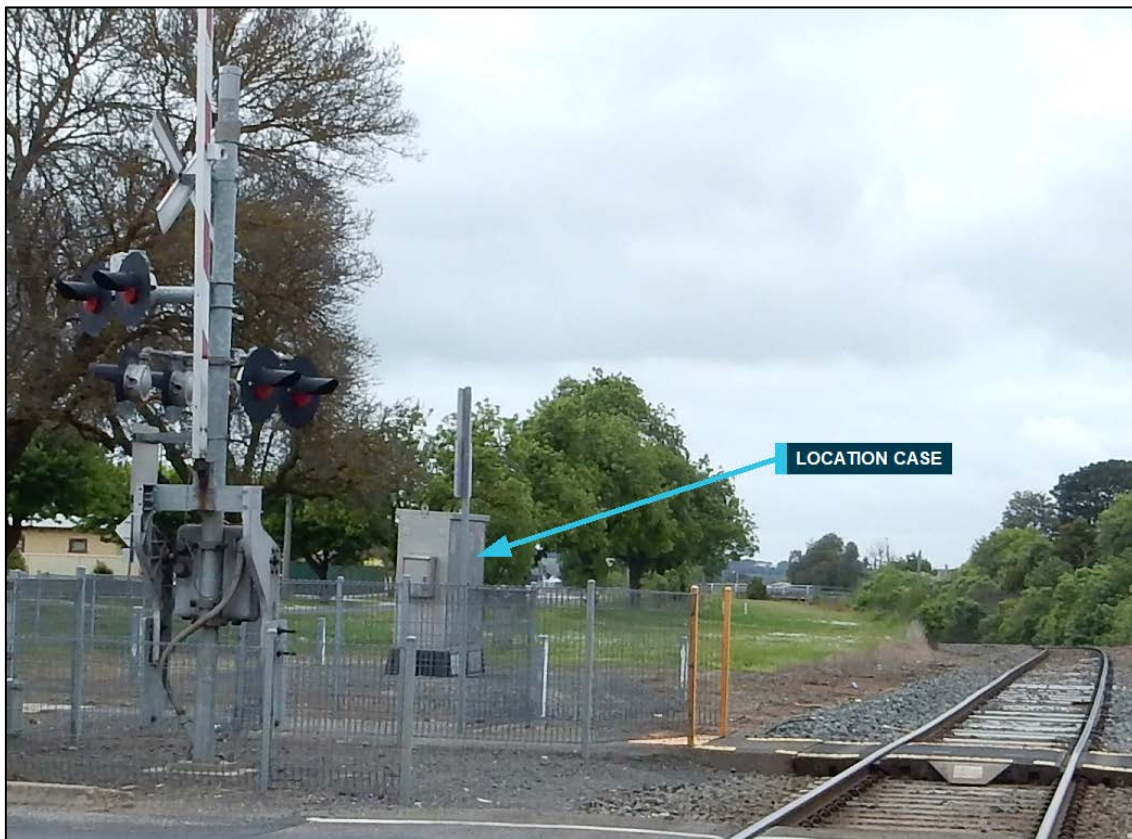
**Figure 3: Position of a typical RLX location case (Hart St, Colac)**

The SMT then reinstated the in-track equipment for Hart Street (1.5 km distant) and went to the location case (the level crossing equipment control box) intending to return the control equipment to operation. However, due to overlapping track circuits<sup>5</sup> not yet being reconnected, the full restoration of the Hart Street crossing protection was not completed at that point in time. The technician then went to undertake other tasks, and subsequently did not return to Hart Street to complete its reinstatement.

Subsequent inspection of the Hart Street RLX active protection revealed that the level crossing protection had not operated because it was still inhibited.
