Loss of separation involving Boeing 737 aircraft, VH-YFW and VH-VZD

near Amberley, Queensland, on 11 October 2018

ATSB Transport Safety Report
Aviation Occurrence Investigation
AO-2018-070
Final – 4 December 2019

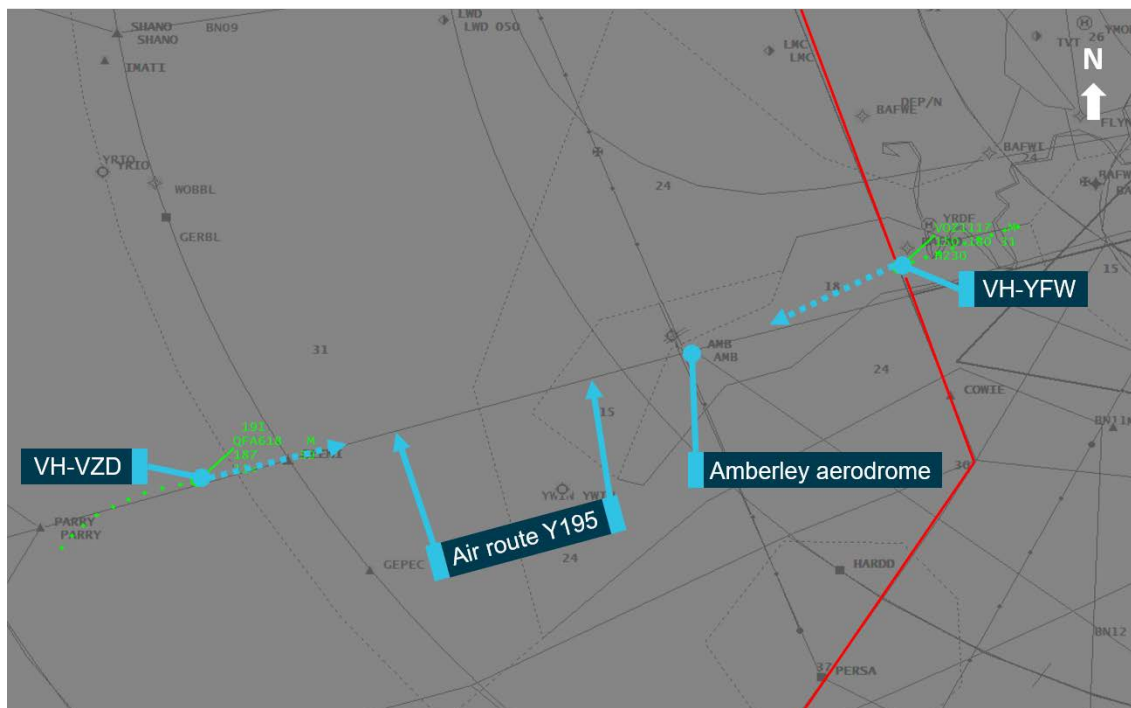
At 1410, as YFW was approaching Amberley airspace, the Brisbane departures controller provided the RAAF Amberley approach controller with an identification on the aircraft, as required by the procedures in the *Manual of Air Traffic Services (MATS): Supplementary South East Queensland*.³ At this time, the Amberley approach controller advised the Brisbane departures controller of the inbound aircraft on air route Y195 (Figure 1). The Brisbane departures controller replied that YFW would be turning right soon. The Brisbane departures controller then asked the flight crew of YFW to advise when they could turn right (north). The flight crew advised they would like to stay on heading 230 for an additional 70 to 80 NM due to the weather. It was around this time that YFW entered Amberley airspace (Figure 1), while still communicating with the Brisbane departures controller.

Figure 1: Position and direction of the two aircraft when VH-YFW entered Amberley airspace at 1411:44. The red line indicates the boundary between Brisbane airspace (right) and Amberley (left) airspace. Air route Y195 was assigned to VH-VZD.

The red line in Figure 1 shows the delineation between Brisbane and Amberley airspace. The local coordination procedures between Brisbane and Amberley ATC are described in the *MATS: Supplementary South East Queensland*. This document included the following:
