Runway excursion involving a Fairchild Metro 23, VH-UUB

Portland, Victoria | 20 February 2014

ATSB Transport Safety Report
Aviation Occurrence Investigation
AO-2014-028
Final – 22 March 2016

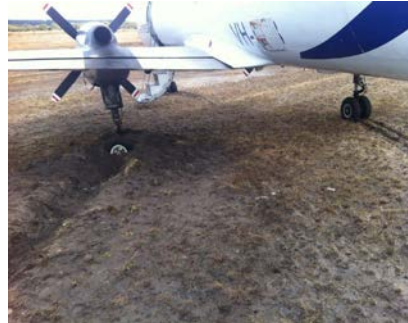
On 20 February 2014 at 1425 EDT, a Fairchild Industries Metro 23 aircraft, registered VH-UUB, was being operated on a charter flight from Avalon to Portland, Victoria with 10 passengers and two crew on board. Shortly after touch-down the torque link on the left, main landing gear (MLG) failed. The aircraft veered left as a result, and came to rest beside the runway. There were no injuries as a result of the occurrence.

UUB after veering off runway

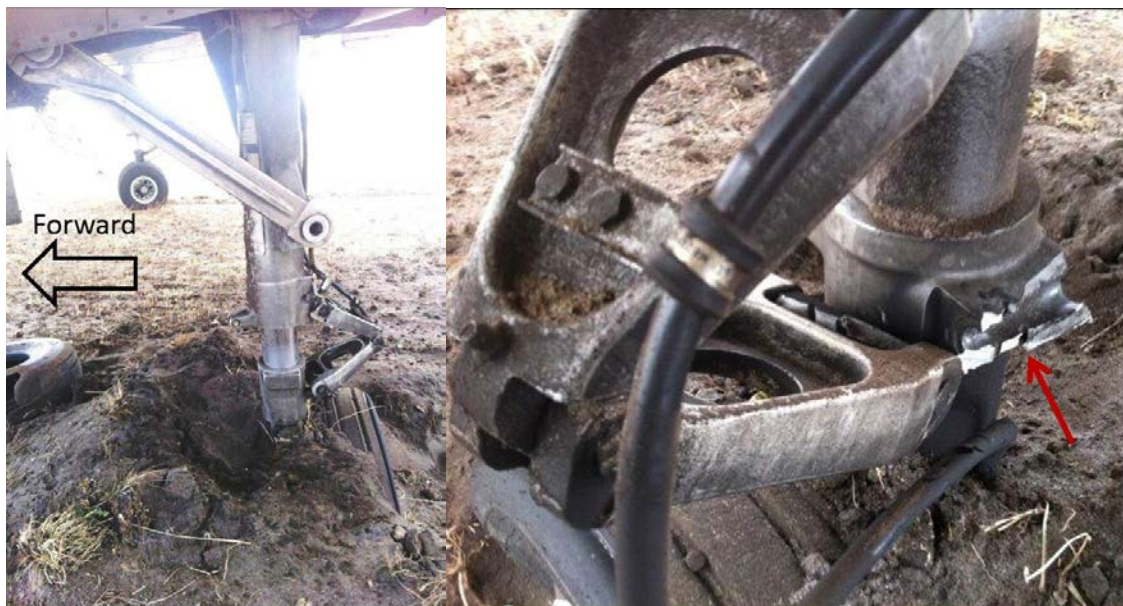
Figure 1: Damage to the left MLG

The runway excursion resulted from failure of the lower torque link attachment lug on the left main landing gear's yoke. This allowed the wheels to rotate through 90° with respect to the direction of aircraft travel and skid, producing a large braking effect on the left side. The flight crew were unable to counteract this and it resulted in the aircraft veering to the left and off the runway.

Subsequent inspection of the aircraft found that the torque link² had detached from a fractured lug on the lower section of the left MLG (arrowed in Figure 1b), allowing the wheel assembly to rotate through 90° w.r.t. the direction of aircraft travel. This resulted in skidding wheels, producing a significant braking effect on the left main gear and causing the aircraft to veer to left and depart the runway (Figure 2).

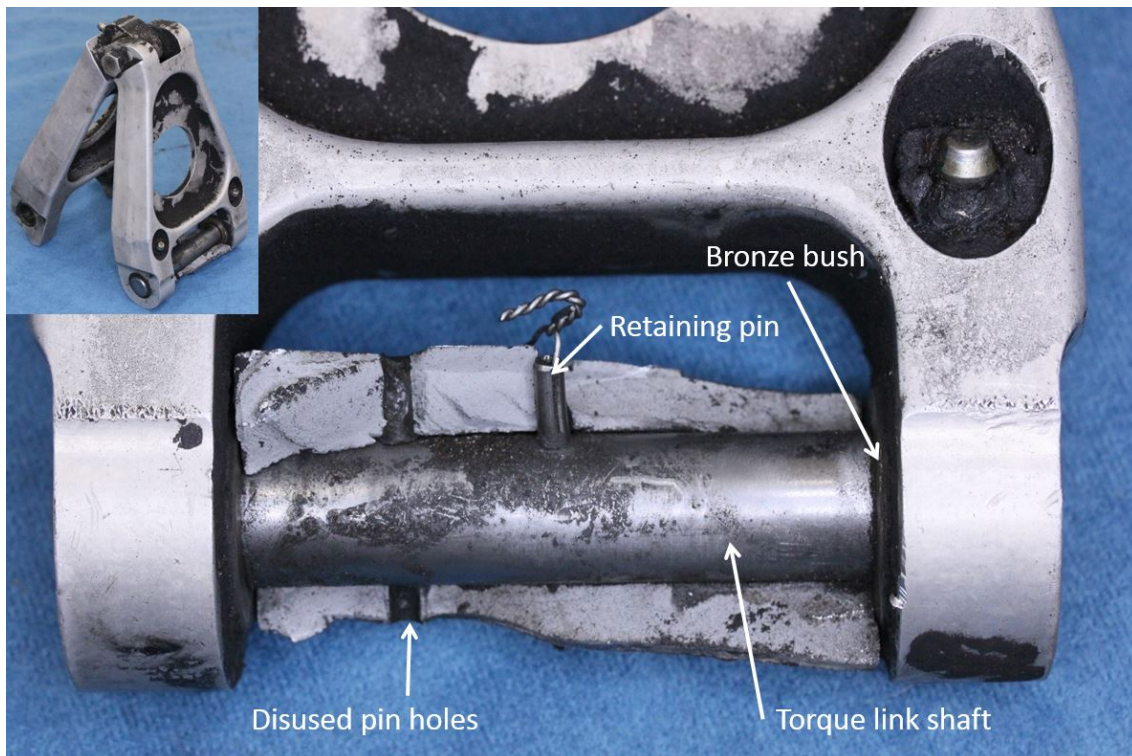
Figure 4: Lower torquelink attachment assembly with fractured lug segment in-situ

The aluminium torque link and yoke were assembled via a steel torque link shaft (TLS) that mated with bronze bushes in the lower link. It was secured with a single, stainless steel retaining (spring) pin with stainless steel lockwire in its bore (Figure 4).

The fractured yoke contained four disused retaining pin holes (two each top and bottom) as a result of compliance with a service bulletin (SB) for installing a replacement TLS (CC7-32-012), released in 2002. The SB required drilling of a new pin hole in the lug to secure the replacement TLS and filling of the redundant holes with sealant. As-examined, the disused holes in the fractured yoke were not sealed, but instead contained black corrosion/wear product. However, traces of sealant around some of the holes suggested that they had probably been filled at the time of service bulletin compliance.

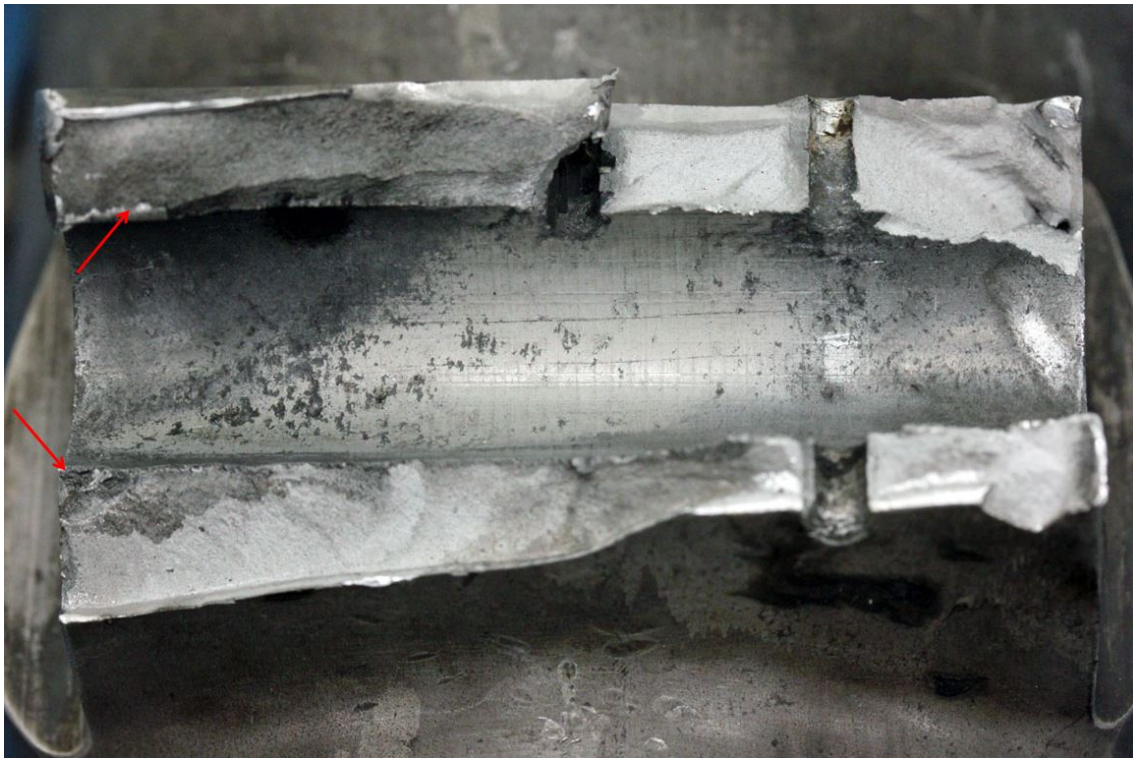
Significant corrosion pitting was evident in the bore of the lug and on the lug flanks, with concentrations around the four disused, spring pin holes (Figure 5). Fatigue crack progression (beach) marks were identified on the lug fracture surfaces with the crack origins located at areas of significant corrosion pitting and wear in the bore. The fatigue cracking progressed across most of the lug cross section before the remaining portion fractured by ductile overstress. The overstress areas were largely defined by a narrow region on the outside radius of the lug (furthest from the bore).

Detailed examination of the corrosion pits adjacent to the fracture surface found evidence of corrosion product as well as a series of crack progression marks radiating outwards from the edge of the corroded areas.

Figure 5: Yoke lug exhibiting corrosion pitting, wear in the bore and fatigue crack progression on the fracture surfaces (main crack origins arrowed)

The yoke lug fractured as a result of a fatigue cracking mechanism with crack initiation points located in the bore of the lug at areas of significant wear and corrosion pitting. The fatigue crack progressed through most of the lug cross section before final fracture during the occurrence landing.

There were several factors that influenced corrosion of the yoke lug bore. Sealing of the disused pin holes in this occurrence was not adequate as the sealant had either broken down over time or otherwise disbonded and come loose during service, providing additional entrance routes for moisture or other corrosives. Another entrance route was associated with wear on the yoke lug flanks where significant pitting was identified. Wear on the flanks and in the bore of the lug was sufficient to remove the protective anodic coating, which increased the susceptibility of the parts to corrosion. With corrosion pitting being a precursor to the fatigue failure of the component, improvement of corrosion protection in the affected areas would further reduce the likelihood of this type of occurrence.

The Civil Aviation Safety Authority (CASA) released Airworthiness Bulletin AWB 32-023 to alert all Fairchild Swearingen Metro and Merlin operators of the need for detailed inspection of the internal bore of the landing gear torque link lugs for any signs of corrosion or wear outside of the manufacturer’s specified limits and to take appropriate action per the aircraft’s structural repair manual, where necessary.

M7 Aerospace has drafted service bulletins SB 226-32-083, 227-32-065, CC7-32-030 entitled “Inspection of Main Landing Gear Yoke for Corrosion and/or Damage” for all operators of SA226- and 227 aeroplanes with M7/Fairchild Main Landing Gear Yoke and Torque Link Shaft installed. The SB will require disassembly of the components and detailed visual inspection, liquid penetrant inspection, magnetic particle inspection and high-frequency eddy current inspections for cracks or corrosion on and inside the torque link lug and shaft of the MLG yoke.

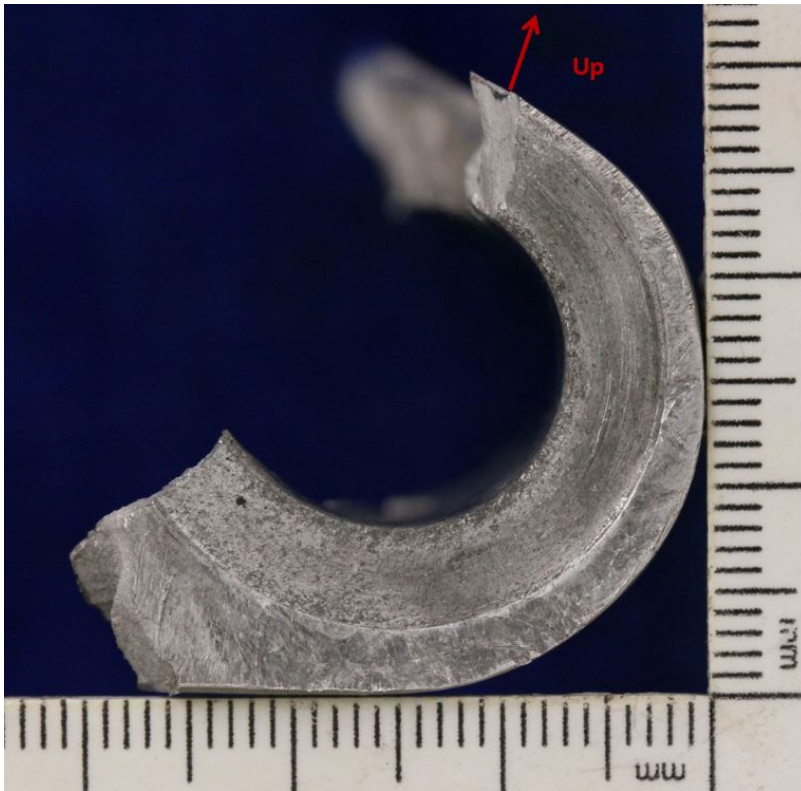
The bronze bushes installed in the lower torque link had worn against the yoke’s lug flanks during normal operation such that, in the areas of greatest wear, the width of the lug was now 66.03mm (2.6”) which was 0.26mm (0.01”), below the minimum dimension of 2.61” (66.294mm) specified in the structural repair manual (Figure 6).

Figure 6: Flank of the fractured yoke lug showing surface wear from mating bush
