Incorrect configuration for landing involving Airbus A320, VH-VQK

Ballina/Byron Gateway Airport, New South Wales, on 18 May 2018

ATSB Transport Safety Report
Aviation Occurrence Investigation
AO-2018-042
Final – 10 December 2019

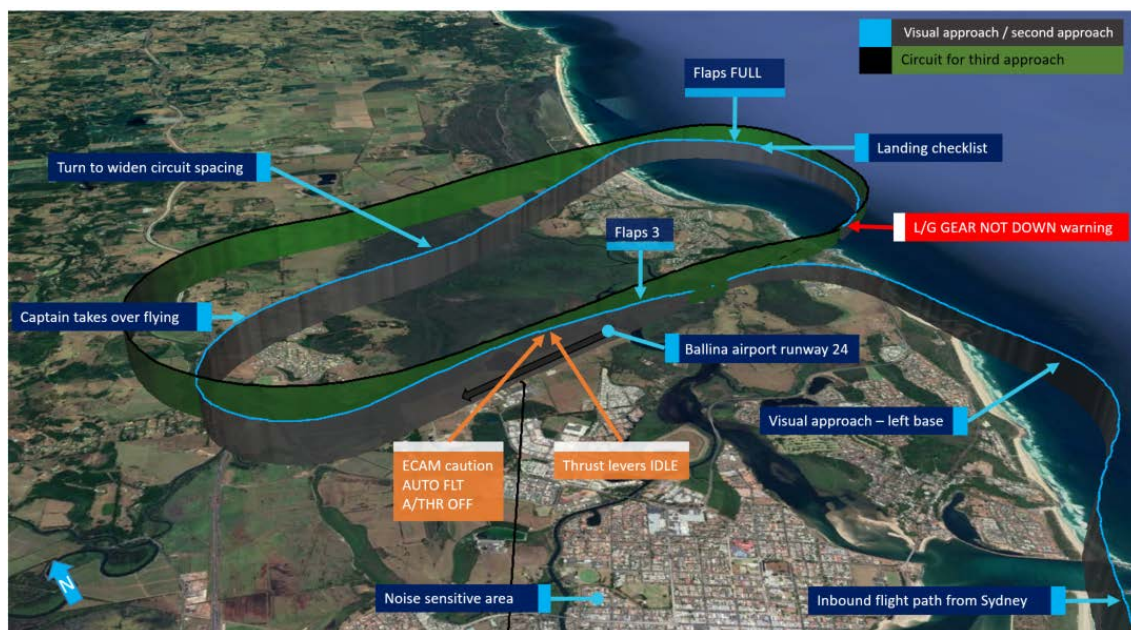
Figure 1: Flight path of VH-VQK during incident flight

At 500 ft above ground level (AGL) the aircraft automatically generated a callout of 'five hundred' and the captain commanded a go-around by calling out 'not stable'. The FO commenced the go-around procedure (Figure 1).

The FO commenced a left turn to conduct a standard left circuit for runway 24, however, the captain instructed the FO to conduct a right circuit. The captain later recalled his decision to conduct a non-standard right circuit was predicated on a number of reasons, but mainly due to the helicopter conducting right circuits and the noise sensitive area over the Ballina township to the south-east of runway 24 (Figure 1).

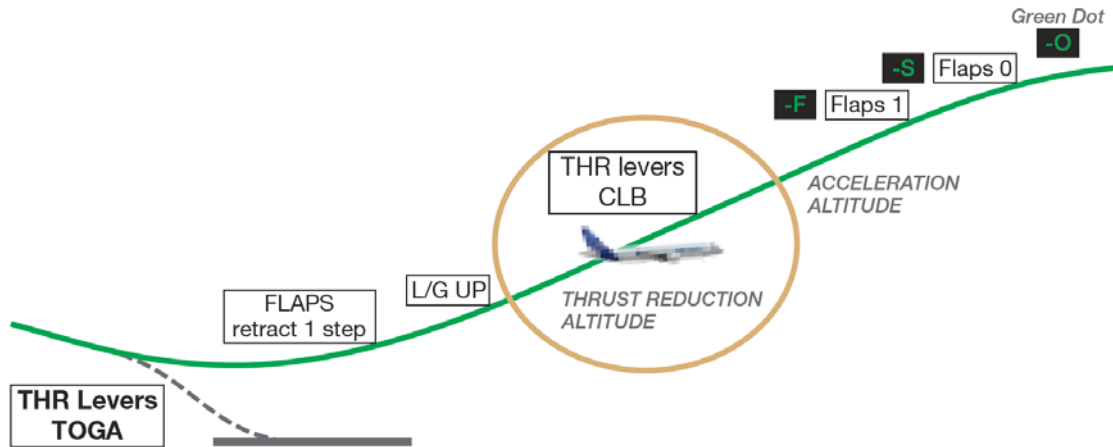
Figure 2: Airbus A320 go-around profile

The operator's procedures stated the pilot flying (PF) must conduct an immediate go-around if the pilot monitoring (PM) called '500 not stable'. The operator's go-around procedure (based on the aircraft manufacturer's procedure) detailed a sequence of actions that the PF and PM were required to perform, as summarised in Figure 2.

For most go-arounds, once the aircraft reached the nominated thrust reduction altitude, the procedure required the thrust levers to be placed into the climb detent by the PF. This action would activate the autothrust system.

In SPEED mode, the autothrust adjusts the thrust in order to acquire and hold a speed target and does not allow speed excursions beyond the maximum speed for each flap configuration. The flaps are not automatically retracted from the Flaps 3 configuration.⁷ As the aircraft accelerates, the flight crew would need to retract flaps to the required position. The operator's procedure when conducting a visual circuit following a go-around was normally to re-configure the aircraft to the Flaps 1 position.

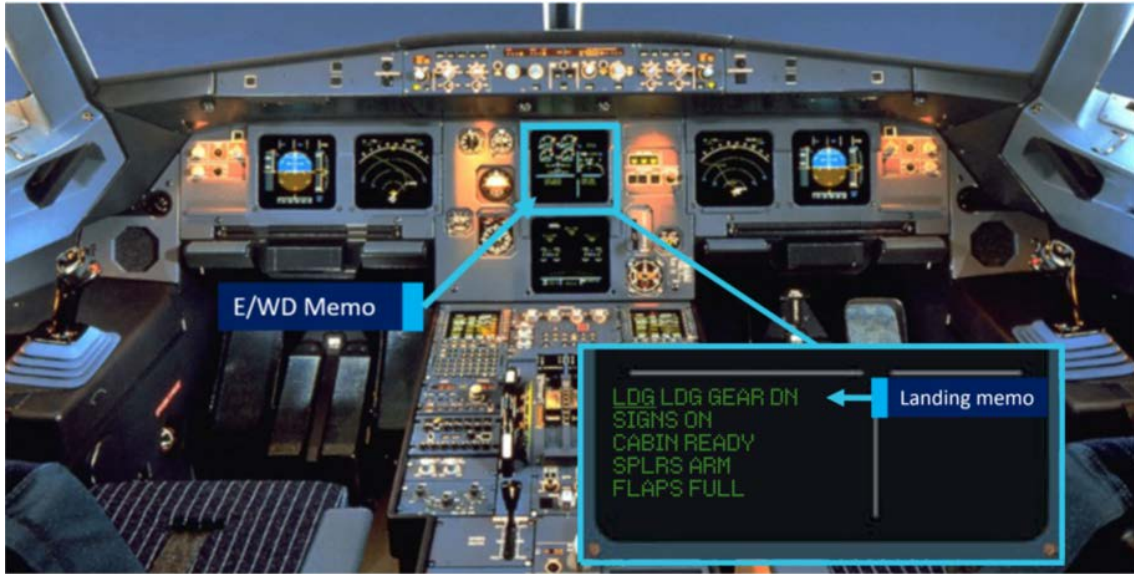
Figure 3: Airbus A320 flight deck and E/WD landing memo

The landing memo is displayed when the aircraft is in the approach phase below 2,000 ft. However, after a go-around the system logic requires the aircraft climb above 2,200 ft radio altitude (RA) in order for the landing memo to reset. If the aircraft conducts a circuit lower than 2,200 ft the landing memo will not be displayed on the E/WD until 800 ft RA on the next approach.
