# Collision of passenger train A42 with buffer stop

Richmond, New South Wales | 22 January 2018

**ATSB Transport Safety Report**  
Rail Occurrence Investigation  
RO-2018-004  
Final – 20 December 2019

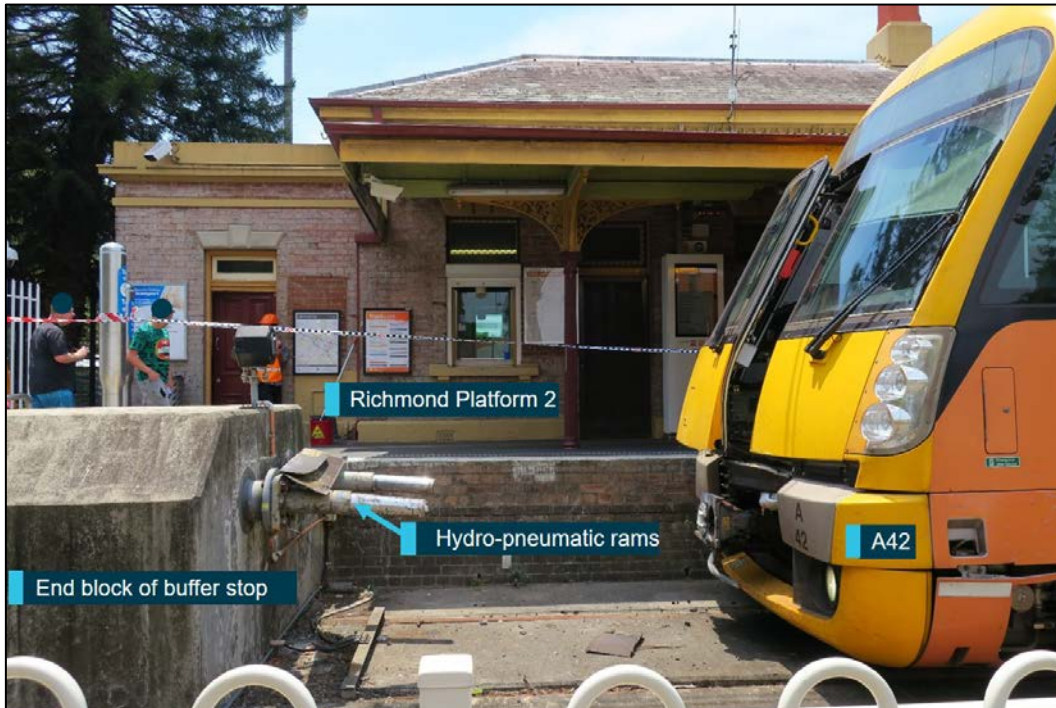
**Figure 3: Platform 2 buffer stop and front of A42**

The collision caused substantial damage to the end-of-track buffer stop with a significant transverse crack opening at the corner of the base and the upright. The two hydro-pneumatic rams positioned on the front of the buffer stop also sustained damage (Figure 3).

*This figure shows the post-collision damage to the buffer stop on Platform 2 and the front of A42.*  
Source: ATSB

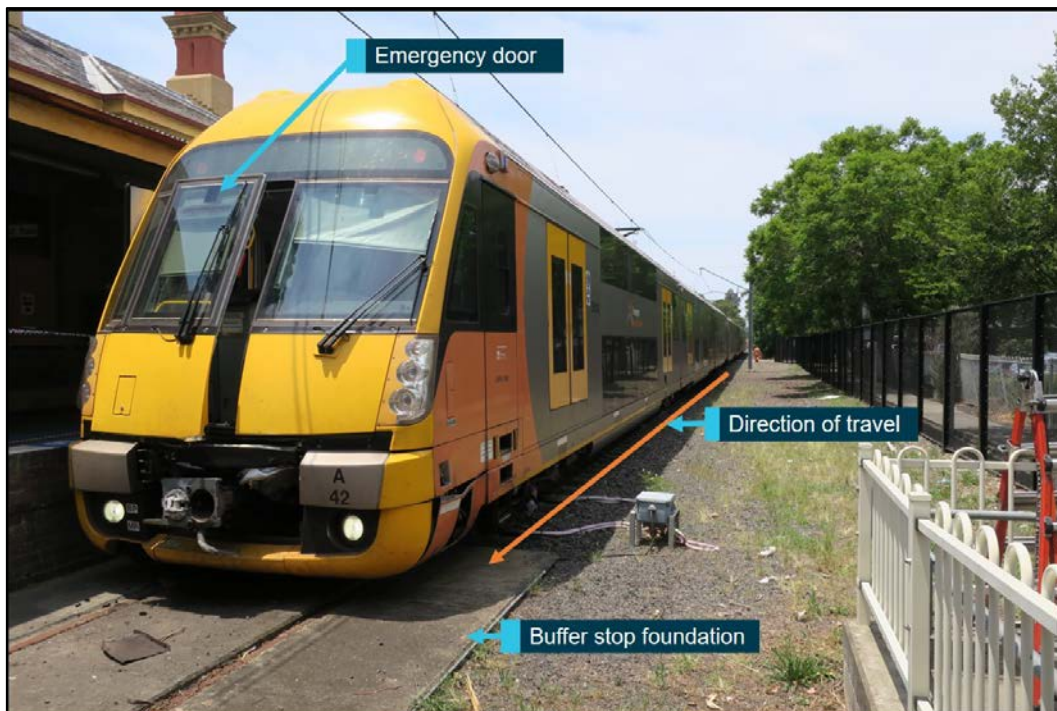
**Figure 6: A42 at Richmond Station post-collision**

There was damage to the front of the train, particularly the head of the Sharfenberg coupler (No.2 end of motor driving carriage D6342), the lower section of the front nose cone and the undercarriage. There was significant damage to the interconnecting areas between cars, the associated door systems and the coupling systems between cars. There was no visible damage to the interior of the driver's cab or to the internal passenger saloon areas. The emergency door at the front of the train had become ajar during of the collision. The exterior stainless steel skin of the carriages, apart from the areas between carriages, sustained no visible damage.<sup>2</sup> All carriage windows and exterior doors were undamaged. The exterior doors and opening systems were all functioning following the collision.

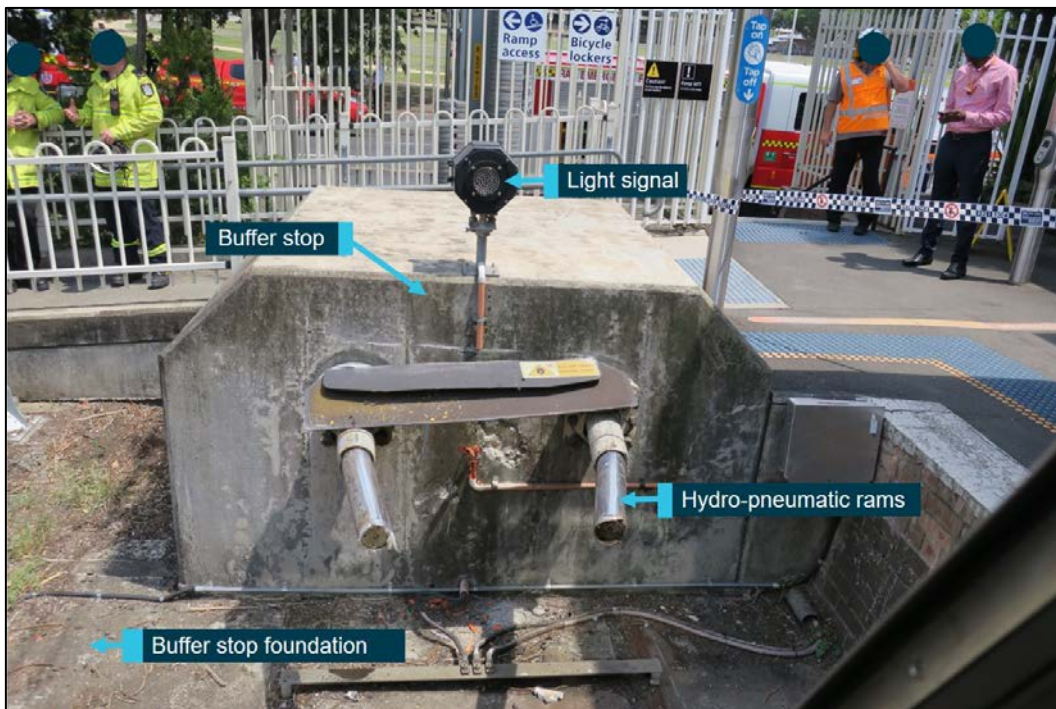
**Figure 8: Platform 2 buffer stop of Richmond Station**

*This diagram shows the post-collision damage to the buffer stop on Platform 2, details at Richmond Station, and the light signal attached to the buffer stop.*  
Source: ATSB

The buffer stop at the end of Platform 2 at Richmond Station (the Richmond buffer stop) did not absorb the energy of the collision with A42 as was expected. The reason is that the hydro-

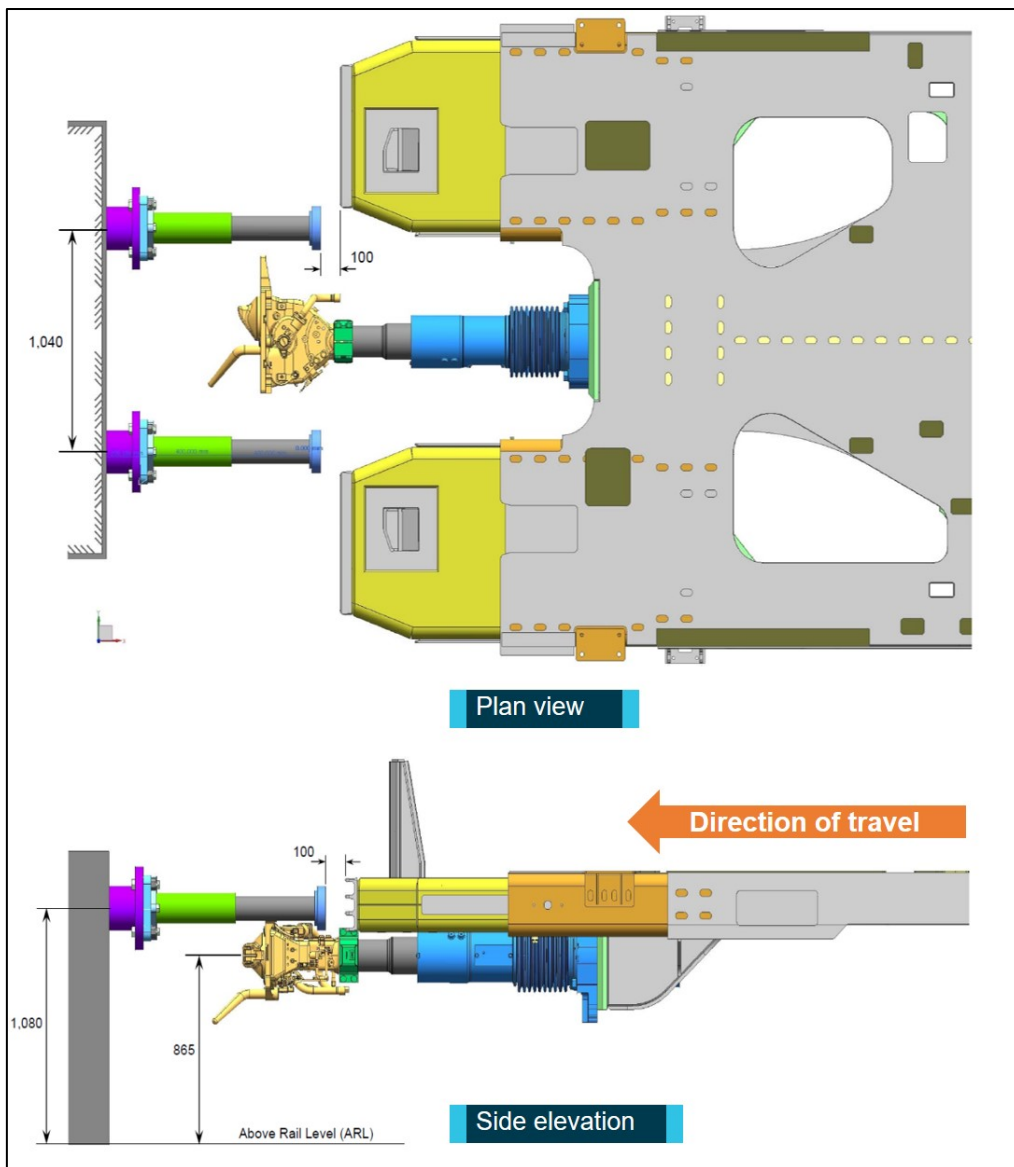
**Figure 18: Richmond buffer stop and front CEMS of A42**

The buffer stop at Richmond has an energy capacity of 896 kJ which represents approximately 8% of the total collision energy associated with an impact speed of 26 km/h. This type of buffer is suited for low-speed collisions of approximately 10 km/h.

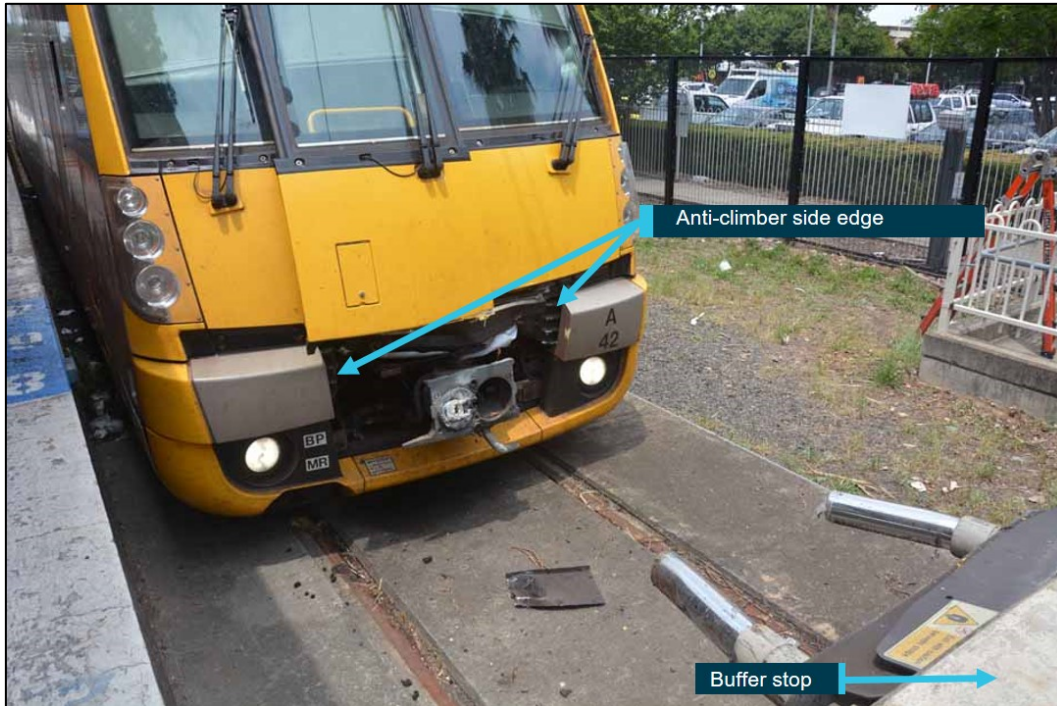
**Figure 25: Position of anti-climbers on leading car**

*This figure shows position of the anti-climbers on the leading car of A42 and the edge which contacted the buffer tube flange.  
Source: ATSB*

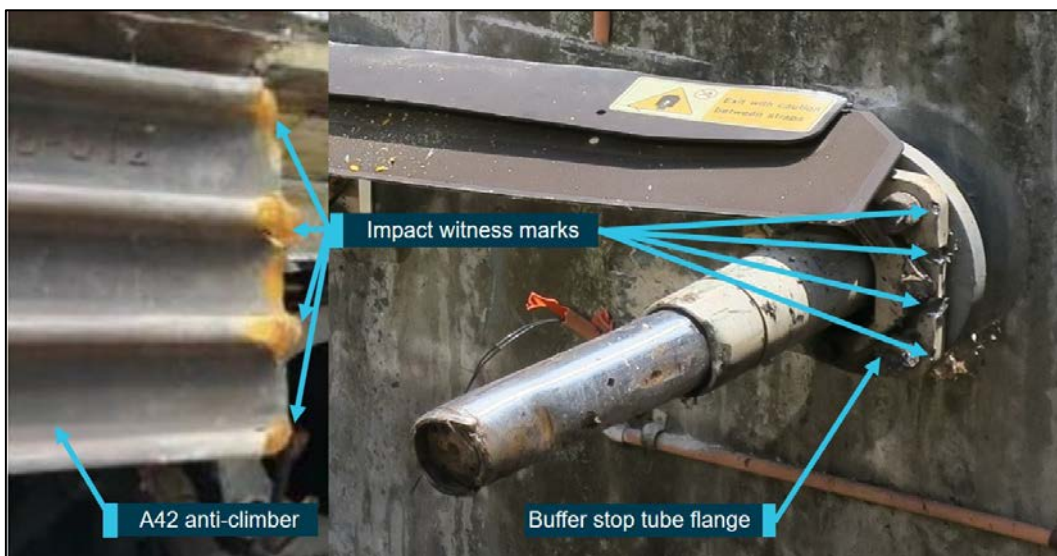
**Figure 26: Damage from impact with anti-climbers**

*This figure shows the damage to the buffer stop tube flange (Right side) following contact with A42's RHS anti-climber (Left side) and the corresponding damage to the RHS anti-climber edge.  
Source: ATSB*

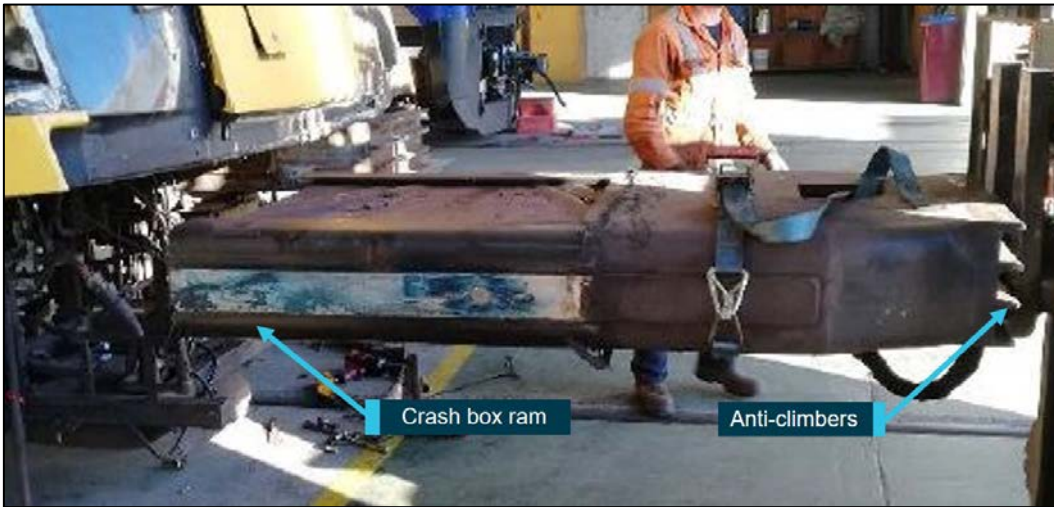
**Figure 27: Crash box ram from left side of A42 leading car**

*This figure shows the crash box ram being removed from A42. This ram did not activate during the collision as the contact area on the anti-climbers was at the side of the crash box on the radius of the outside corner of the anti-climber teeth. The anti-climber teeth fractured or sustained plastic flow under the extreme contact pressure and lost the force on the front of the crash box.*  
 Source: Downer with annotations by ATSB

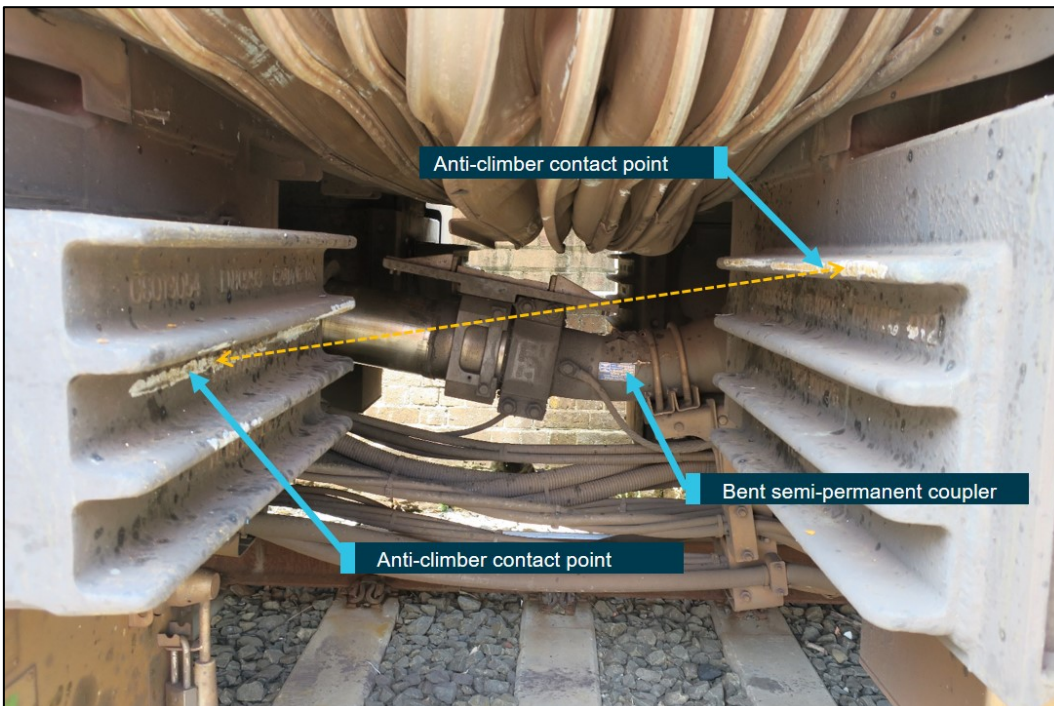
**Figure 28: Bent semi-permanent coupler**

The semi-permanent coupler between the first and second cars (Figure 28), and that between the second and third cars were bent and damaged. The vertical angular movement of the semi-permanent coupler is limited to 8 degrees (by design). This vertical limit was exceeded by the excessive pitching due to the CEMS not properly activating. The other four semi-permanent couplers also sustained damage. The anti-climbers between the third and fourth cars did not engage and instead one anti-climber damaged the 1500V DC junction box on the other car (Figure 29). The only semi-permanent coupler not to sustain damage was the semi-permanent coupler between the seventh and eighth cars.

*This figure shows the bent coupler between the first and second cars (D6342 and N5342) and also the contact witness marks on the anti-climbers.*

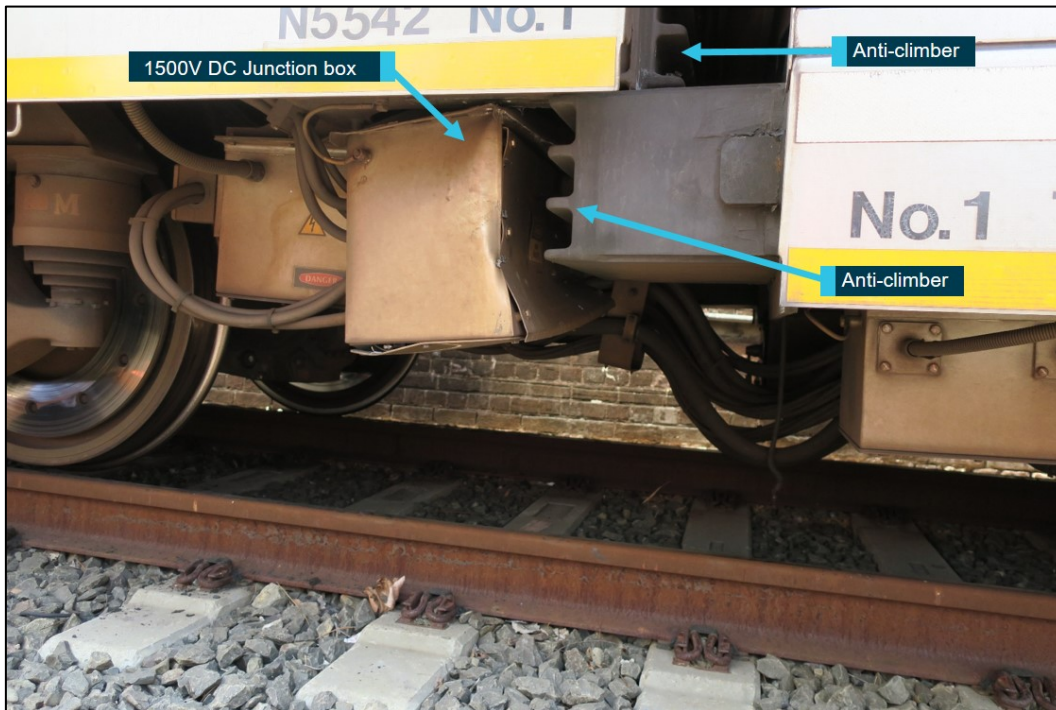
**Figure 29: Anti-climber into junction box**

*This figure shows the No. 1 end of motor car N5542 overriding the No. 1 end of trailer car T6542, between the third and fourth cars. The anti-climber has damaged the 1500V DC junction box.  
Source: ATSB*

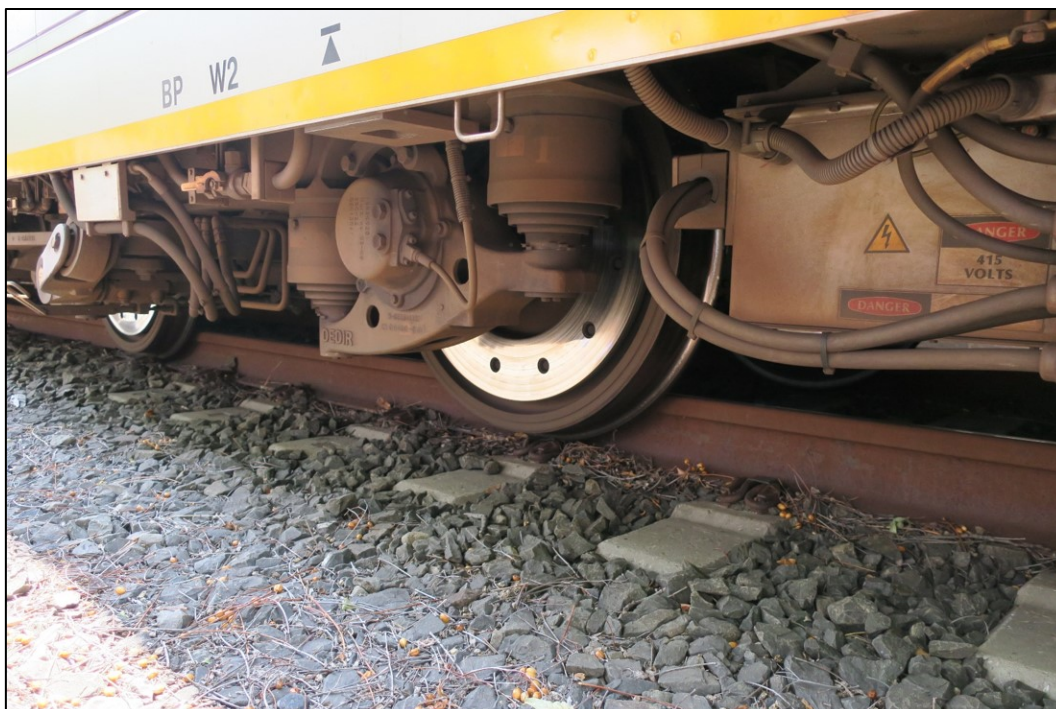
**Figure 30: Derailed wheels**

The bending of the couplers between the first two car interfaces, and the derailment of all wheels of a bogie (Figure 30), is indicative of vertical pitching that occurred because of the forces being transferred along the train not in a line of action close to the centreline through the couplers. This affected the alignment of the anti-climbers, which reduced their effectiveness in containing vertical movement (Figure 31).

*This figure shows the derailed wheels on the bogie on the No.1 end of the fifth car (T6642) (non-platform side).*
