# Running line collision with worker involving passenger train T570

Petrie, Queensland, on 29 May 2017

**ATSB Transport Safety Report**

RO-2017-003

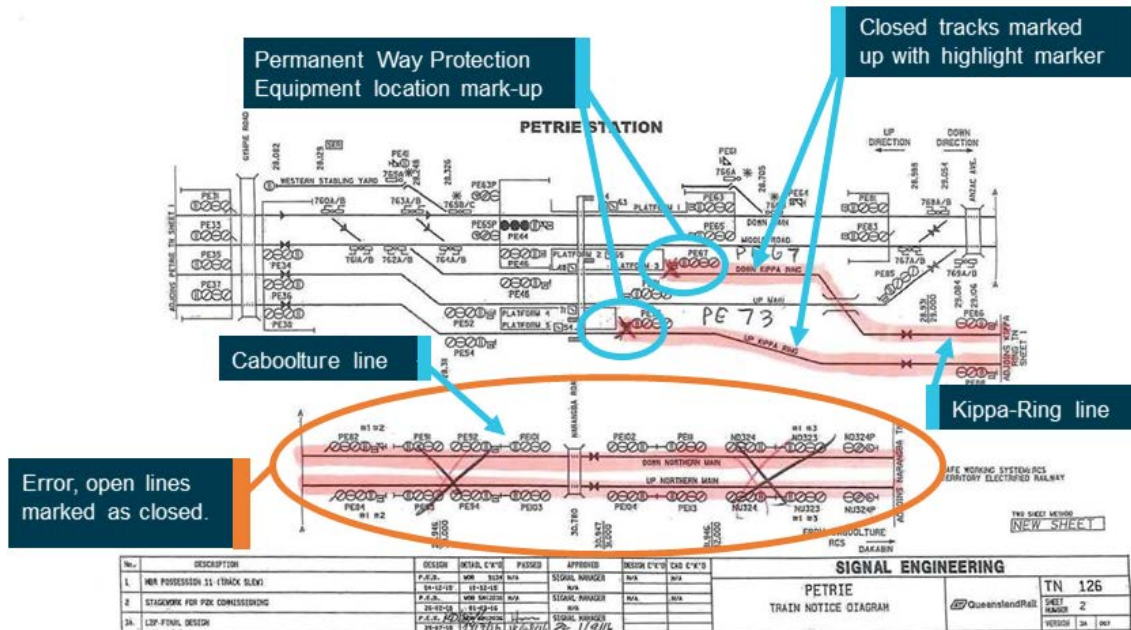
Figure 14: Train Notice Diagram pre-planning mark-up

The mark-up of the safety information on the Train Notice Diagram involved highlighting the closed tracks, and recording where the permanent way protection equipment was to be placed (Figure 14). QR representatives advised that this mark-up would normally be undertaken by the protection officer in charge. However, in this case the supervisor marked up the Train Notice Diagram. The supervisor’s mark-up contained errors that did not accurately depict the open and closed tracks (Figure 14).

Although not a formal process, an independent check of this mark-up would normally be undertaken by either the supervisor or one of the other senior leaders before the protection officers departed for the worksite. On the night of the accident, no independent check of the Train Notice Diagram mark-up was conducted.

Image showing the Petrie Train Notice Diagram marked up with closure safety information. Noting that highlighted portions of track are intended to depict closed tracks and other markings relate to the location of permanent way protection equipment placement. Image also shows marking error where the Caboolture line was marked as closed. Source: Queensland Rail, annotated by ATSB

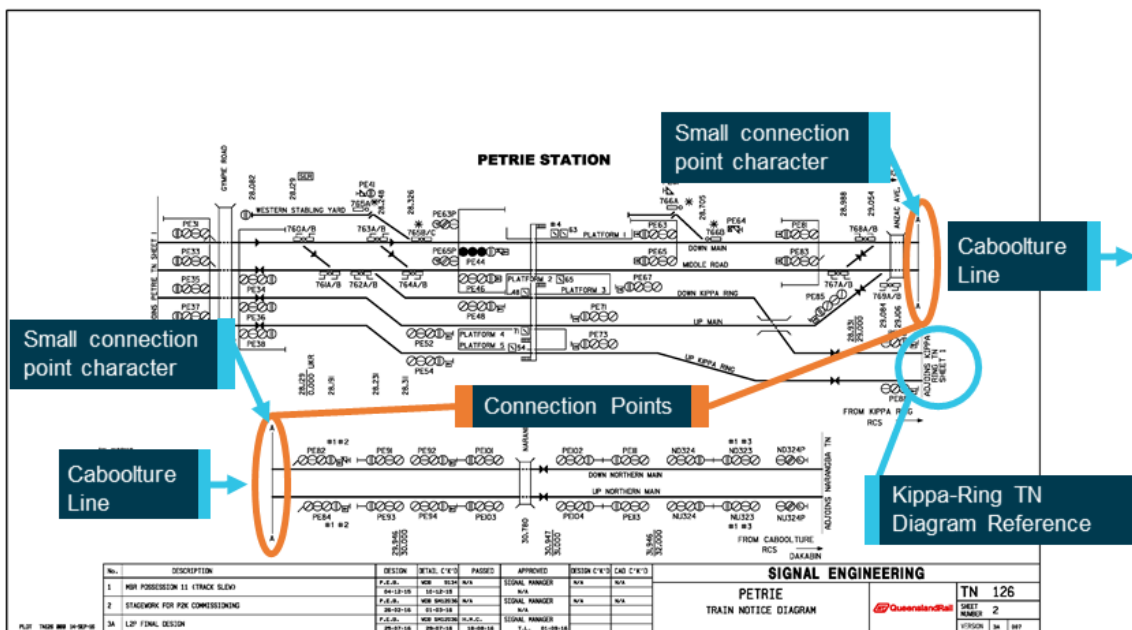
Figure 15: Train Notice Diagram TN 126, for Petrie Station

Image showing Train Notice Diagram TN 126, which describes the rail infrastructure layout and some operational information for Petrie Station. This diagram has been annotated to show the connection points between the two portions of the Caboolture line, and the conspicuity of the connection point character. Source: Queensland Rail, annotated by ATSB

This layout is potentially conducive to misinterpretation as the Up and Down Caboolture rail lines can be associated as being linked to the Up and Down Kippa-Ring lines due to their close proximity. This is further influenced by the small size and conspicuity of the 'connection point A'

character used to link or connect the two Caboolture line sections. The potential for error can increase, particularly under conditions of low lighting, or as relevant to this accident, under time pressure.

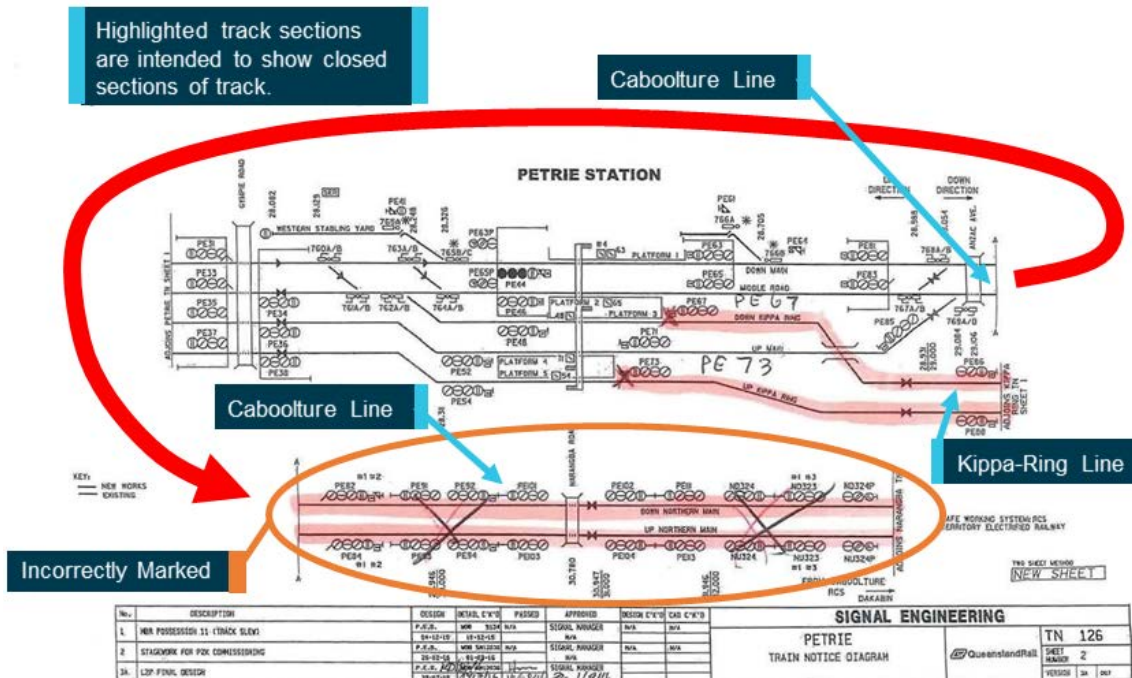
**Figure 16: Train Notice Diagram TN 126, of Petrie Station, as marked up for the Kippa-Ring line closure.**

Image showing Train Notice Diagram TN 126 as marked up in error for the Kippa-Ring line closure. Noting that the highlighted portions of the track are intended to show closed track sections within the planned closure, and red arrow indicates connection points of track sections. Source: Queensland Rail, annotated by ATSB

Likely, due to time pressures, the supervisor departed from the normal process and did not seek an independent check of the marked-up Train Notice Diagram from one of the other senior leaders.

It can be observed that there was a potential for confusion in interpreting the Train Notice Diagram with the mark-up errors. However, it cannot be determined what effect the Train Notice Diagram mark-up errors had, if any, on PO1's understanding of which tracks were open and closed.

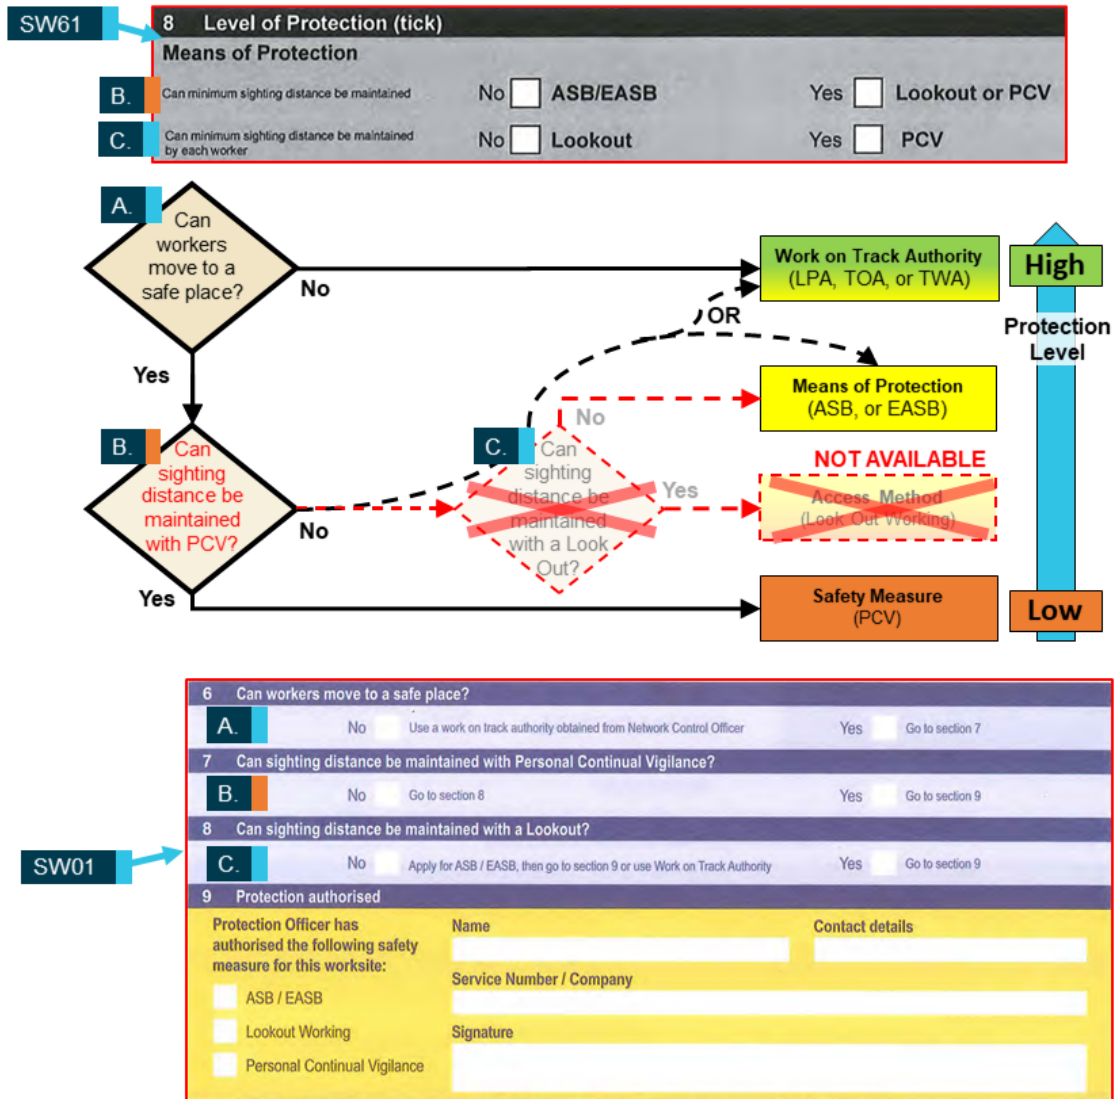
**Figure 17: Flowchart showing effect of local preclusion of LOW on protection selection decision-making process, informed by Queensland Rail SW61 and SW01 forms.**

This image shows protection level selection flowchart created by the ATSB to explain the effect of the local preclusion of LOW on the protection level selection decision-making process and decision assistance guidance contained in Queensland Rail Corridor Access Safety Assessment (SW61) and Trackside Safety Protection Planner (SW01) forms. Note that the labels, A, B, C within this image depict the procedural flow, which starts at A and proceeds through B to C. Source: Queensland Rail, Annotated by the ATSB.

Protection officers reported that the common operational practice was to select PCV as the preferred choice for initial access to the Danger Zone when placing permanent way protection equipment, or when crossing from place to place.
