# Safeworking irregularity involving Track Work Authority

Blackheath, New South Wales, on 2 September 2018

**ATSB Transport Safety Report**

RO-2018-016

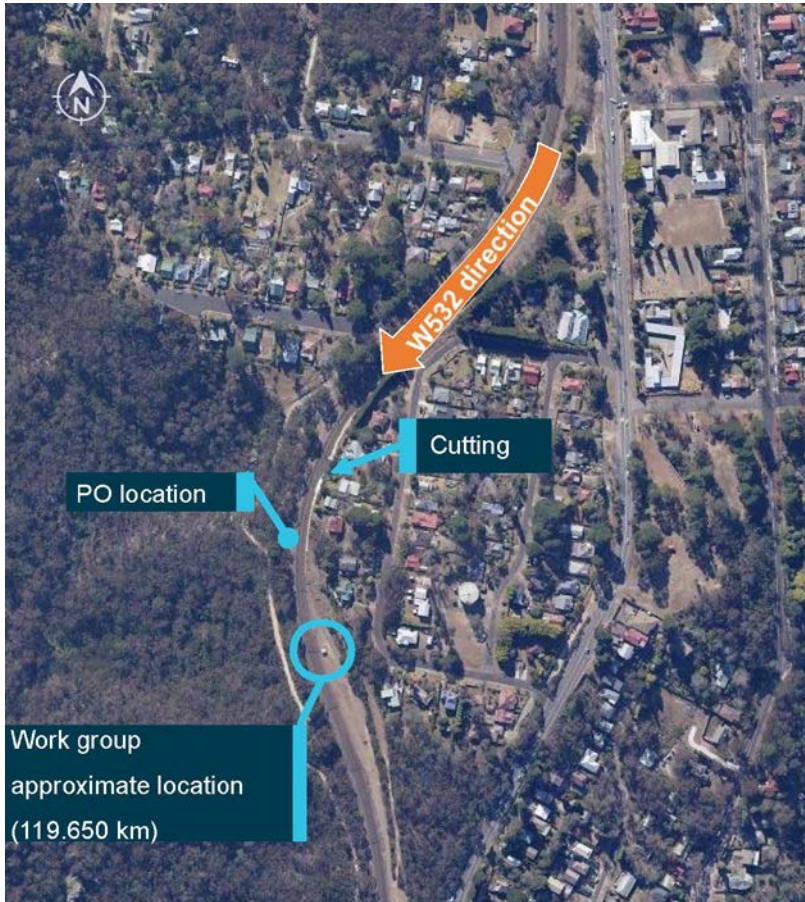
Figure 2: Location detail

At 0809, W532 departed Blackheath station (120.622km) on the Up main line towards Sydney. A short while later, the driver of W532 observed a work group on the tracks as the train exited a left hand curve in a cutting between 119.614 km and 119.650 km (see Figures 2 and 3).

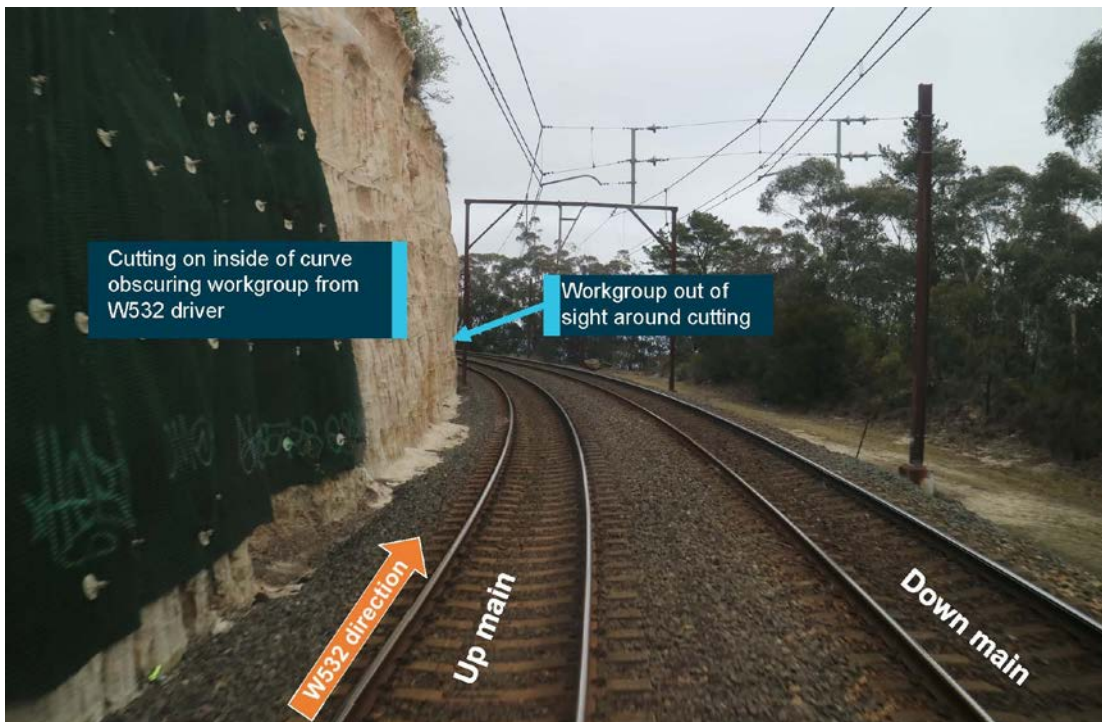
Figure 3: Line of sight between train and workgroup obscured by cutting

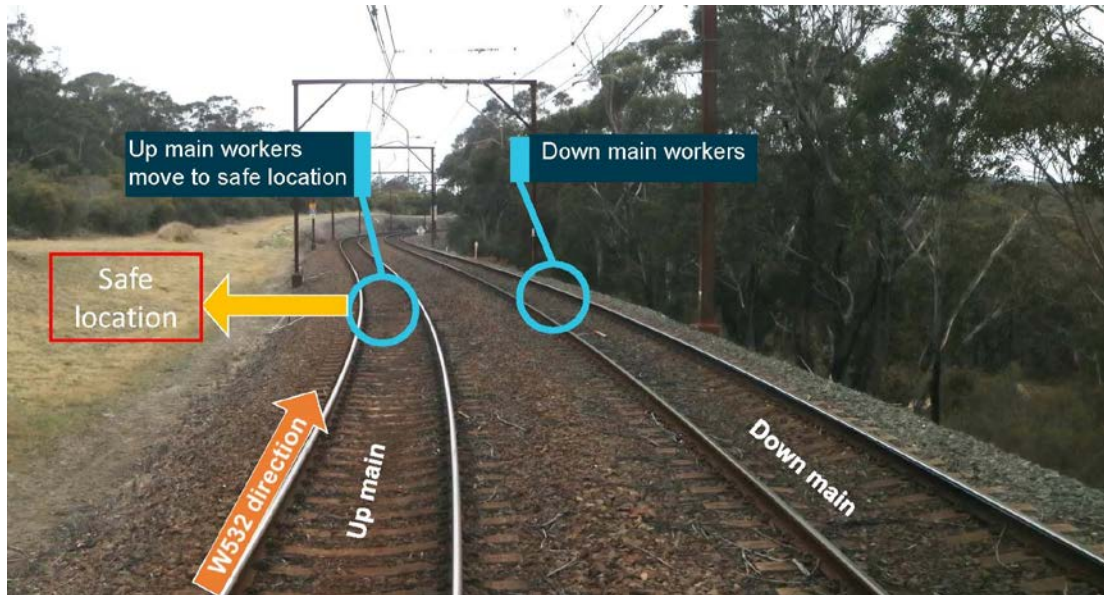
The workers on the Up line, realising that W532 was approaching, moved to a safe location beside the tracks (see Figure 4). The workers on the Down line waited for W532 to pass before joining the rest of the work group at the safe location.

**Figure 4: Driver’s view of the incident site**
