Collision of passenger train TD 6591 with buffer stop

Newport siding, Victoria, on 25 February 2019

ATSB Transport Safety Report

RO-2019-006

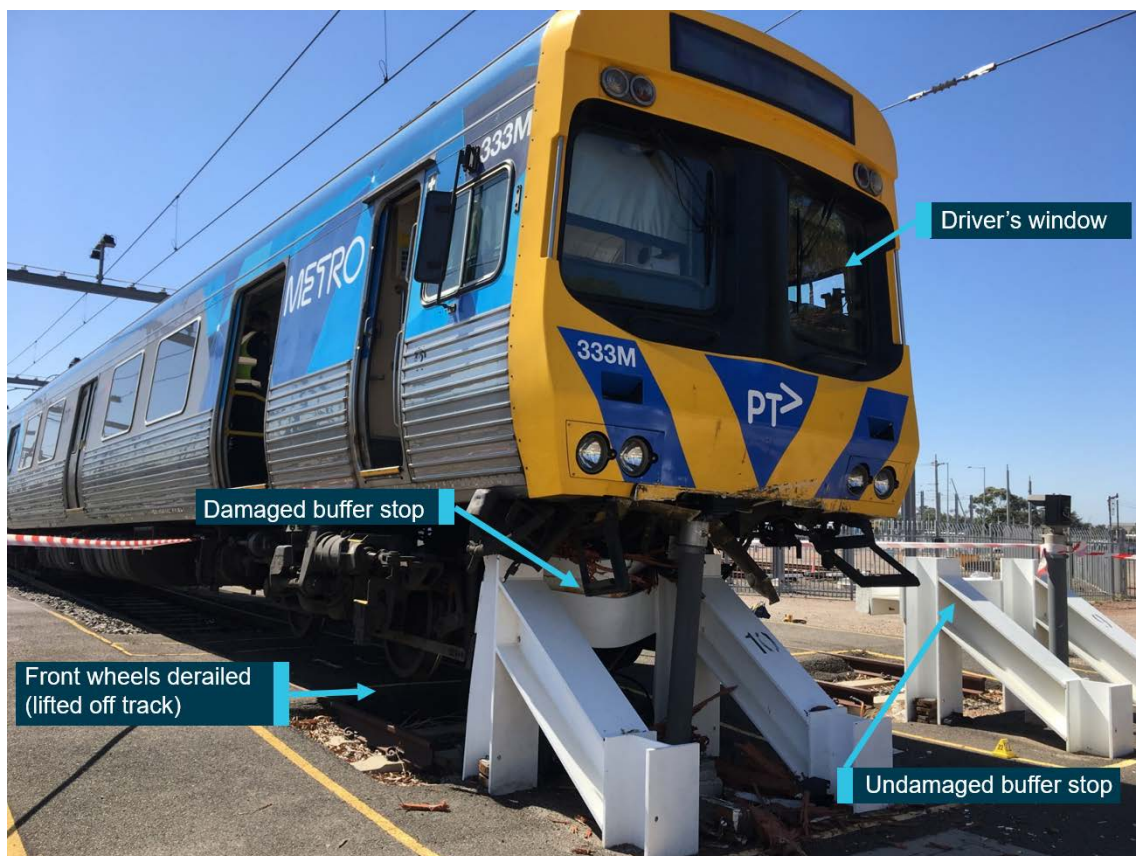
At about 0931 Eastern Daylight-saving Time on 25 February 2019, Train TD 6591, an empty Comeng passenger train operated by Metro Trains Melbourne (MTM) collided with the end of line protection (buffer stop) at Newport siding, Victoria. The collision damaged the buffer stop and the front of the train. The leading carriage (333M) derailed, and the train driver (the only person on board) was hospitalised with minor injuries.

While approaching the stabling location, for about 25 seconds from 0930:35 Eastern Daylight-saving Time,² there were no recorded inputs from the driver. At about 0931, the train collided with the end of line protection (buffer stop) and derailed. Recorded data showed a brake application about 1.5 seconds prior to impact, which was after the train had passed the required stopping point. The collision resulted in substantial damage to the front of the train and the buffer stop, and the driver was hospitalised with minor injuries (Figure 1).

Figure 1: Front of Comeng train TD 6591, showing collision with buffer stop and derailment

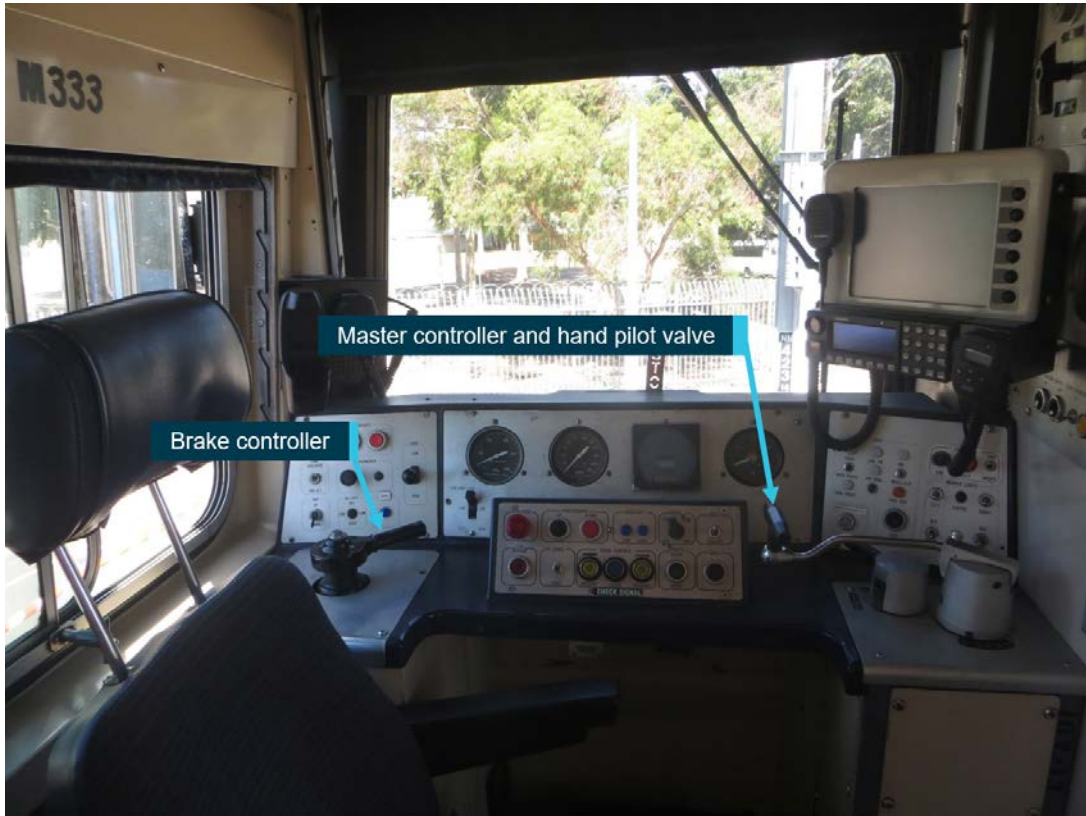
The train was also equipped with a pilot valve system which was designed as a fail-safe mechanism such that the brakes would apply if there was no pressure applied by the driver (such as from incapacitation). When the pilot valve was 'opened' the brake pipe pressure would release and the brakes would apply. In order to keep the pilot valve 'closed', pressure was required to be maintained by the driver through either a foot pedal or hand controller. The hand controller for the pilot valve (hand pilot valve) formed part of the master controller (Figure 2).

The driver was using the hand pilot valve at the time of the accident. The hand pilot valve required a minimum downward pressure of 0.6–1 kg be maintained on the master controller handle to keep the valve in a closed position, preventing the brakes from applying.

Post-accident testing of the train's braking system and hand pilot valve found no faults that would have contributed to a failure to stop.

Figure 2: Comeng driver’s cab of 333M, showing location of the brake controller, and combined master controller with hand pilot valve

The pilot valve was part of the overall train safety system, including the trip-lever and vigilance system. In this situation, the pilot valve was the only aspect of the safety system that could have activated and applied the brakes to protect against driver incapacitation. The hand pilot valve required minimal pressure to prevent the brakes from applying. It is very likely that adequate pressure was maintained on the pilot valve (master controller) during the period when no driver inputs were made, and therefore this part of the safety system was not triggered to activate the brakes and stop the train.
