Incorrect configuration involving Airbus A320, VH-VFX

near Sydney Airport, New South Wales, on 29 September 2018

ATSB Transport Safety Report
Aviation Occurrence Investigation
AO-2018-067
Final – 24 February 2020

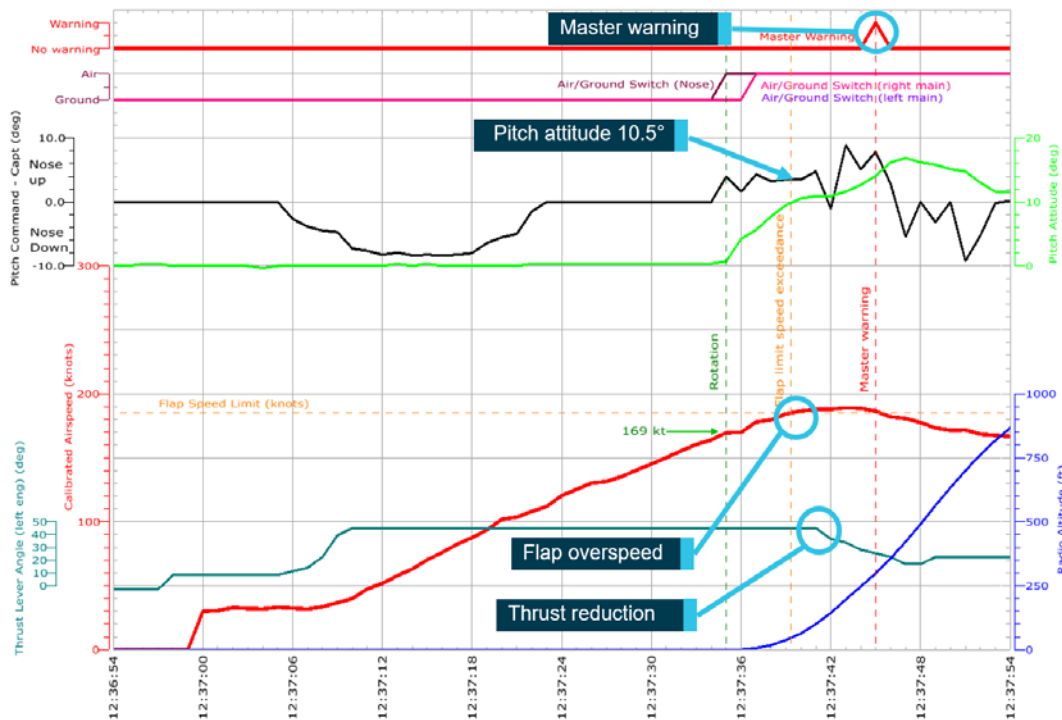
Figure 1: Quick access recorder data graph showing take-off period

The PM reported then calling ‘speed, speed’, indicating that the aircraft was nearly at maximum speed for the flap extension configuration. The aircraft exceeded the flap extended limit speed 5 seconds after rotation (Table 1 and Figure 1).¹³ By this time, at 1237:40 UTC, the aircraft was about 63 ft above ground level (AGL) and had a pitch attitude of 10.5° (green graph in Figure 1).

The overspeed warning was triggered when the airspeed exceeded the maximum flap extended speed (V_{FE} ¹⁴) by more than 4 kt. This occurred at a time between 1237:42 and 1237:43 UTC (the yellow and orange lines in Table 1). Airbus advised that the aircraft was at 180 ft radio altitude (AGL) at that time. The overspeed warning was displayed on the electronic centralised aircraft monitor, in addition to an aural warning and the master warning light.

This graph shows when the master warning was recorded in the QAR data.
 Source: Jetstar Airways quick access recorder data – graphed by ATSB

The PF retarded the thrust levers from the TOGA position 2 seconds after the flap overspeed, while the aircraft was at 144 ft AGL, which was below the thrust reduction altitude of 800 ft. After a further 7 seconds, the PF increased the thrust by advancing the thrust levers to the climb detent. The PF then retracted the flaps from position 3 to position 1.¹⁵ The autopilot was engaged in climb mode and the aircraft continued climb with subsequent retraction of the flaps from position 1 to 0.¹⁶

The actual rotation speed of 169 kt was only 16 kt below the maximum flap extended speed (185 kt), 41 kt closer than the correct rotation speed would have been. The PF rotated the aircraft at a rate significantly below the recommended rate of 3°/s. This resulted in the aircraft attitude reaching 10.5° pitch-up, instead of 15°, 5 seconds after rotation when the maximum flap extended speed was exceeded. The pitch attitude reached 15°; 11 seconds after rotation.
