# External sling loading accident involving Bell 205, VH-HUE

39 km south-east of Talbingo, NSW, on 10 January 2019

**ATSB Transport Safety Report**  
Aviation Occurrence Investigation  
AO-2019-003  
Final – 10 March 2020

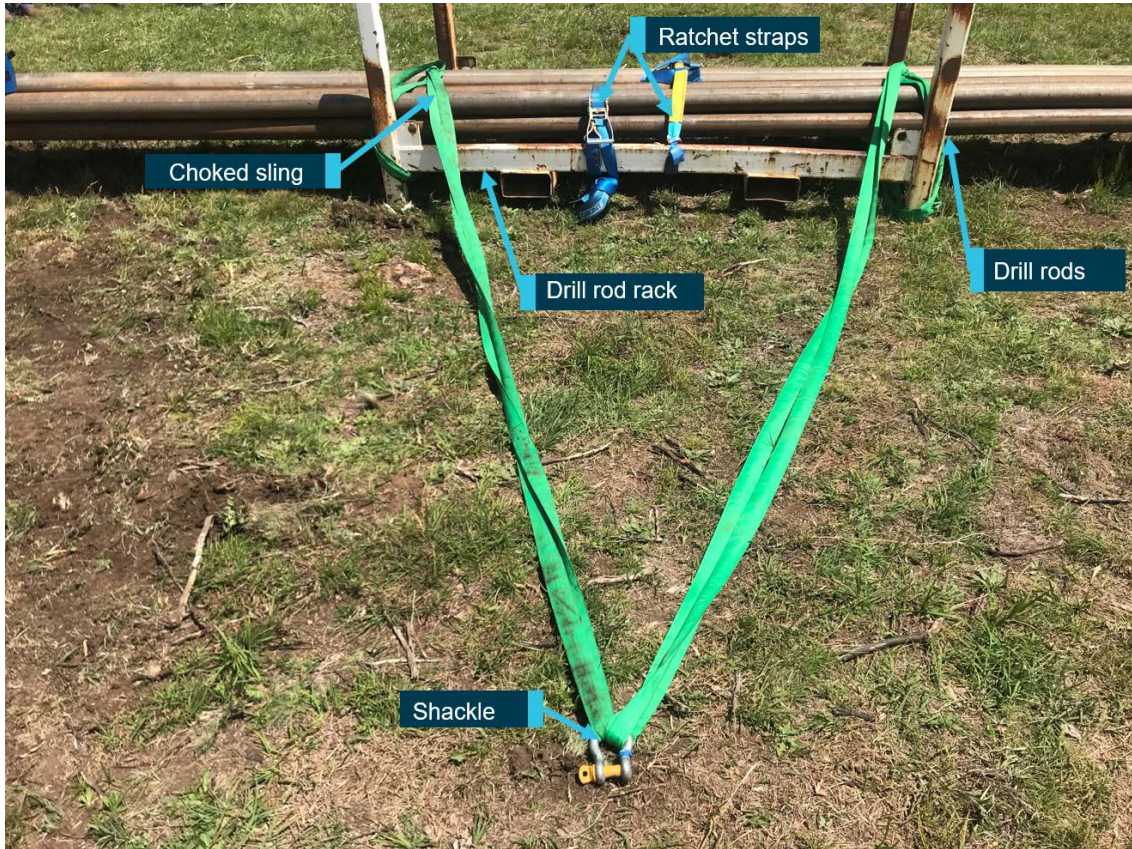
**Figure 1: Drill rods ratcheted to the rack and slings attached.**

Among the loads were three lots of drill rods on drill racks (Figure 1). The loadmasters decided not to use the lift points on the drill racks, as the lift points were not rated or stamped. Working together, the loadmasters ensured the weight of the loads were equal, secured the drill rods to the rack and rigged the slings, so the loads would be balanced during flight. To do this, they used two 6 m round slings, rated to carry 2,000 kg, choked at either end of the rod rack. The slings were then attached to a shackle, which connected directly to the remote cargo hook. A 5.6 m tag line was attached to the load, to assist with manoeuvring the load into the required position at the receiving site. The loadmasters rigged the loads a number of times before they were happy with the rigging.

*The figure shows the drill rods ratcheted to the drill rod rack and the slings which are choked at the ends of the drill rack.  
Source: NSW police, annotated by ATSB*

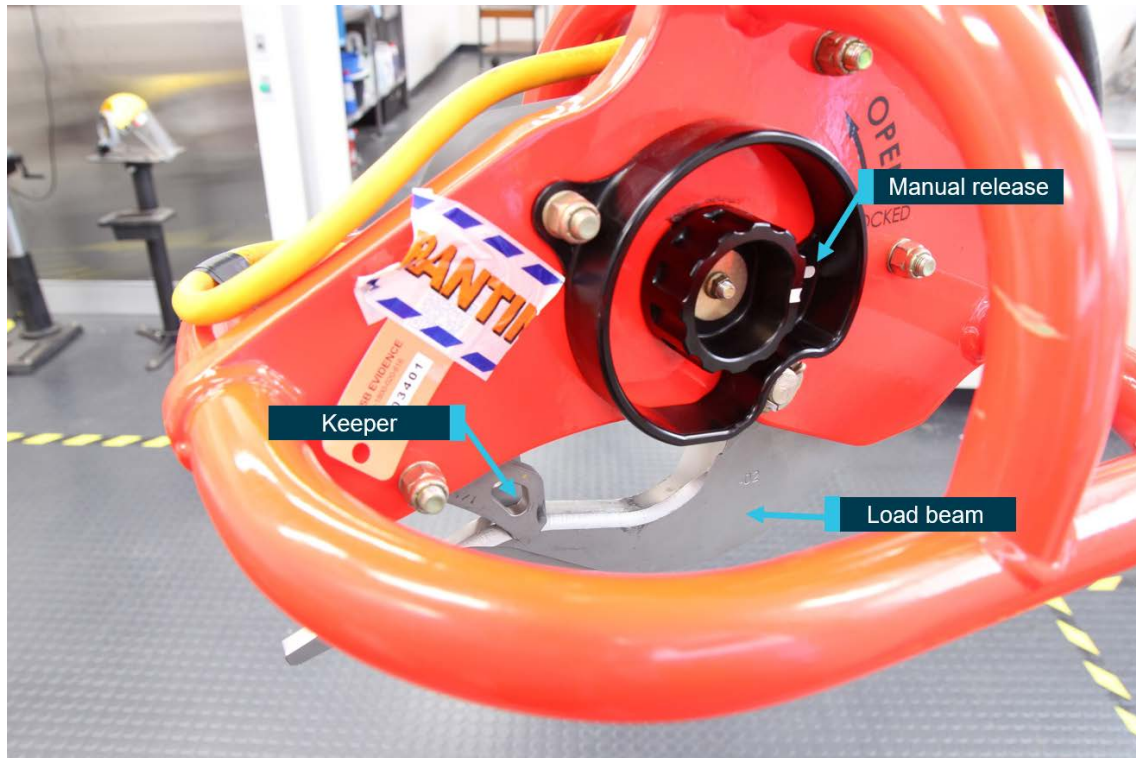
**Figure 2: Cargo hook**

The remote cargo hook used by the operator of HUE was a TALON 6K half-cage cargo hook (Figure 2). This was the first operational use of this hook following a recent overhaul and was also the first time the helicopter (HUE) was used with this long line and remote hook combination.

There were no indications that the remote hook release mechanism was faulty after the previous overhaul and the pilot and loadmasters conducted an operational check of the mechanism before operations began on the day. It also successfully lifted the two previous loads and lifted the load off the loadmaster after the incident. In addition, the manual release mechanism operated correctly at the ATSB facility and an examination of the hook release electrical system in the helicopter did not reveal any faults. Despite this, a transient hook fault that resulted in an inadvertent release of the load could not be ruled out.

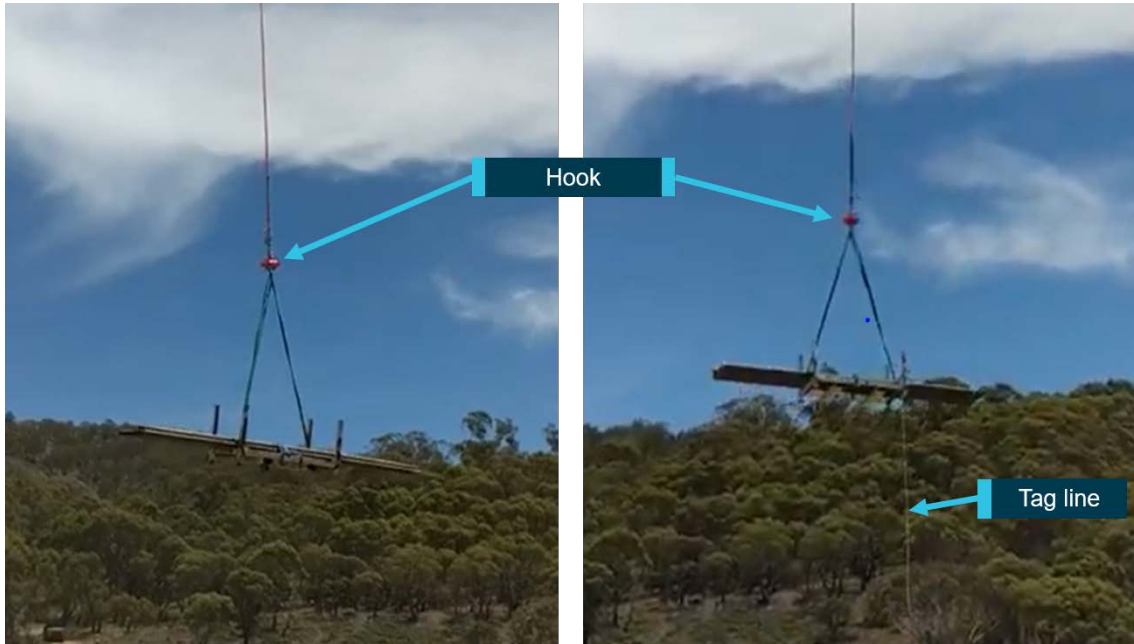
**Figure 3: Images showing the occurrence load during departure from loading site.**

and placed the hook on the load. After adjustment to the sling, the load lifted evenly and was flown to the drill site (Figure 3).

The image on the left shows that on departure the load was slightly uneven, the image on the right shows the load after loadmaster had adjusted the slings.

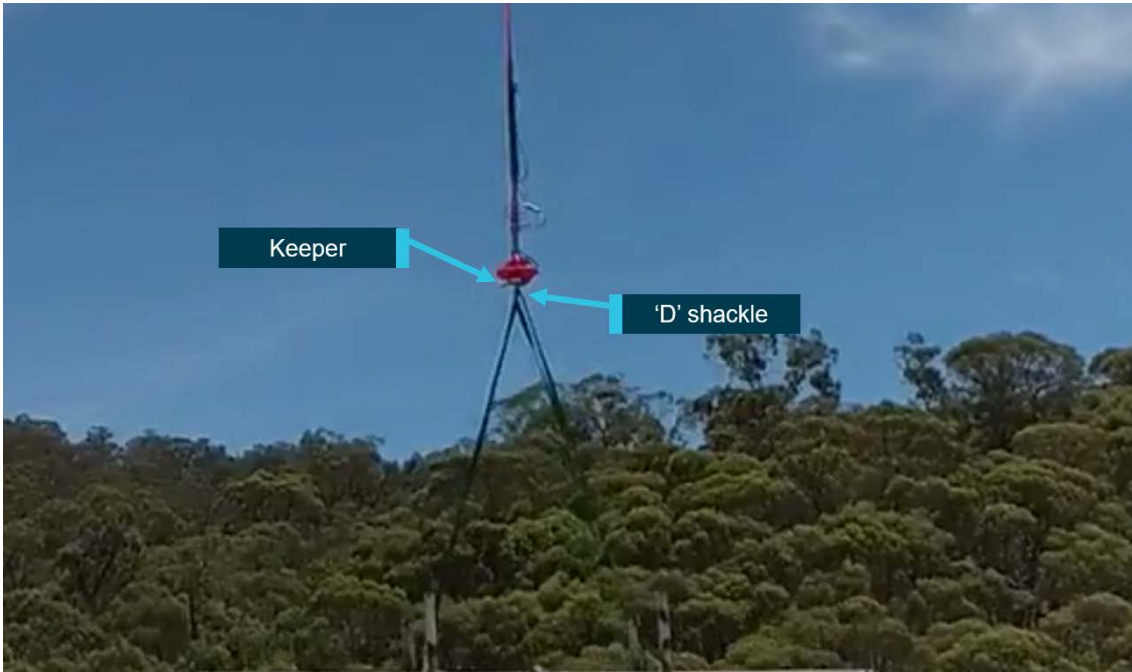
**Figure 4: Image shows that the ‘D’ shackle was behind the keeper.**

The ATSB examined video footage of the helicopter lifting the load from the loading site. It showed that the 'D' shackle was behind the keeper (Figure 4) when the helicopter departed and that the load was evenly balanced as the helicopter flew towards the drill site (Figure 3).

*The image shows that on departure after the load had been adjusted, the ‘D’ shackle was behind the keeper.*  
 Source: Helicopter operator A, annotated by the ATSB

The shackle was the appropriate size, to ensure a dynamic rollout would not occur. The video footage shows that the ‘D’ shackle was securely behind the keeper as the helicopter departed from the loading area.
