# Track obstruction due to loss of freight from train 7WB3 and subsequent impact of passenger train NT32 with track obstruction

near Telegraph Point, New South Wales, on 17 June 2018

**ATSB Transport Safety Report**

RO-2018-010

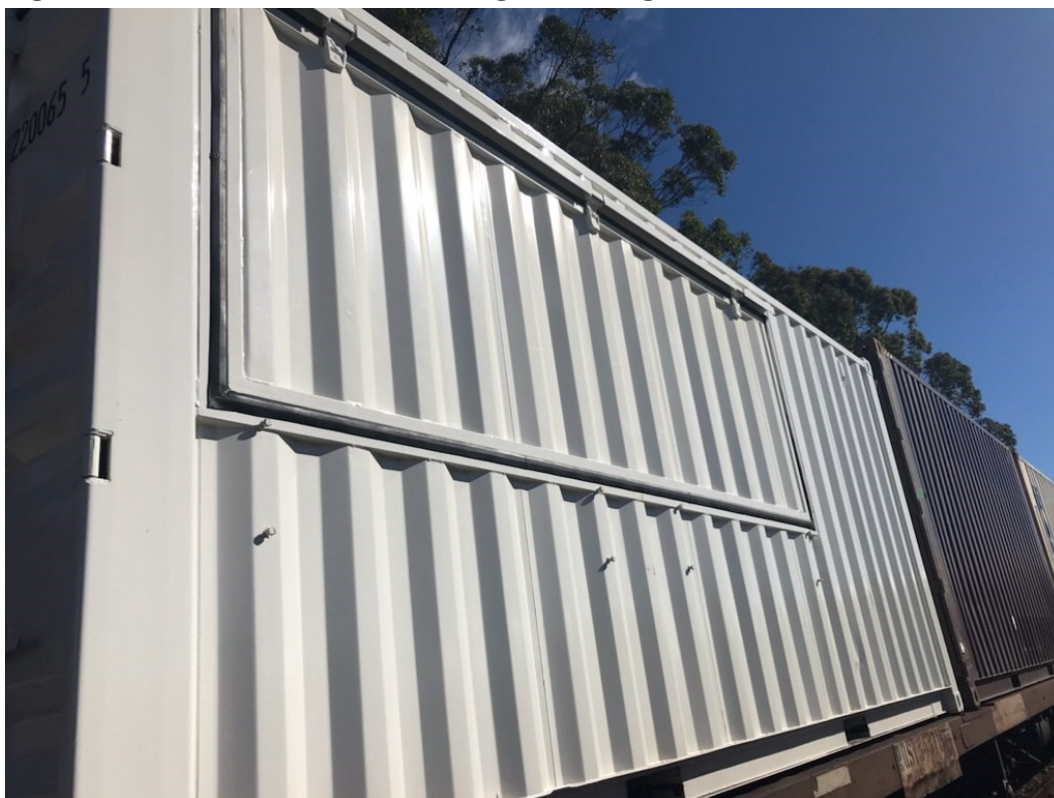
**Figure 1: View of the container showing the awning on one side**

On 15 June 2018, a container (number 2200655) was delivered to the loading facility at Carrington, New South Wales (NSW), for loading onto a rail wagon. The container was loaded onto wagon RQSY 34371M, one of nine wagons loaded with container freight bound for Brisbane, Queensland (Qld). The container was a 20 ft (6 m) shipping container that had been modified for use as a canteen. The modifications included the addition of an awning on one side of the container, pictured below (Figure 1).

Container number 2200655 had been modified by Port Shipping Containers to include a large side opening that was about 1.2 m high by 3 m long, approximately one-quarter of one sidewall of the container (Figure 1). This opening was intended for use as an awning. During the sequence of events, notifications by the train crews and the Australian Rail Track Corporation (ARTC) network control officer (NCO) referred to the awning as a ‘door’ and ‘window’. It was understood that all such references were to the awning and not the container end doors.

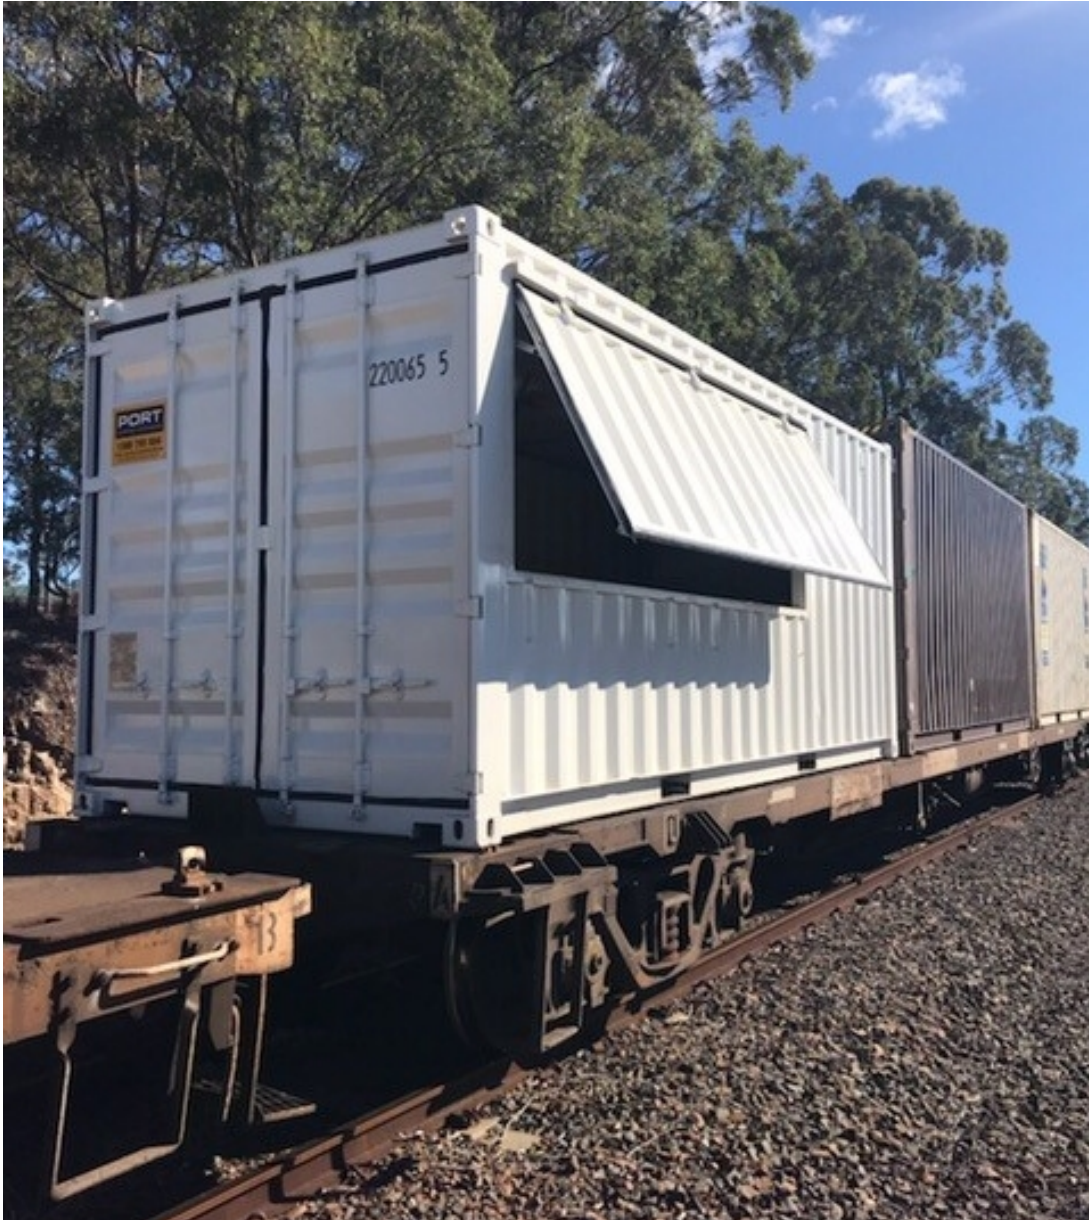
**Figure 2: View of the container with the open ‘door’ and ‘window’ (awning)**

Upon returning to the lead locomotive, the crew contacted the NCO at about 0824 and reported finding and resecuring an 'open window' on an 'office container' on wagon RQSY 34371M. The NCO subsequently cleared 7WB3 to proceed. Photographs taken of the container by the crew member before and after resecuring show that the 'door' and 'window' referred to above were the awning on the side of the container (Figure 1 and Figure 2). The container number, 2200655, was visible in Figure 2.

*The image shows the awning open when inspected at Craven North. The container number 2200655 is also visible on the end door  
Source: Pacific National*

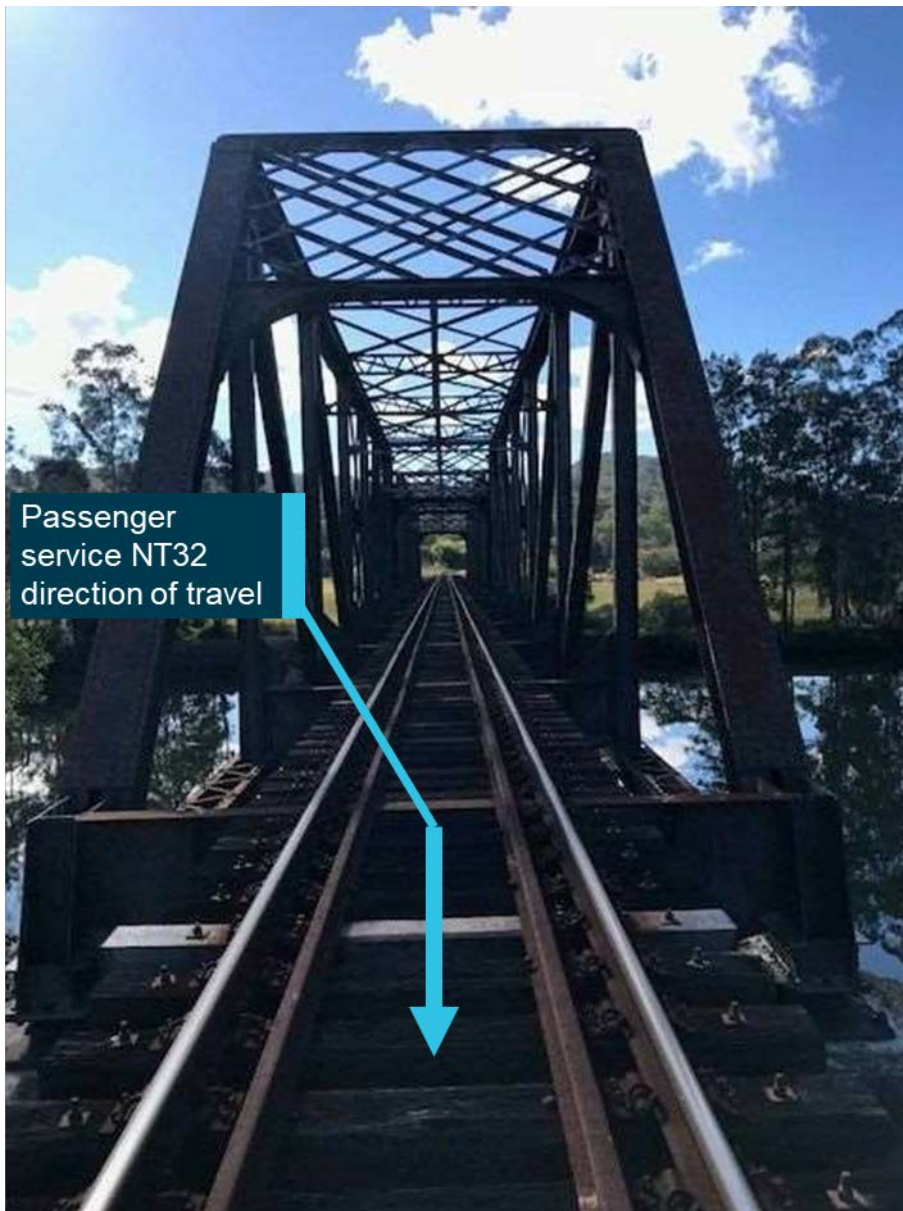
**Figure 3: View of the Wilson River Bridge**

After crossing 7WB3 at Telegraph Point, train NT32 proceeded south and struck an object on the track while crossing the Wilson River Bridge, a steel through-truss bridge (Figure 3).

*The southern access to the Wilson River Bridge, facing north. This view shows the steel through truss structure that the awning struck.*  
Source: Pacific National

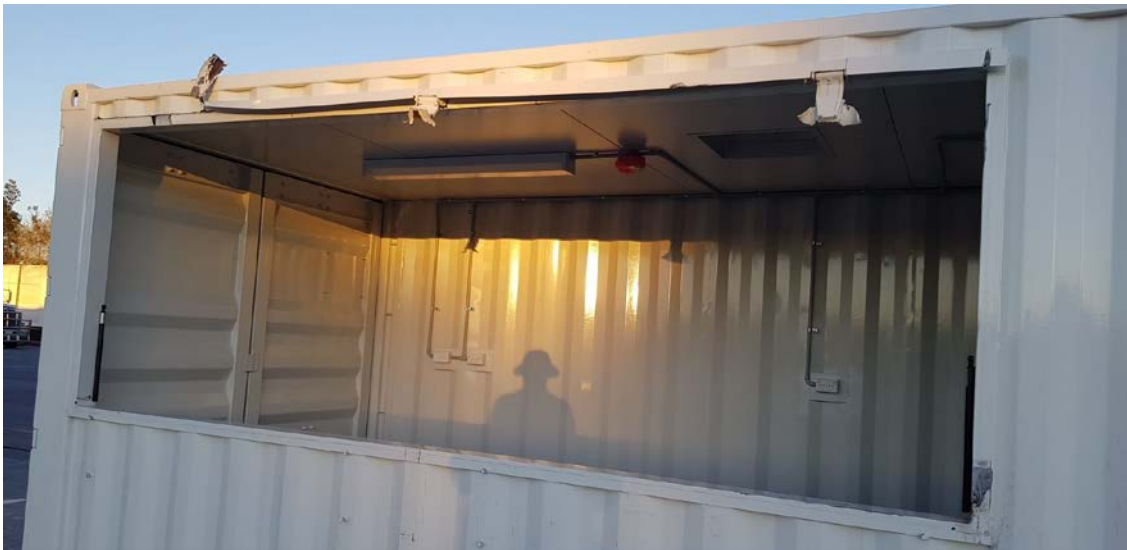
**Figure 4: View of the container showing the damage from the missing awning**

The damaged container was photographed by PN upon arrival at the Brisbane Freight Terminal (Figure 4). The damaged awning was subsequently recovered from the Wilson River (Figure 5).

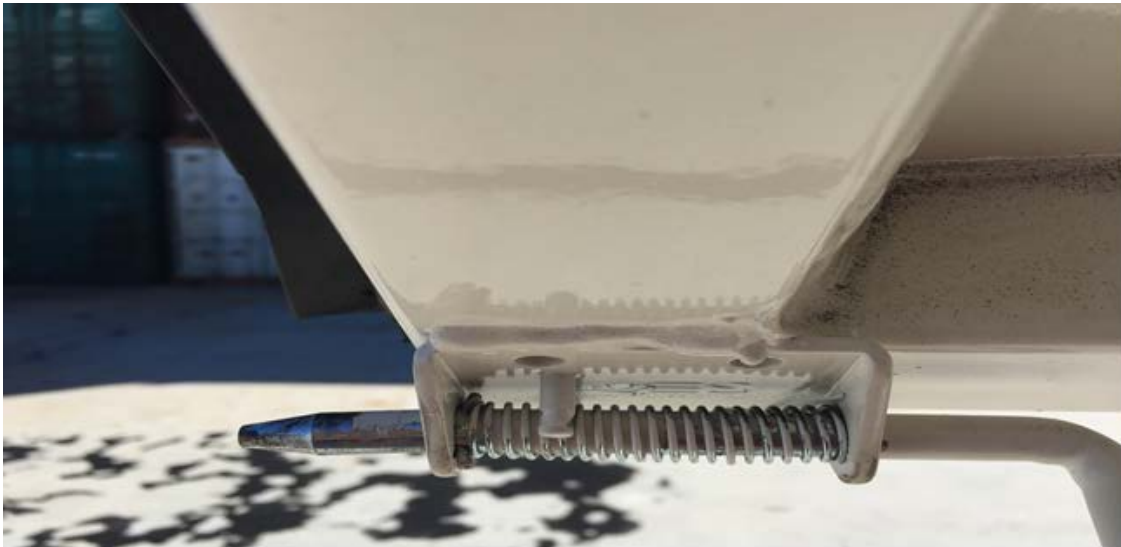
**Figure 6: A view of one of the spring-loaded bolts used to hold the awning closed**

The awning was held closed with two spring-loaded bolts accessed from the inside of the container (Figure 7). There was no locking mechanism provided that was accessible from the outside of the container. The bolts latched into holes in the outside frame, one of which is visible in Figure 8.

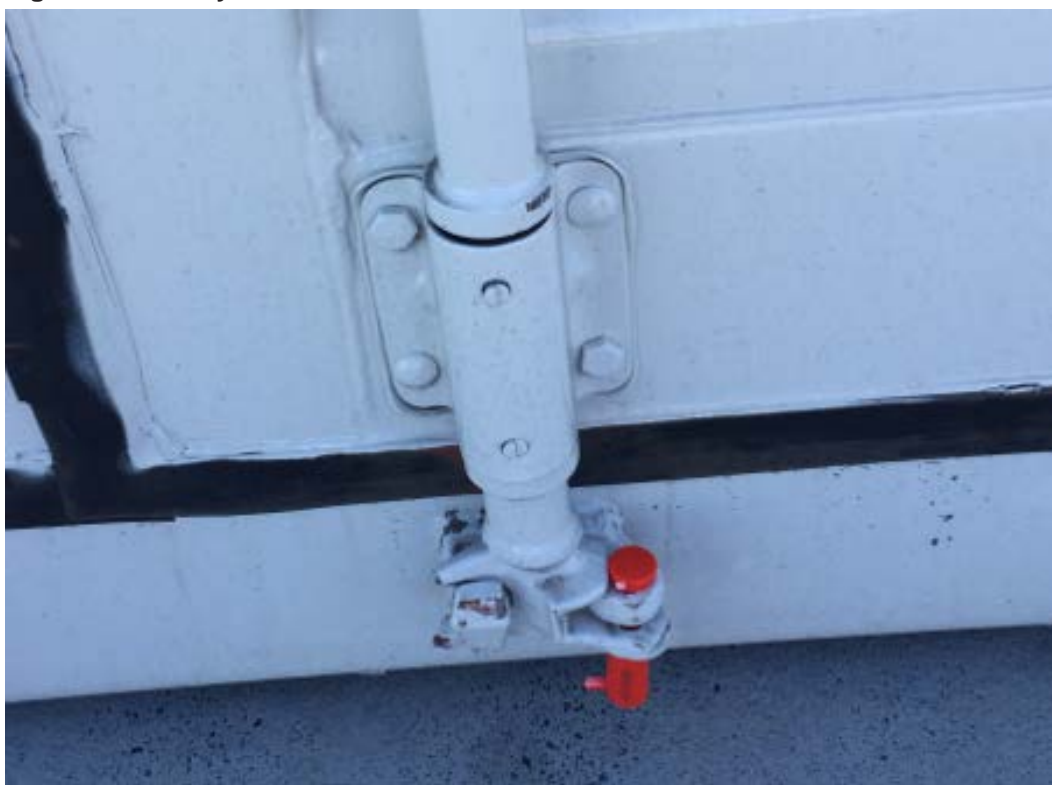
**Figure 8: Security seal on the end door of the container**

PN provided a photograph, taken when the container involved in the occurrence was later inspected at Brisbane Freight Terminal, showing an approved type of seal applied to the latch of the end door of the container (Figure 9).

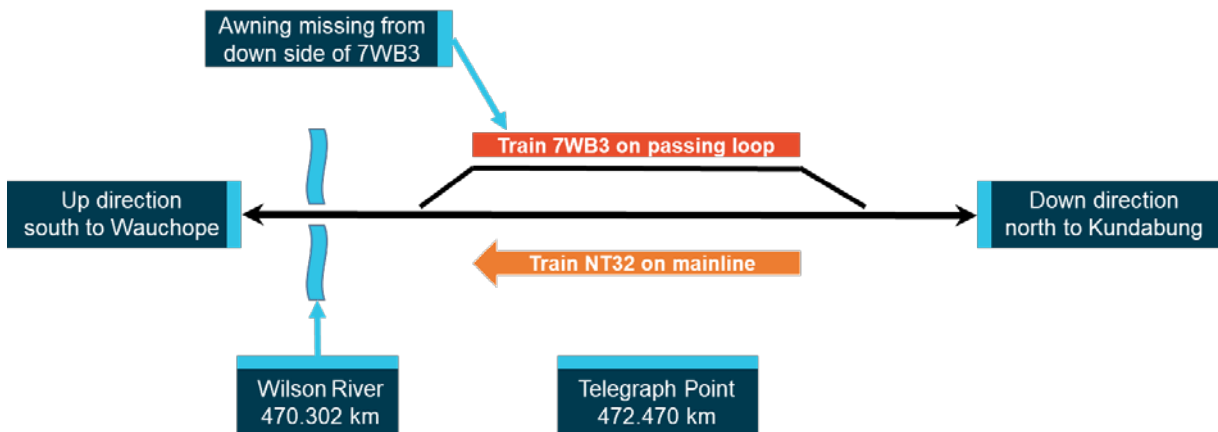
Figure 9: Train NT32 passing Train 7WB3 at Telegraph Point

PN reported that train 7WB3 stopped in the passing loop at Telegraph Point to allow NT32 to pass on the mainline. PN also indicated that the container was loaded on the train with the awning on the down<sup>5</sup> side of the train. As Figure 10 shows, this meant that the driver of train NT32 did not have visibility of the damaged side of the container as his train was passing on the up side of 7WB3.

When train 7WB3 passed, the driver of NT32 had the opportunity to perform a roll-by inspection. By that time, the awning had become separated. However, as the awning opening and damage to the container was on the other side of the train (down side), it would not have been visible to the driver.
