# Loss of control in flight involving Leonardo Helicopters AW139 helicopter, VH-YHF

Near Adelaide River mouth, 38 km ENE of Darwin, NT, on 13 May 2018

**ATSB Transport Safety Report**  
Aviation Occurrence Investigation  
AO-2018-039  
Final – 16 April 2020

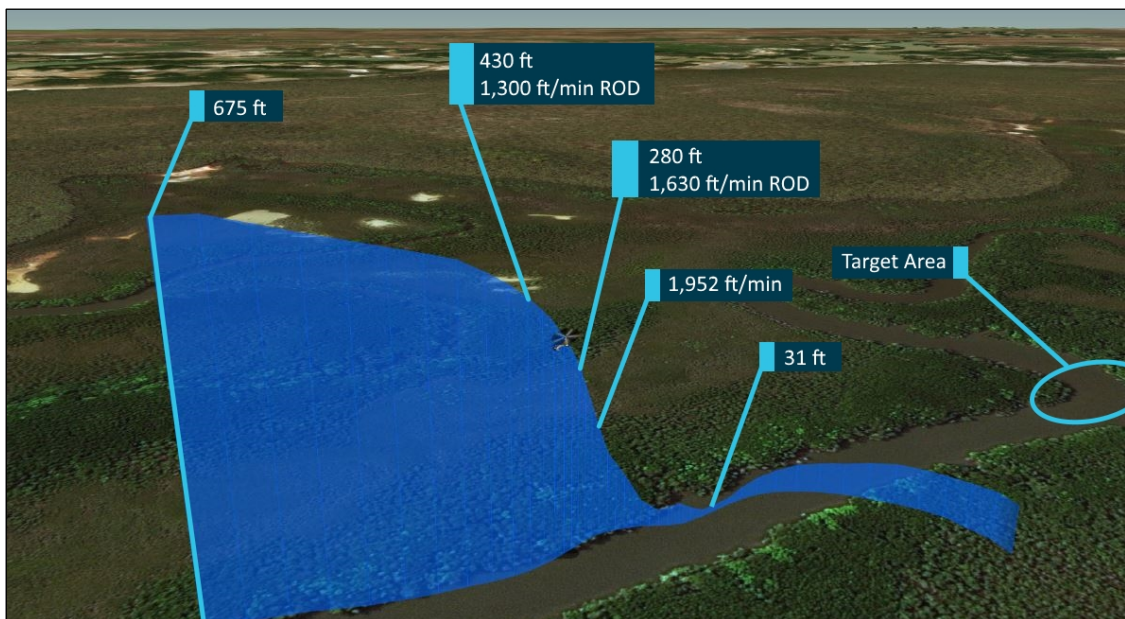
**Figure 2: Flight path of VH-YHF during the event**

At 2110:30, the crew commenced an approach from the north to a point of interest in Salt Water Arm. The pilot reported visibility on approach to the target as good to the north-west, and dark to the north and east. During this approach, the pilot lost visual references. At 2110:40, the pilot activated HOV mode. At this time, the helicopter had already developed an undesired high rate of descent (Figure 2).

- While on approach in a degraded visual environment, without the protections of flight instrument use or monitoring, the helicopter entered an uncommanded, undetected high rate of descent, resulting in a transmission overtorque during recovery.

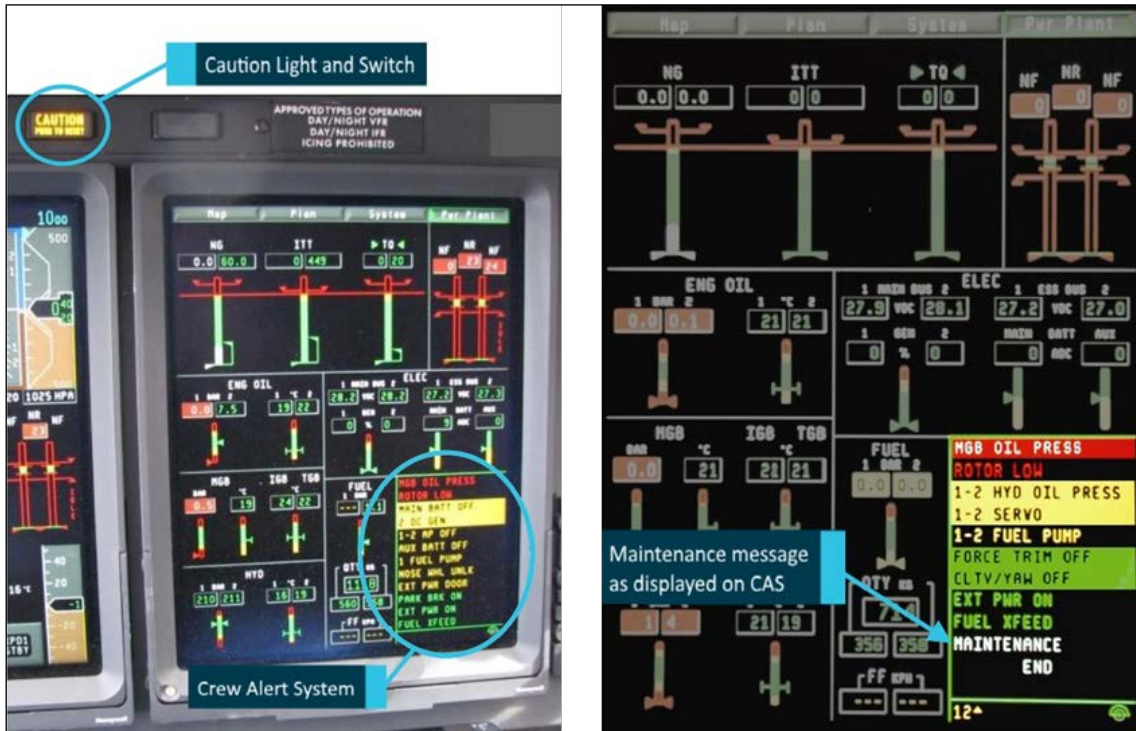
Figure 6: Exemplar caution light and maintenance message on CAS

A warning or caution message will show with a coloured background until acknowledged. Once acknowledged, it appears as coloured text on a black background. Some messages such as "XMSN OVTQ" (main transmission overtorque) will disappear when the condition causing them has passed. White status messages will only show on the ground with weight on wheels (Figure 6).

The "MAINTENANCE" message is significant because following exceedance of a limit such as torque, it will illuminate after landing. The presence of the "MAINTENANCE" message is a cue to an aircraft maintenance engineer (engineer) to investigate and rectify the cause of the message before cancelling the message.

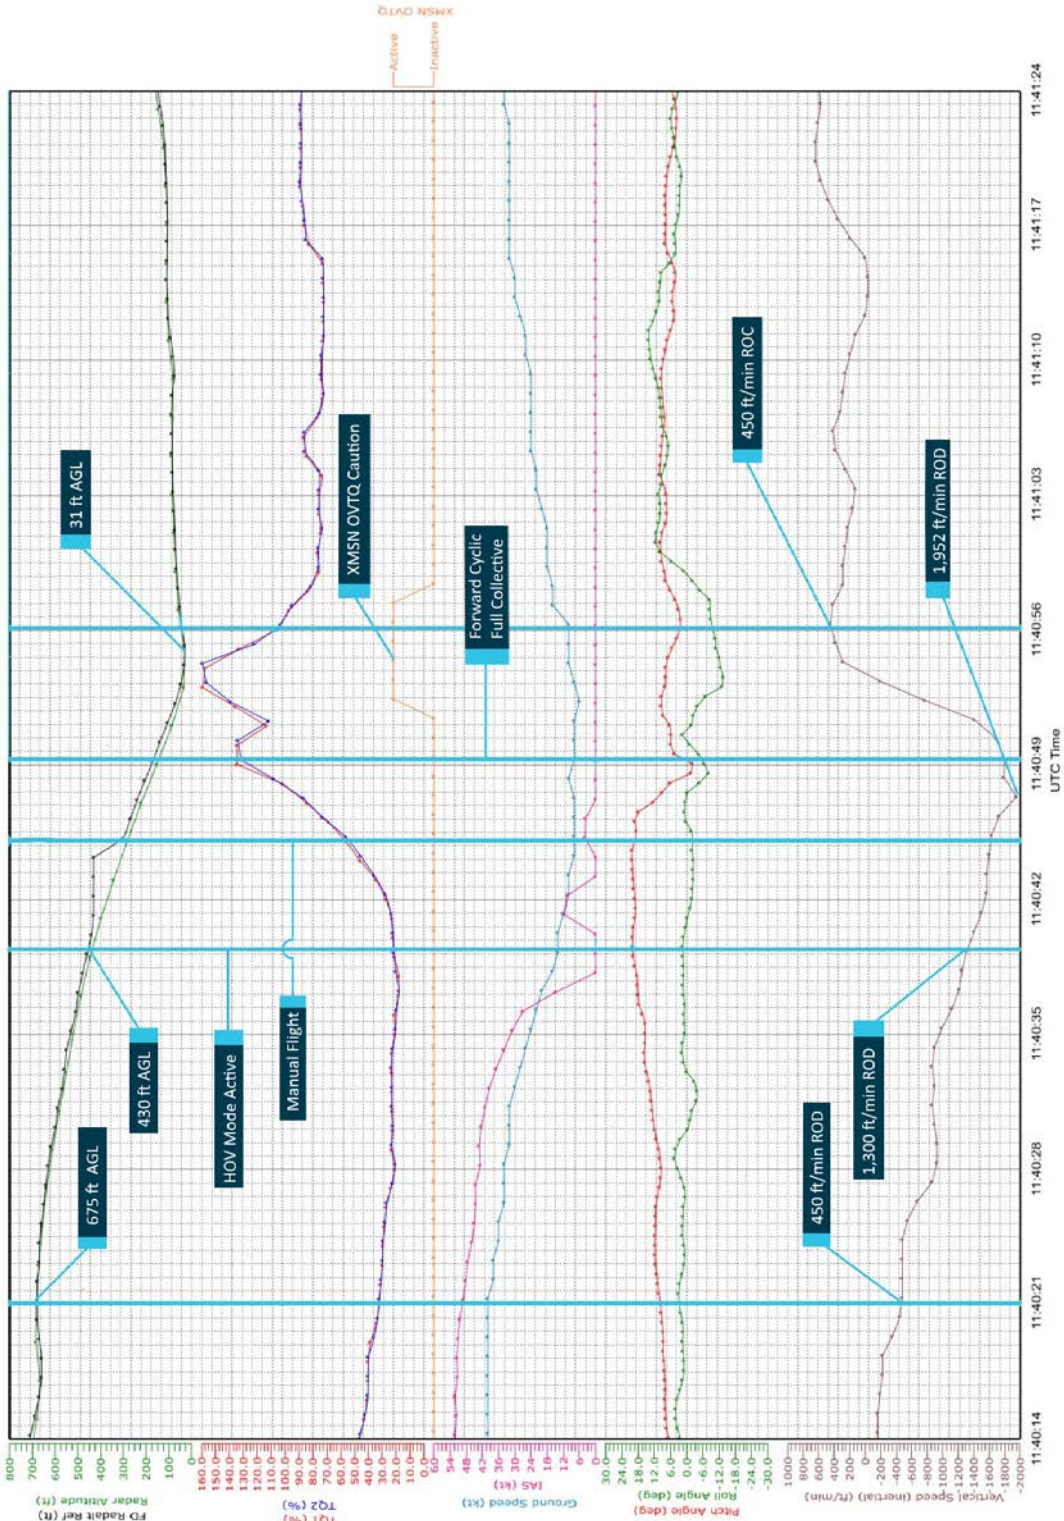
Figure 8: Incident flight data

The engineer downloaded and analysed the data. An overtorque in excess of 125 per cent requires grounding of the aircraft, and analysis of the data by the engine and airframe manufacturers. He found that a main gearbox overtorque to 159.5 per cent had occurred during the first flight. The extent of the overtorque was such that the helicopter should not have been flown until the engine and airframe manufacturers declared the helicopter serviceable.
