Track worker fatally injured when struck by train W510

Clyde, New South Wales, on 18 June 2016

ATSB Transport Safety Report

RO-2016-008 – 20 April 2020

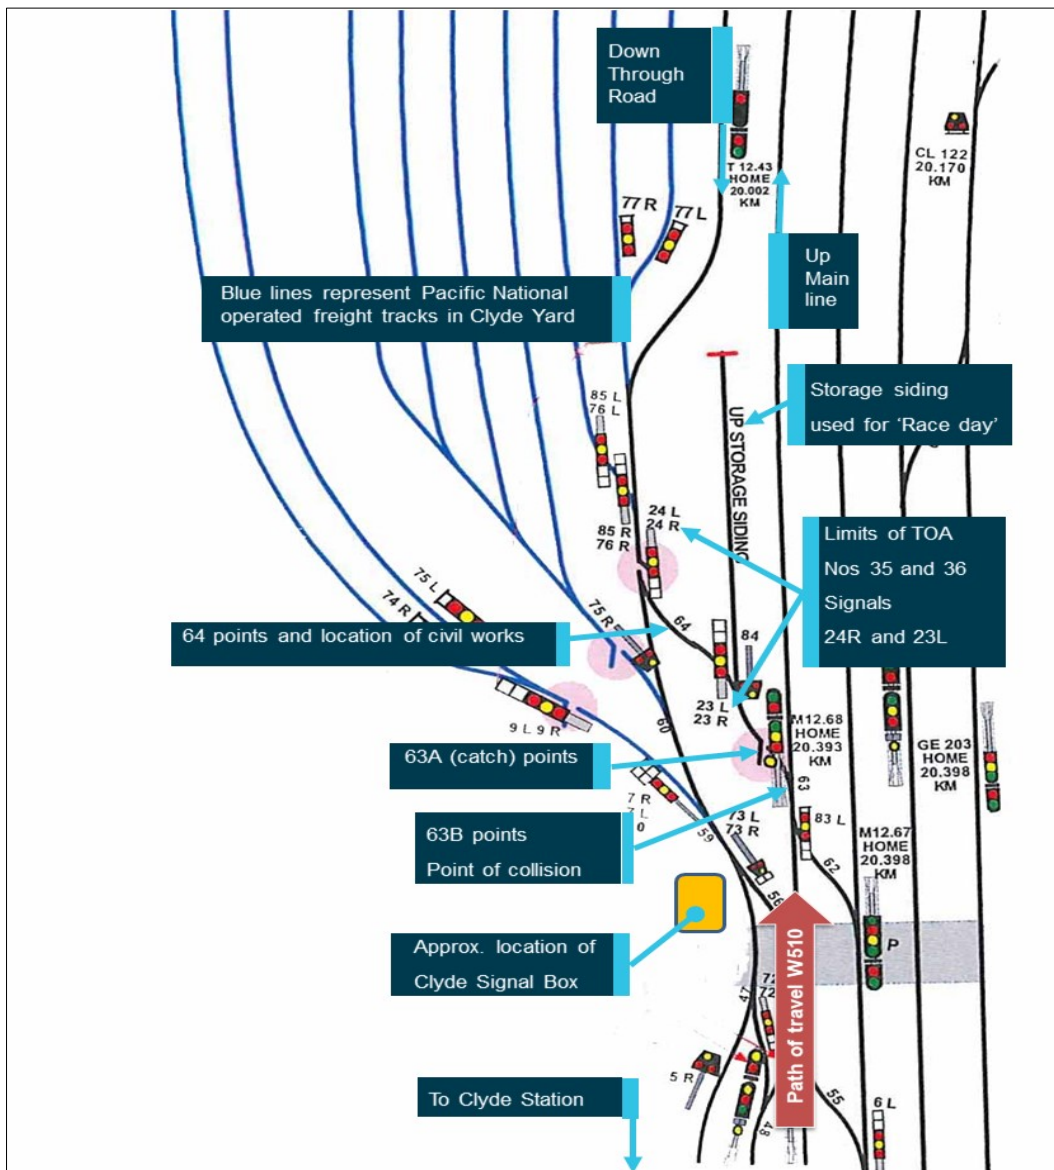
Figure 1: Site map of Clyde showing area of civil works and involved points

During the inspection, team members identified deficiencies associated with 64 points involving subsidence in the track formation material and decaying timber sleepers. The team categorised the deficiencies as an E2² defect and arranged Infrastructure Booking Authorities³ (IBA) to remove 64 points and other signalling infrastructure from service. As an E2 defect required action to minimise risk within 24 hours, the team also recommended booking 63B points out of service to prevent trains accessing 64 points from the Up⁴ Main Line (Figure 1).

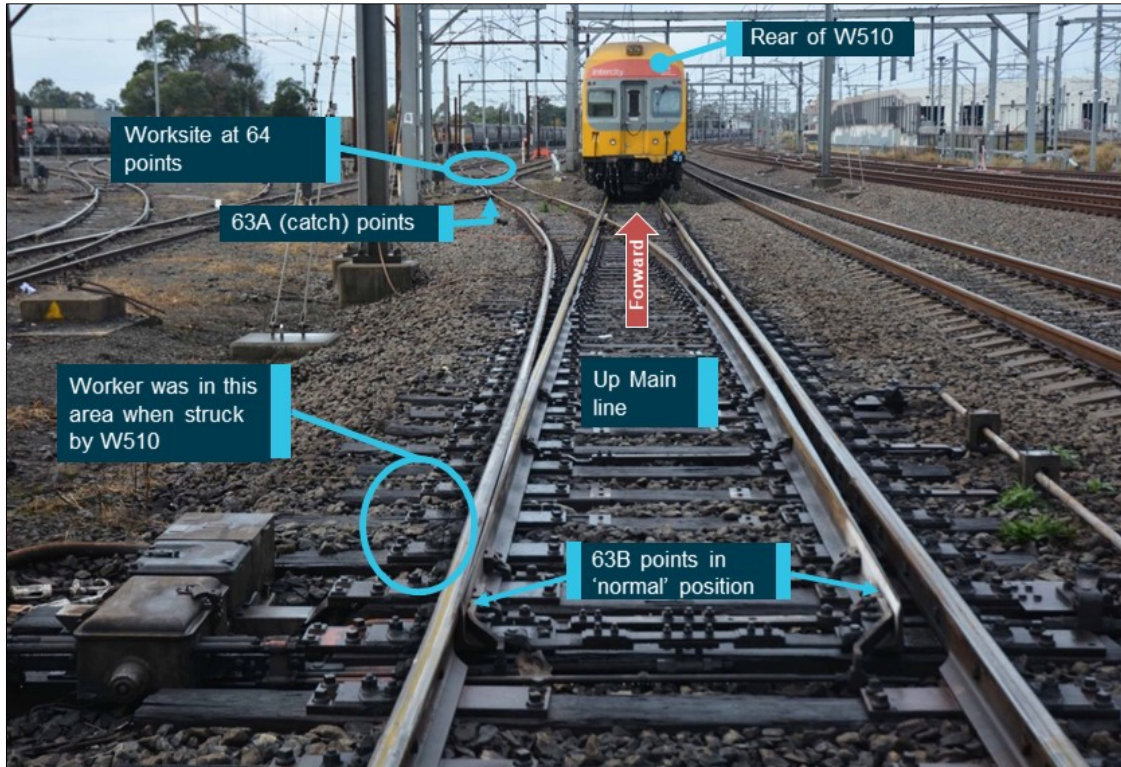
Figure 2: 63B points in normal position prevents movements towards 64 points

The SMT Electrician recalled he was conversing with the Clyde Signaller regarding the IBA for 63B points while opening the lid to the point machine to check for lock and detection when he noticed the approaching train and yelled a warning to the SMT Mechanic. About the same time, train W510 passed over 63B points, striking and fatally injuring the SMT Mechanic.

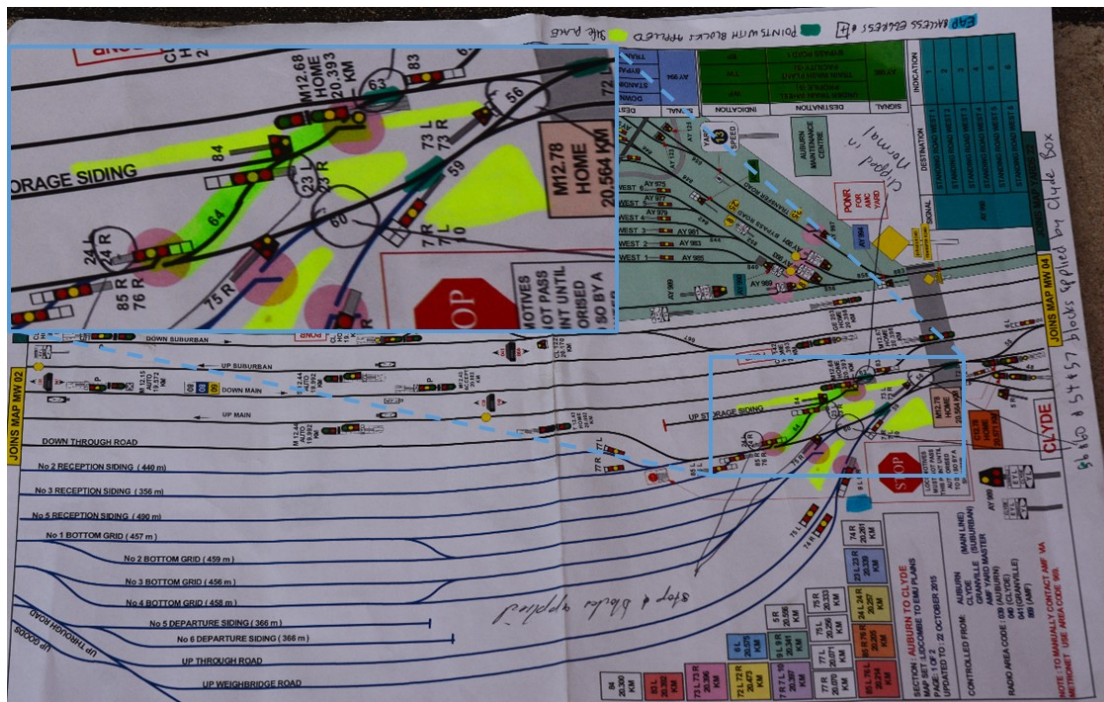
Figure 9: Photograph of PO's work plan with annotation on the DRKD

The DRKD did not identify all signals and points used by the PO and Clyde Signaller to protect the movement of the excavator when crossing the tracks to access the worksite (Figure 9).

The PO annotated the DRKD to record that the Clyde Signaller applied blocking facilities to 54, 56, 57 and 60 points that were outside the limits of TOA 35. The limits of TOA 35 were the Clyde end of Storage Siding to Down through Road between 23L Signal and 24R Signal and indicated by a light green highlighted area on the DRKD (Figure 9). In order to protect the limits of the TOA, the Clyde Signaller placed 23L and 24R signals at stop and applied manual blocking facilities on the route and track (including points) ahead of those signals. The application of the blocking facilities was a second layer of control to prevent the inadvertent clearing of the signals and movement of points.

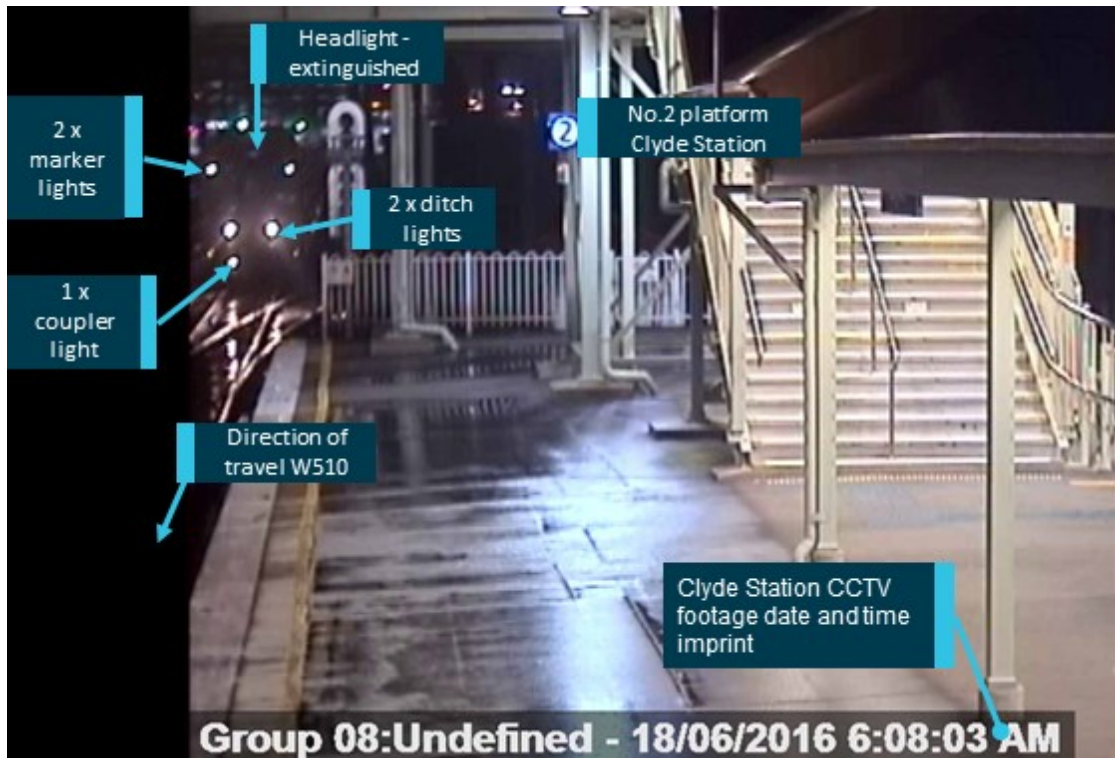
Figure 10: Train lighting on front of W510 as it approached Clyde Station

While addressing risks associated with headlight glare, the practice of extinguishing the headlights and reverting to visibility lights may have increased the risk that a train driver would not sight workers on or about the track during times of low ambient light conditions.

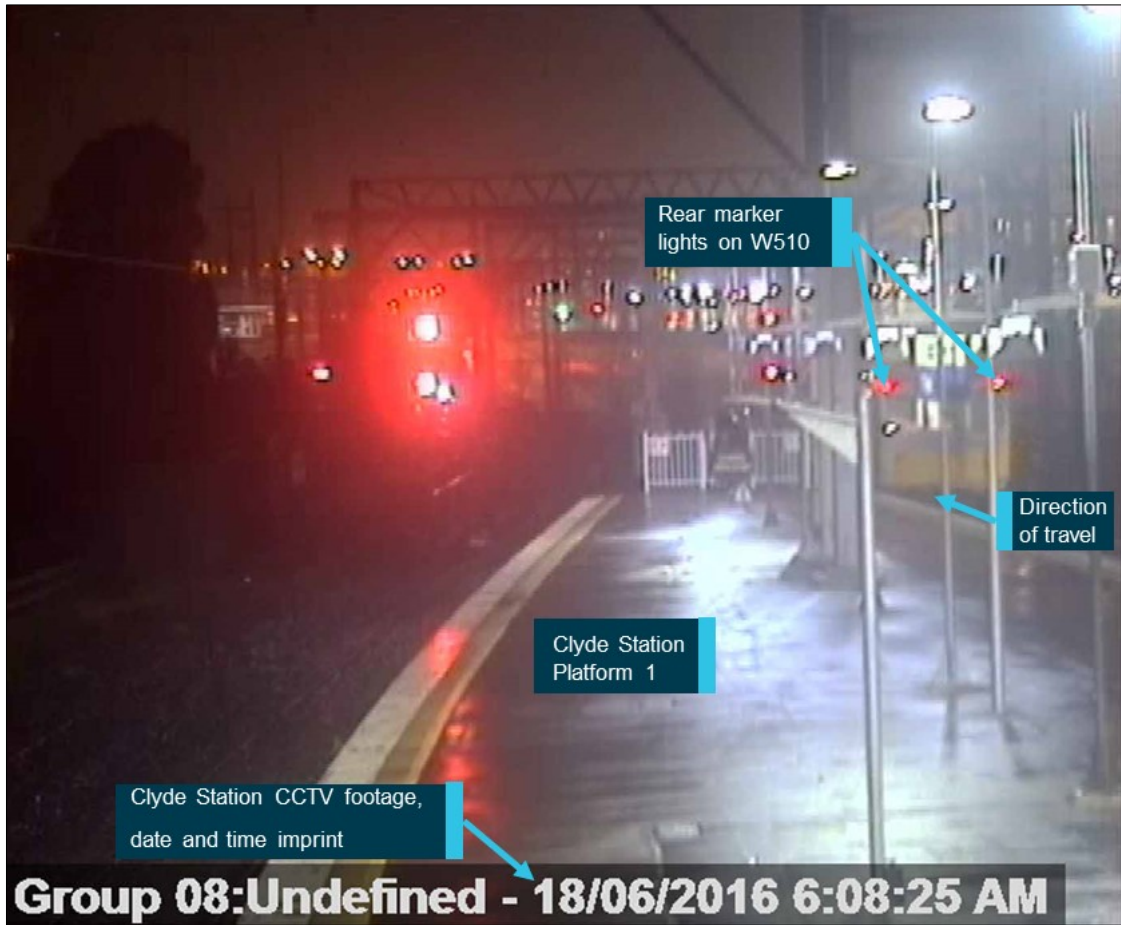
Figure 13: CCTV footage depicting environmental conditions as W510 passed through Clyde station moments before the accident

At the approximate time of the accident, there was little ambient lighting in the area around 63B points. The floodlighting used by the CMT during the sleeper replacement works was off and the CMT team leader and SMT were working on the tracks using torchlight.

CCTV footage from Clyde Station and the nearby Auburn Maintenance Centre illustrated the likely level of ambient lighting present and the presence of steady rainfall around the time of the accident (Figure 13).

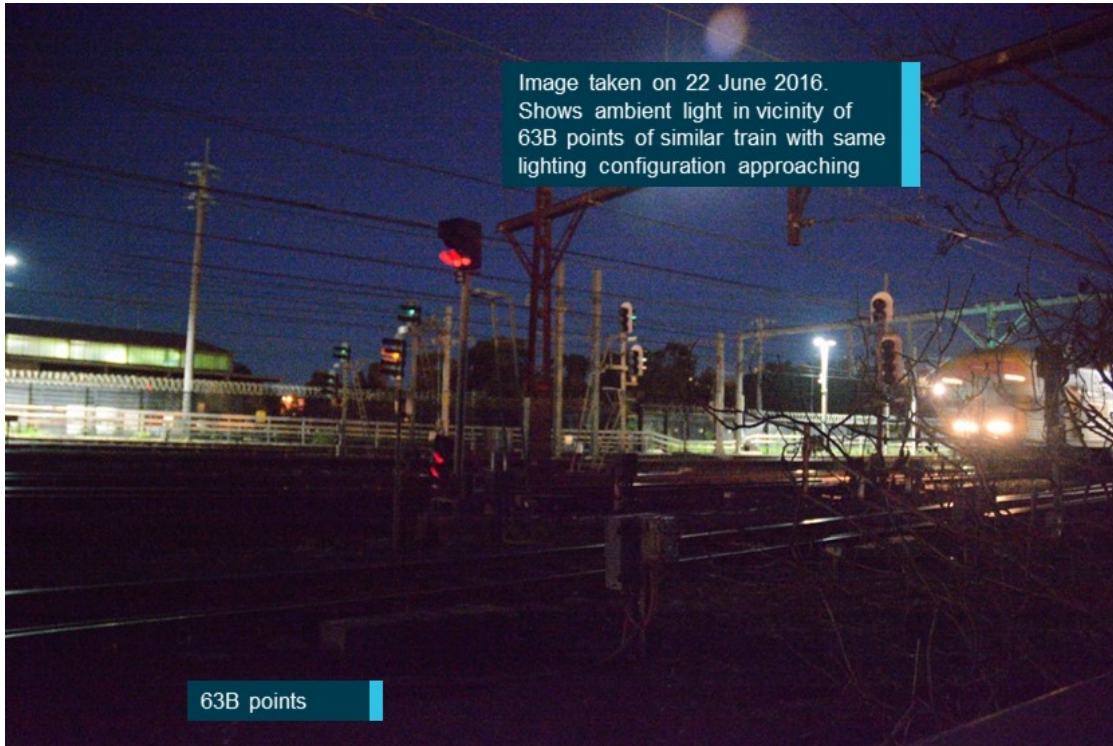
Figure 14: Ambient lighting near 63B points on 22 June 2016

A site visit on 22 June 2016 conducted at a similar time to the accident photographed the ambient lighting conditions at 63B points (Figure 14). The train service shown had a similar lighting configuration to the lead car on train W510. A slight increase in illumination in close proximity to the front of the train due to the visibility lights is evident.

On the morning of 18 June 2006, the area near 63B points presented as a low light condition. The SMT members were using handheld torchlights directed towards their work (63B points).

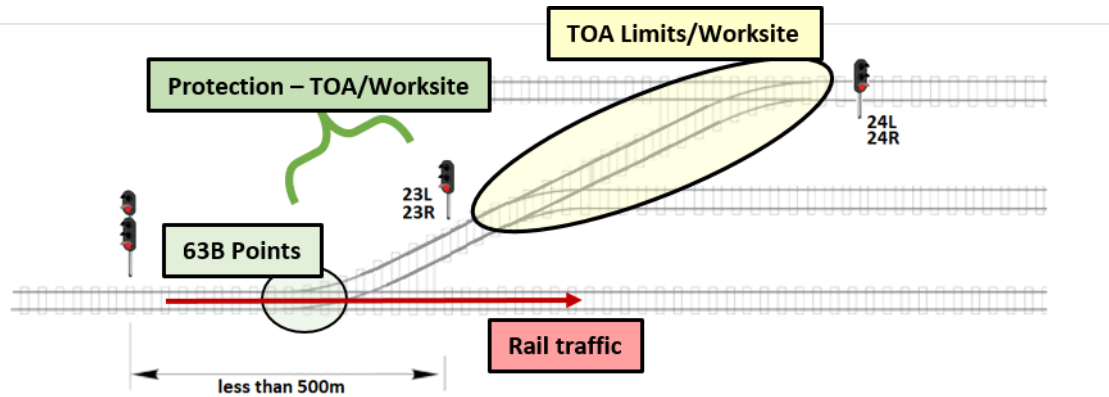
Figure 16: Worksite protection

In this case, the authority (TOA 35) defined the limits as the track between 23L signal and 24R signal. This also reflected the worksite boundaries since both signals were relatively close to 64 points. No further protection was provided on the main line, since 63B points were already clipped and locked. Consequently, the main line remained available for unrestricted rail traffic while work was undertaken on 64 points (Figure 16). This method did not provide advice of approaching trains on the Up Main.

Under the arrangements implemented on 17/18 June 2016, the buffer zone between the worksite and unrestricted main line rail traffic was considerably less than 500 m, noting the distance between the worksite and 63B points was about 50 m. It is evident that under this arrangement, there is an increased probability, a track worker could move along the track, inadvertently exit the worksite, and subsequently be in the immediate vicinity of operational main line rail traffic. The arrangement did not include any additional audible or visual warning devices for approaching trains, or any facilities for reminding track workers of the worksite limits.

In addition, the arrangement allowed main line rail traffic to operate normally over the facilities used for protecting the TOA limits and worksite, a condition not permitted under any other protection arrangement defined in the TOA rules.
