**Australian Transport Safety Bureau**

# Drum stock fuel contamination

Cloncurry Airport, Queensland on 7 September 2016

**ATSB Transport Safety Report**  
Aviation Occurrence Investigation  
AO-2016-144  
Final – 22 April 2020

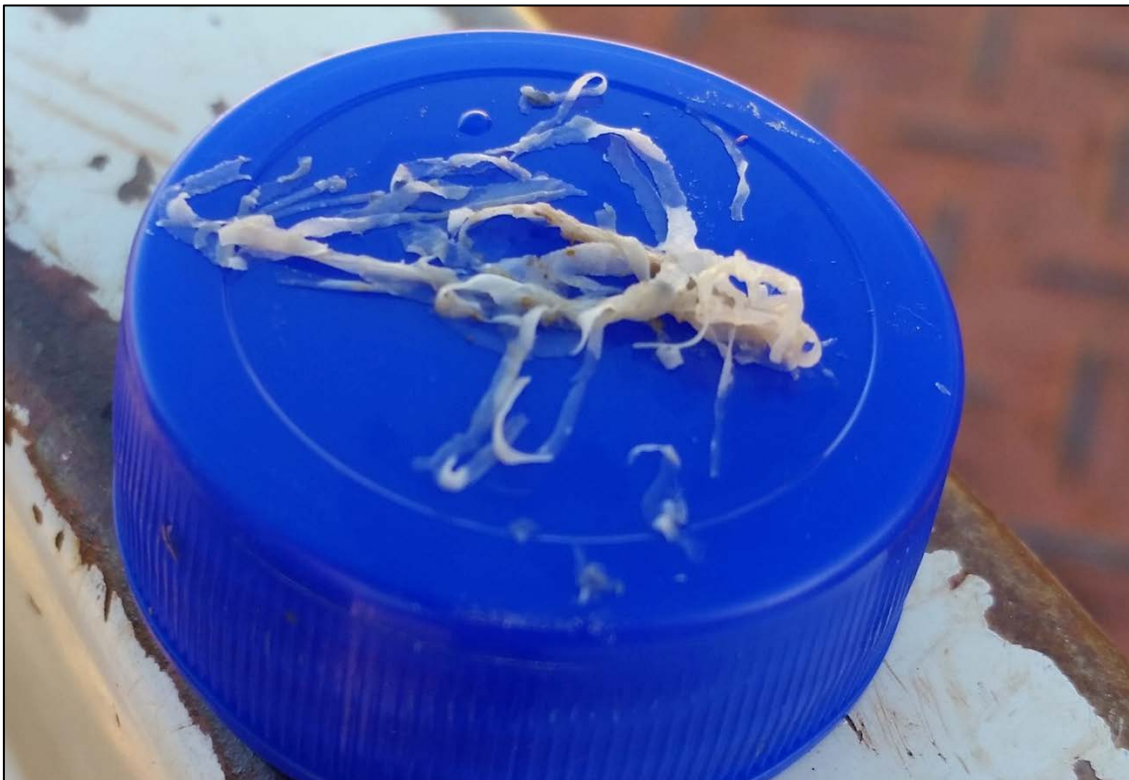
In September 2016, the ATSB received a report from a helicopter operator regarding contaminated drum stock fuel in Cloncurry, Queensland. One of the operator's pilots observed white particles floating in Jet A1 fuel while inspecting one of several recently arrived drums. The same contaminant was subsequently found in all seven of the drums that were opened and inspected. Similar contaminants were found in the fuel filtration system of the drum transfer pump.

**Figure 1: Contaminant removed from the drum**

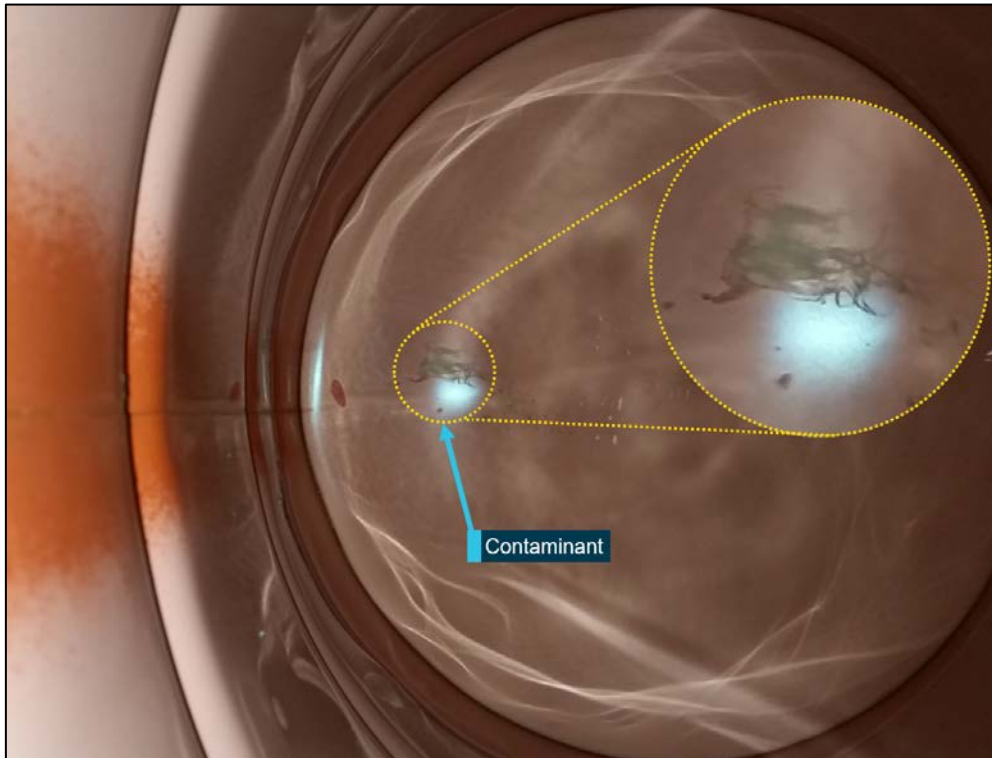
The white, stringy material was observed in the Jet A1 fuel drums in each instance of contamination. Figure 2 shows the largest of these contaminants.

**Figure 2: A large contaminant observed at the base of a drum of Jet A1 fuel**

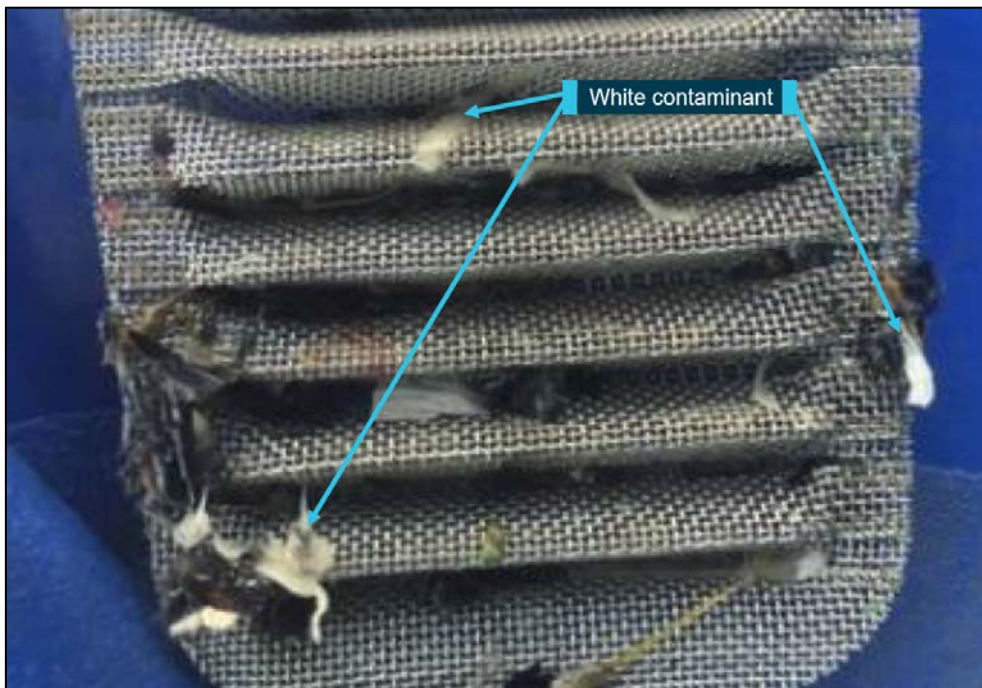
On several occasions, contaminants were also found within the fuel filtration system of the pump used for fuelling aircraft. Several pieces of the white contaminant can be seen in the coarse filter shown in Figure 3.

**Figure 3: White contaminants in the ‘rock catcher’ – part of the fuel pump system**

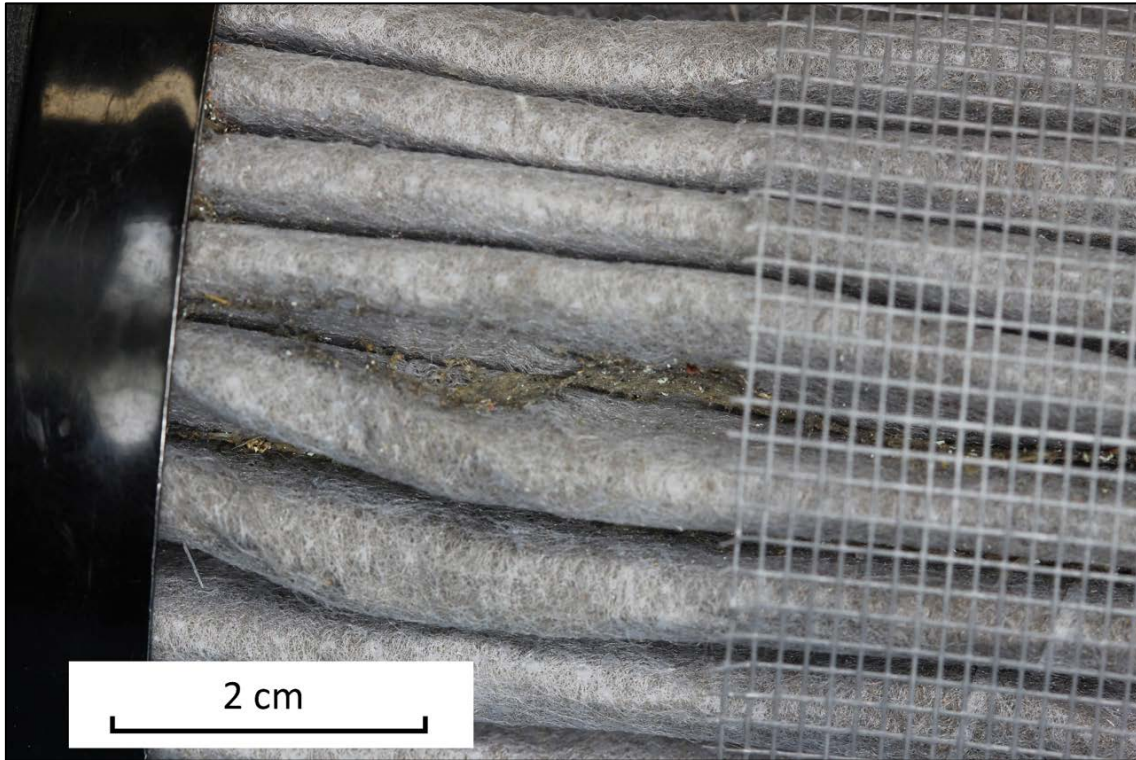
Contaminants were also found beyond the ‘rock catcher’, such as in the micron pre-filter seen in Figure 4. This filter was from a fuel pump involved in the April 2017 occurrence, and was provided to the ATSB for examination. Figure 5 shows contaminants removed from the same filter. These

rubbery contaminants appeared too large to pass through the upstream coarse filter, as well as the mesh surrounding the filter shown in Figure 4. Assuming the filters were all functioning properly, the large contaminants found in the pre-filter were likely the result of many small pieces (less than 1 mm) coalescing into a larger piece. Other small contaminants (such as dirt and metal) were found within these larger pieces (Figure 5). The smaller pieces were not identified in the fuel drum, most likely because they were too small to be visually observed.

**Figure 4: Micronic pre-filter containing contaminants from April 2017**

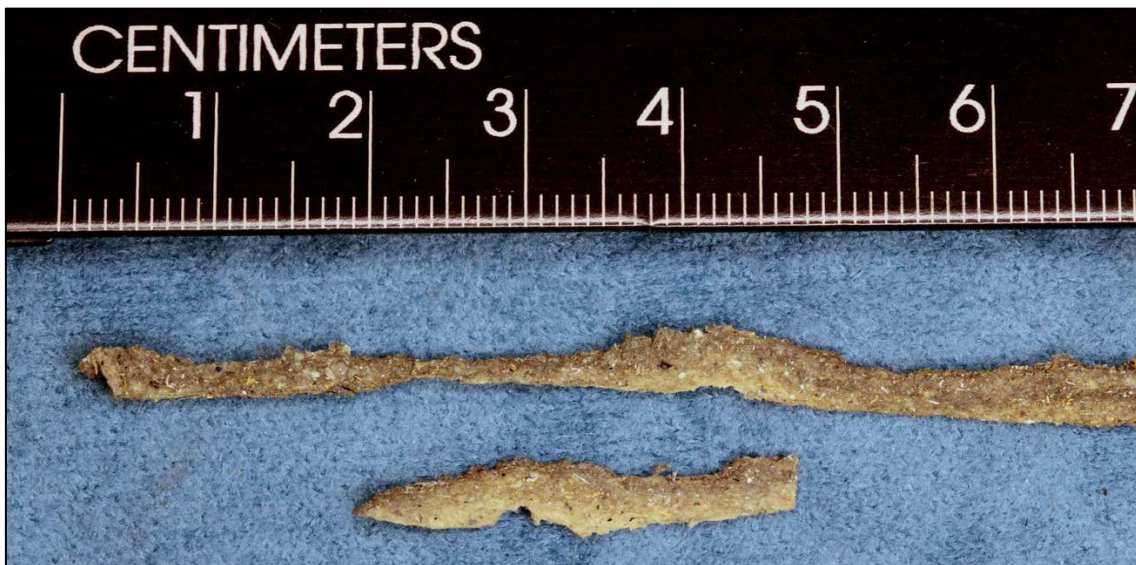
**Figure 5: Contaminants removed from a pre-filter involved in the April 2017 occurrence**

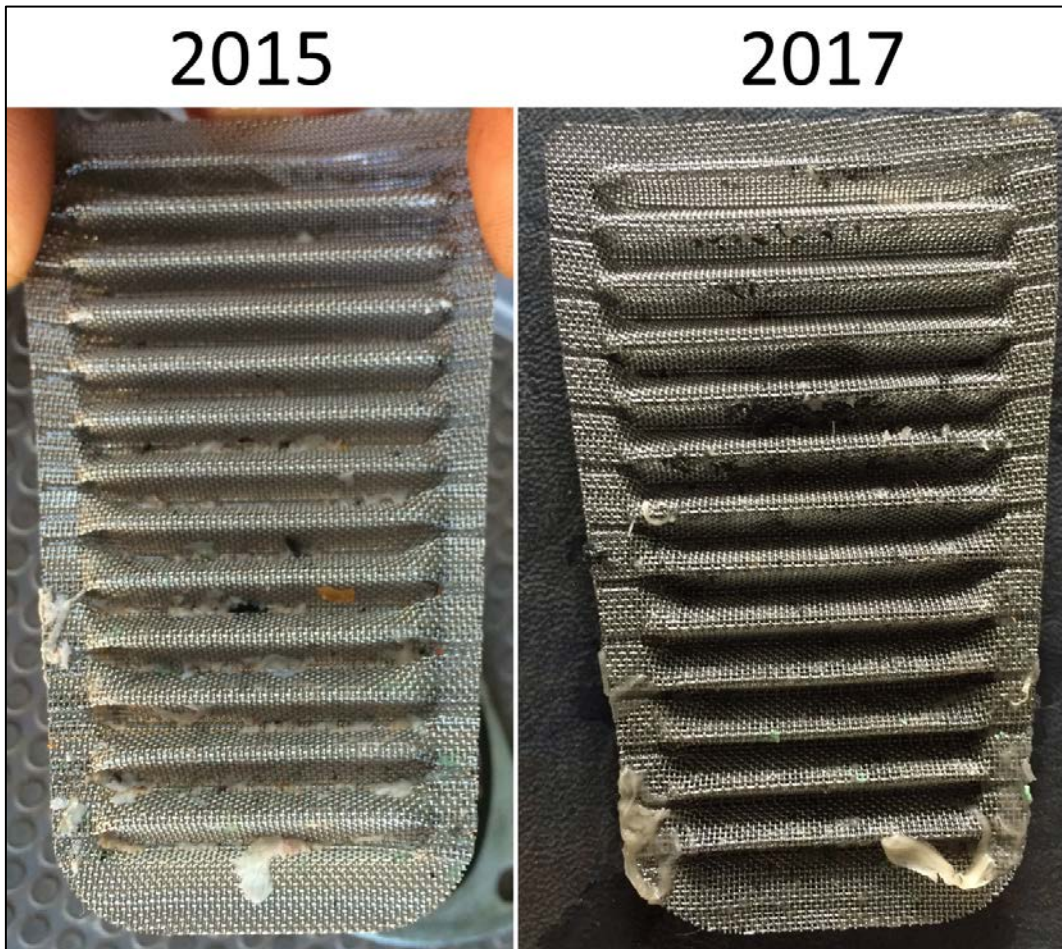
In 2015, a refueller in Western Australia reported an instance of fuel contamination to the Civil Aviation Safety Authority. The contamination was discovered by an operator in the Kimberley region. The drums were also supplied by the same manufacturer. Contaminants were found in drums as well as filters in the refuelling system. The refueller arranged to have the material tested, and found that the contaminant was consistent with the sealant used on the lids and bases of the fuel drums manufactured by VIP Packaging. The refueller published a customer alert identifying the contaminant as drum sealant, and urged customers to inspect their drums, filters, and strainers for any evidence of the contaminant. Figure 7 shows a comparison of the contaminant found in the 'rock catcher' filters in 2015 and the most recent occurrence in 2017.

Figure 7: A comparison of the white contaminant found in 2015 and in April 2017

The refueller reportedly brought the issue to the attention of the drum manufacturer, who sent them a batch of new drums manufactured in a different factory. However, the refueller found the new drums had the same contamination present.

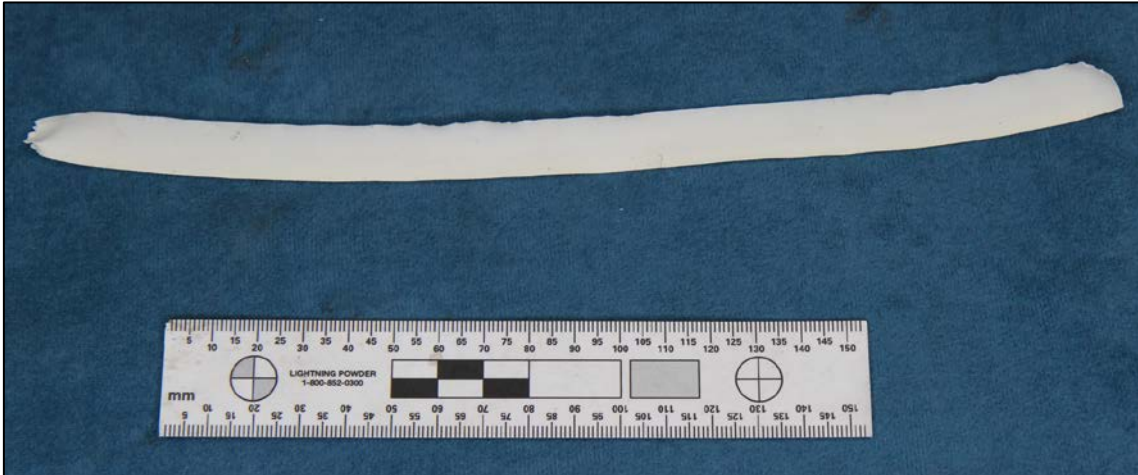
A drum base was provided by the manufacturer in order to test the behaviour of the sealant in Jet A1. The base had a bead of sealant applied around its circumference, which was removed for testing. The removed sealant exhibited the behaviour of a piece of thin, elastic tape (Figure 8).

**Figure 8: A section of sealant removed from a drum base.**

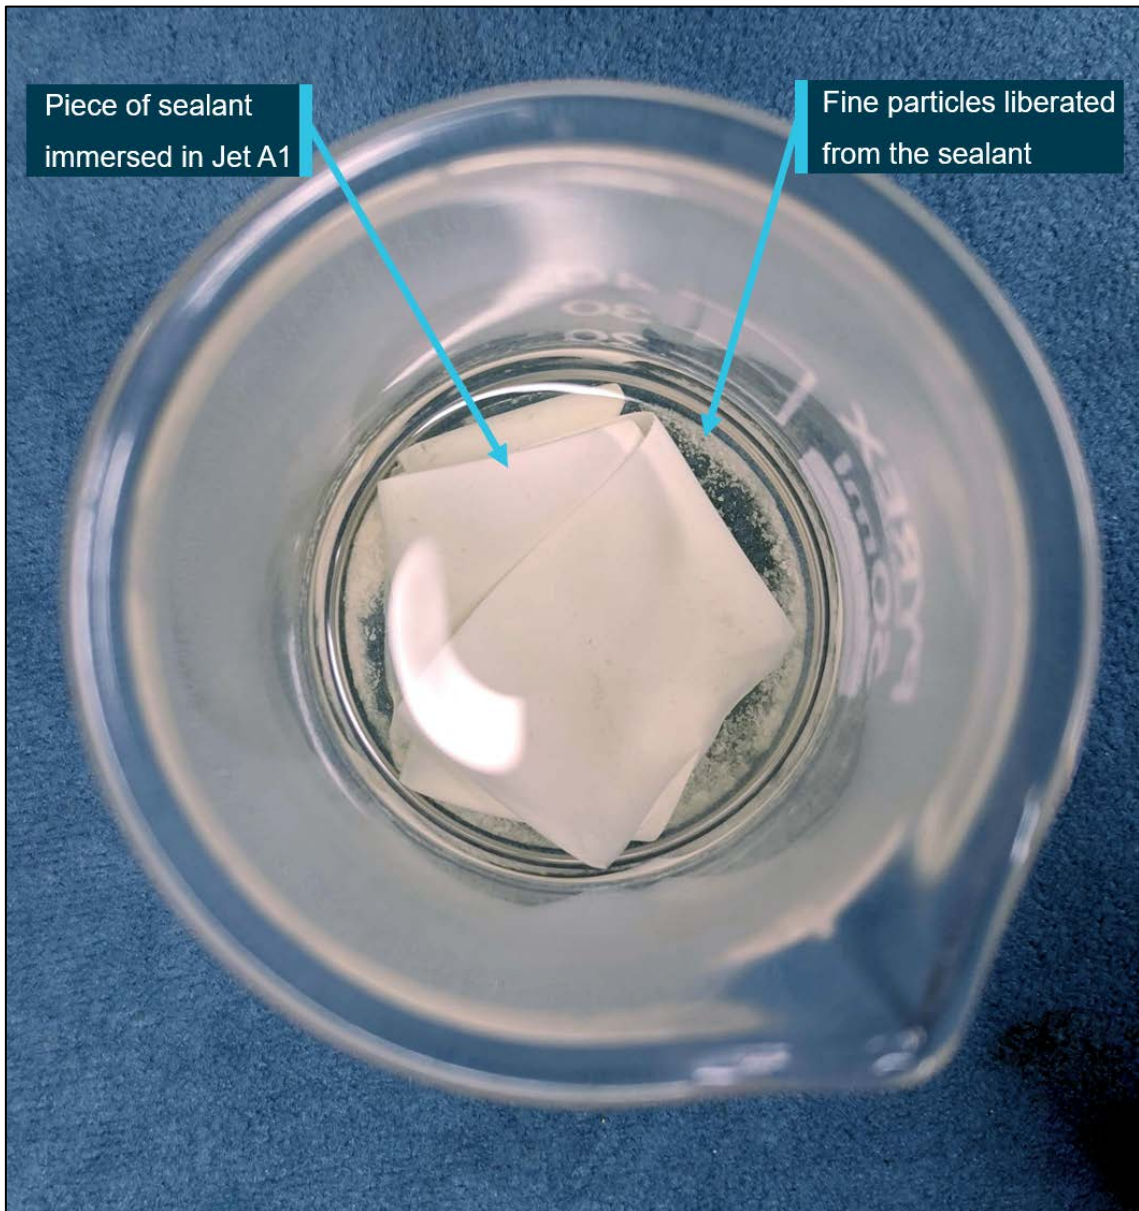
It was found that after 24 hours of immersion in Jet A1, the appearance and properties of the sealant changed noticeably. Specifically the:

- width of the sealant increased by approximately 50 per cent
- extension to failure dropped from ~250 per cent of original length down to less than 20 percent
- sealant became friable when held.

Temperature had no noticeable effect on the sealant, but agitation by the stirrer and the ultrasonic bath both caused the sealant to degrade. The stirrer caused the sealant to break into pieces of varying sizes, while the ultrasonic bath liberated very fine particles from the single piece of sealant (Figure 9). When the sealant was removed from the Jet A1 and dried, the appearance and properties appeared to return to normal. There was insufficient evidence to suggest the sealant dissolved in Jet A1. When immersed in water, the sealant did not appear to change properties or appearance at all.

**Figure 9: A piece of sealant after immersion in Jet A1 fuel and ultrasonic agitation**

Once properly dried, the sealant's properties returned to normal. Therefore, it was concluded that the interaction between sealant and Jet A1 was primarily physical rather than chemical. The substantial change in the width of the sealant suggested that Jet A1 was being temporarily absorbed into the material, causing the change in properties.
