Derailment of freight train 7MB9

Goulburn, New South Wales, on 31 March 2019

ATSB Transport Safety Report

RO-2019-010

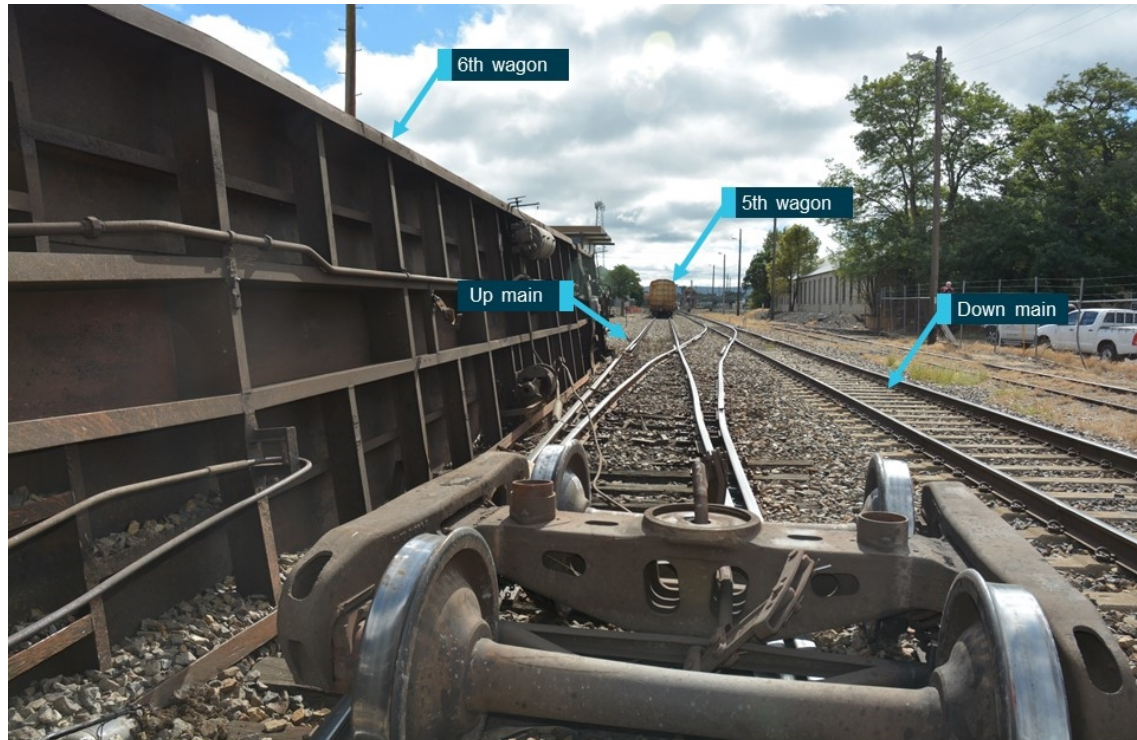
Figure 3: Derailed wagon and detached bogie

A total of five wagons derailed due to a broken Up rail at 225.413 km³ with the wagons coming to a rest across the Up and Down main lines (Figure 3 to Figure 5).

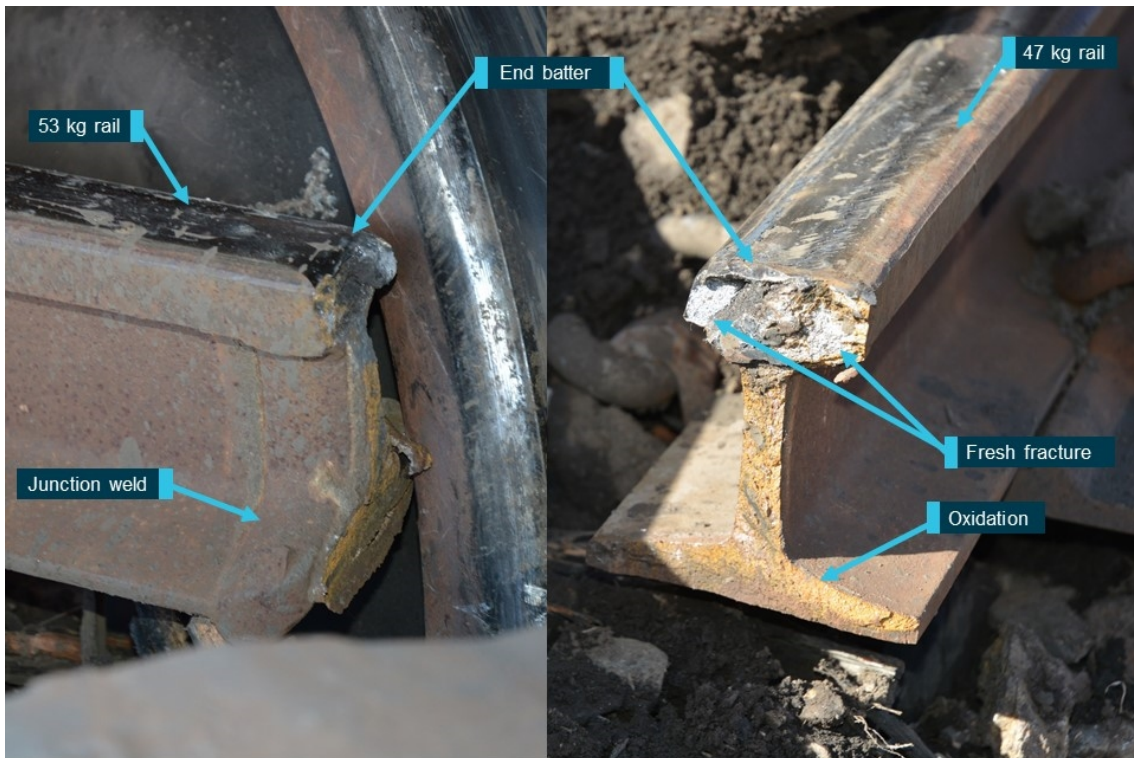
Figure 11: Broken Up rail

Post-derailment inspection completed on 31 March 2019 determined that the Up rail broke at an aluminothermic junction weld joining 47 kg/m and 53 kg/m rail. The fracture face exhibited signs of oxidation across the foot and web of the rail, with two small sections in the rail head without oxidation indicating a fresh fracture surface (Figure 11). The rail head at the break also displayed some signs of end batter.¹³

Further analysis of the broken Up rail undertaken by an independent metallurgist on behalf of ARTC identified a lack of weld fusion on the foot of the rail between the two rail types. The lack of weld fusion most likely went undetected at the time of welding. This weld fault likely created a stress raiser leading to the initial fracture at the foot of the rail. ARTC were unable to provide welding or maintenance records for the junction weld, however they assessed the weld as having had a long service life.

It is likely the fracture progressed from the foot of the rail and through the rail cross-section after the date of the last ultrasonic inspection. The crack was most likely detectable once the defect propagated into the web of the rail, however, testing was not due until July 2019, as per ARTC maintenance standards. This defect would have been unlikely to be detected during a routine track patrol inspection, in particular, a track patrol completed from a hi-rail vehicle.

Safety action taken: ARTC undertook restorative work following the derailment and repaired the section of track.

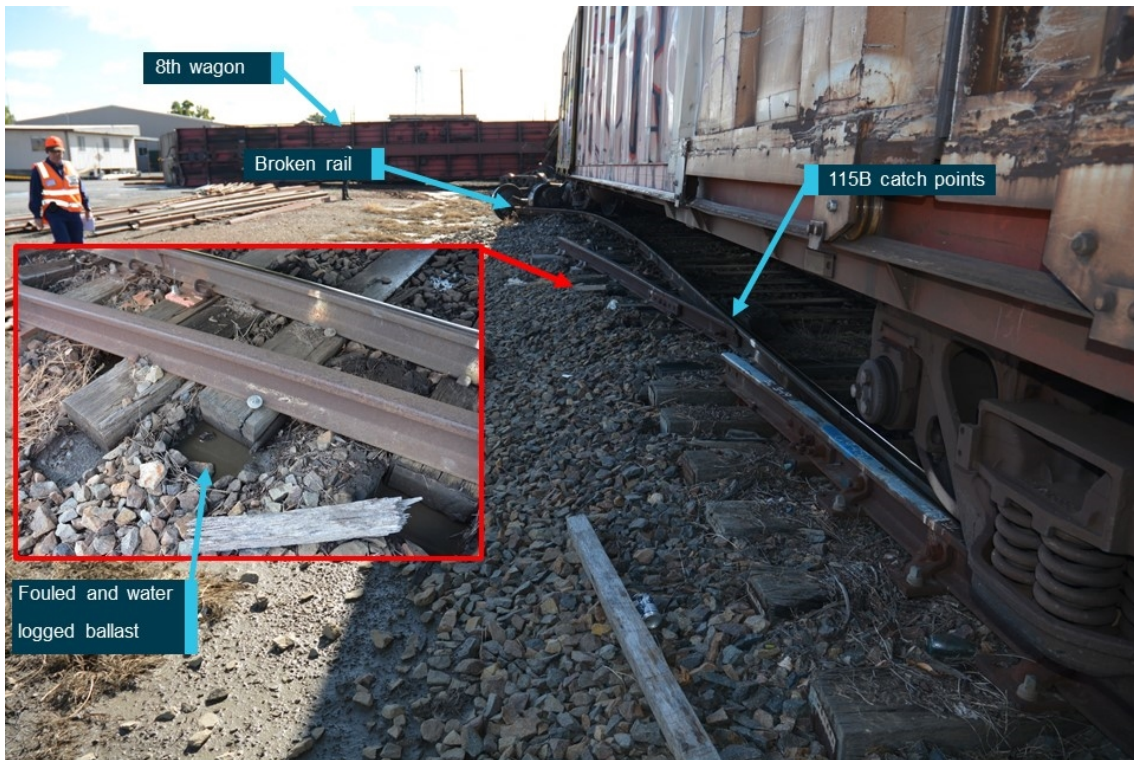
Figure 12: Refuge track condition near point of derailment

The ballast and sleepers at the site of the broken Up rail were destroyed, preventing a detailed inspection. The broken sleepers in this area fractured into small pieces and appeared to indicate some degree of decaying and the ballast appeared fouled with mud and dirt. It is likely that the track condition at the point of derailment was similar to that of the area in the turnout. It is possible the fouled ballast reduced the track stability and may have allowed greater track movement in this area.

ARTC advised that in 2017, they identified decayed sleepers in the refuge. In May 2017, ARTC replaced 70 sleepers with concrete sleepers between the 225.440 km and 225.590 km. A further 200 sleepers had been identified as requiring replacement and were being monitored annually. There were no concrete sleepers near the point of derailment.

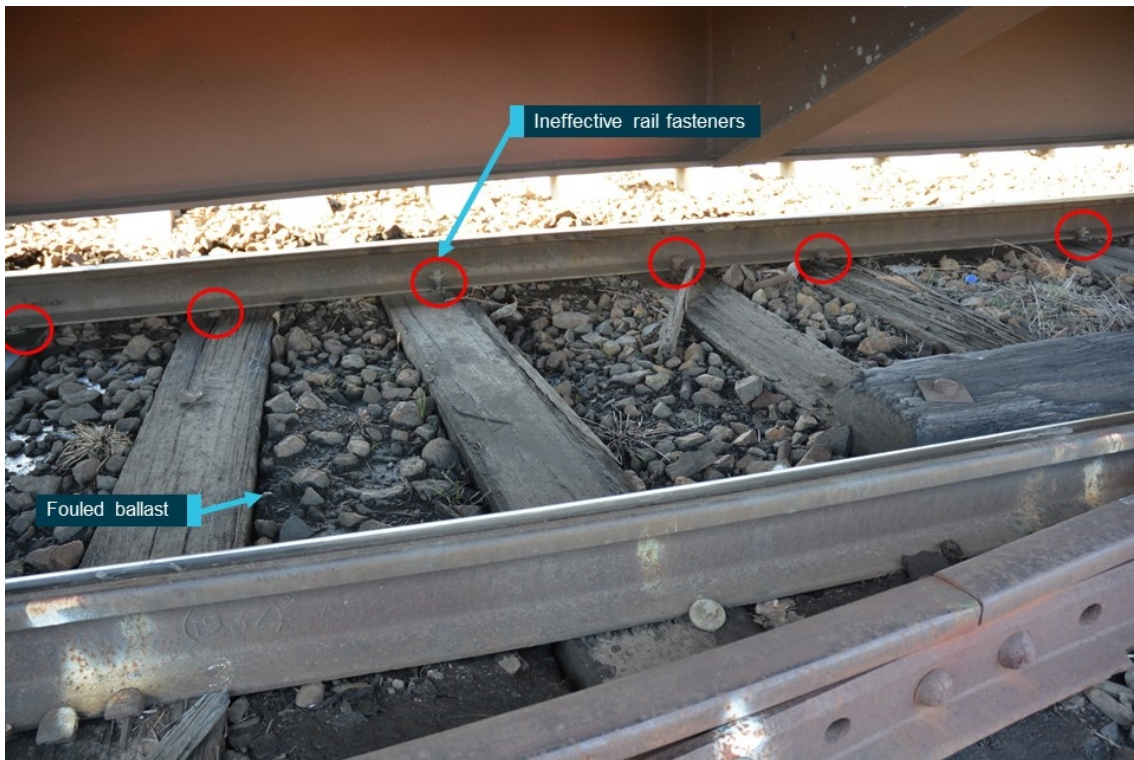
Figure 13: Ineffective rail fasteners

Under the 10th wagon, there were also six sleepers in a row where the fastener was either displaced and not securing the rail foot, or was secured to the sleeper but not in contact with the foot of the rail (Figure 13). It did not appear that these fasteners had displaced as part of the derailment sequence and appeared to be a pre-existing defect.

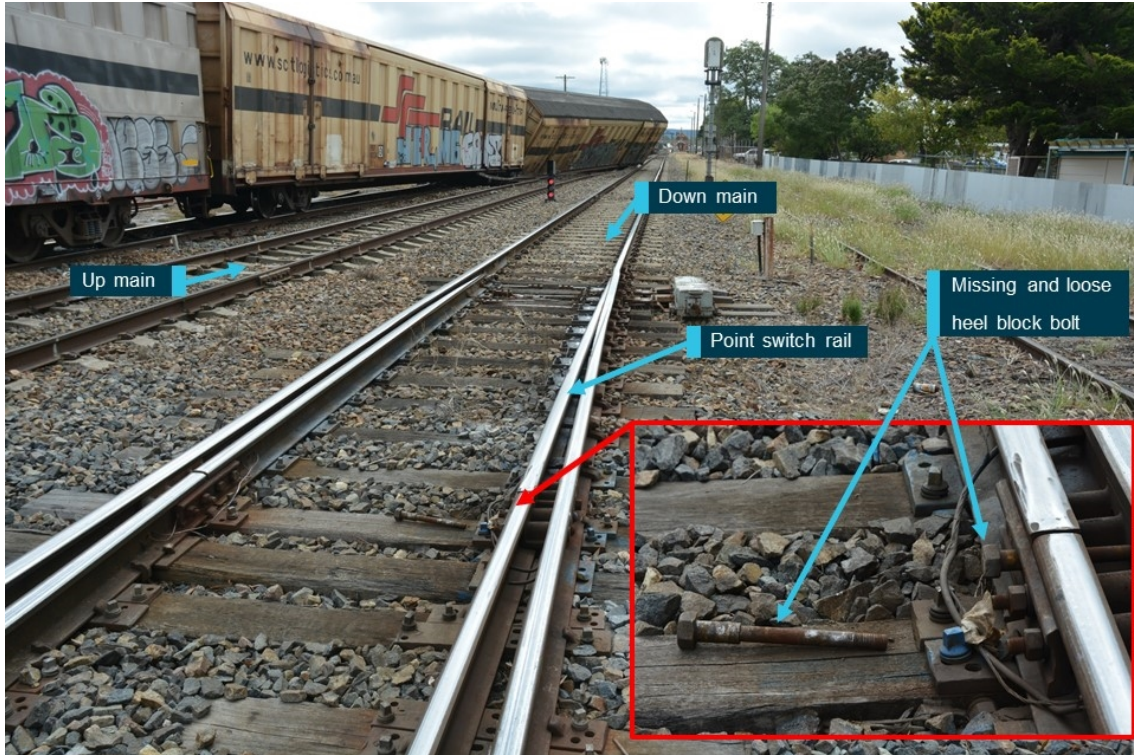
Figure 14: Down main heel block bolt missing

While walking the derailment site, the ATSB also identified points 114A on the Down main with ineffective heel block¹⁷ fastening. One heel block bolt was found in the four-foot¹⁸ and the second bolt securing the point switch was loose (Figure 14). The ATSB raised the defect with the ARTC representative on the day of the derailment.

Maintenance records indicated that the most recent track patrol was performed on 28 March 2019, with no reported defects at this location. It was not possible to determine when the bolt dislodged, however the derailment is not believed to have contributed to these defects found on the adjacent track.
