In-flight deployment of ditching dam involving De Havilland Aircraft of Canada DHC-8, VH-SCE

80 km south-south-east of Whyalla Airport, South Australia on 8 August 2019

ATSB Transport Safety Report
Aviation Occurrence Investigation
AO-2019-044
Final – 14 May 2020

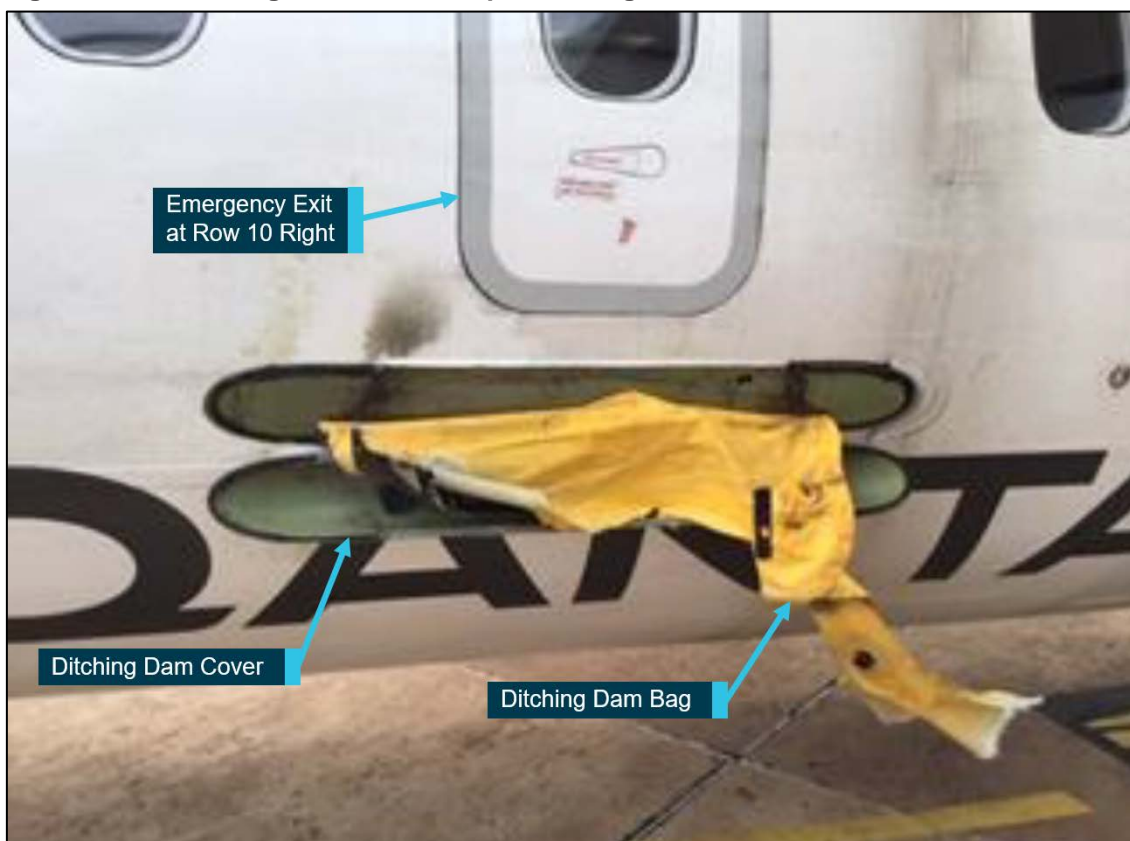
After landing, it was confirmed that the ditching dam at the right-hand rear emergency exit had opened in flight and been destroyed by aerodynamic forces (Figure 1).

It was subsequently determined that the ditching dam had not inflated but rather, for unknown reasons, the ditching dam cover had opened in flight, allowing the uninflated dam to unfurl into the slipstream. When the replacement ditching dam assembly cover was installed, it did not initially meet the required engagement tolerance into the airframe channel that retains it. The flight crew member who conducted the pre-flight inspection reported that the ditching dam cover was securely engaged before the flight.

Figure 1: The ditching dam as found upon landing

The specific reason for the ditching dam cover opening could not be determined.

It was reported that the cover was secure prior to the flight, but post-occurrence replacement of the ditching dam identified that it did not initially meet the required engagement tolerance into the airframe retaining channel. That raised the possibility that the occurrence cover may have appeared to be visually secure during the pre-flight inspection while also not being properly engaged.

Once the cover partially opened, aerodynamic forces drove the cover fully open and permitted the dam bag to unfurl into the airstream. The bag, cover and inflation hose then hit the fuselage repeatedly, which was the loud noise heard by the occupants of the aircraft. As a result of the deployment and given its location on the aircraft, if the device or part thereof had come loose, it was unlikely to have resulted in further damage to the aircraft.

- The ditching dam cover opened in-flight, possibly due to exposure to severe icing and turbulence and/or improper engagement of the cover with the airframe.
- The deployment of the ditching dam did not increase the risk of damage to other aircraft systems or to continued safe flight.
