Derailment of grain train 8838N

Narwonah, New South Wales, on 1 October 2017

ATSB Transport Safety Report

RO-2017-014

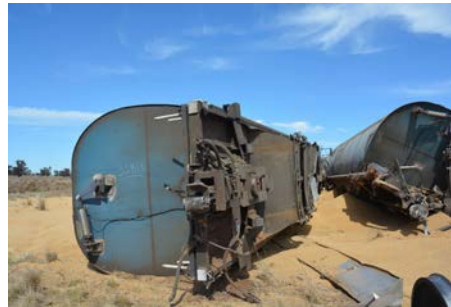
Derailed grain wagons

The ATSB found that the derailment occurred at a location with identified poor track condition around a rail joint on the down rail. This, and a short twist defect at the point of mount, contributed to the vertical unloading of wheels on the twelfth wagon in the consist (NGPF35911) and the subsequent derailment of that wagon and 10 trailing wagons.

Approximately 300 m of rail, fasteners and sleepers were replaced and 150 m of new formation was required around the derailment site. Thirteen 12-m track panels were constructed on site and lifted into place by cranes. The rail joints were welded and the track readjusted.

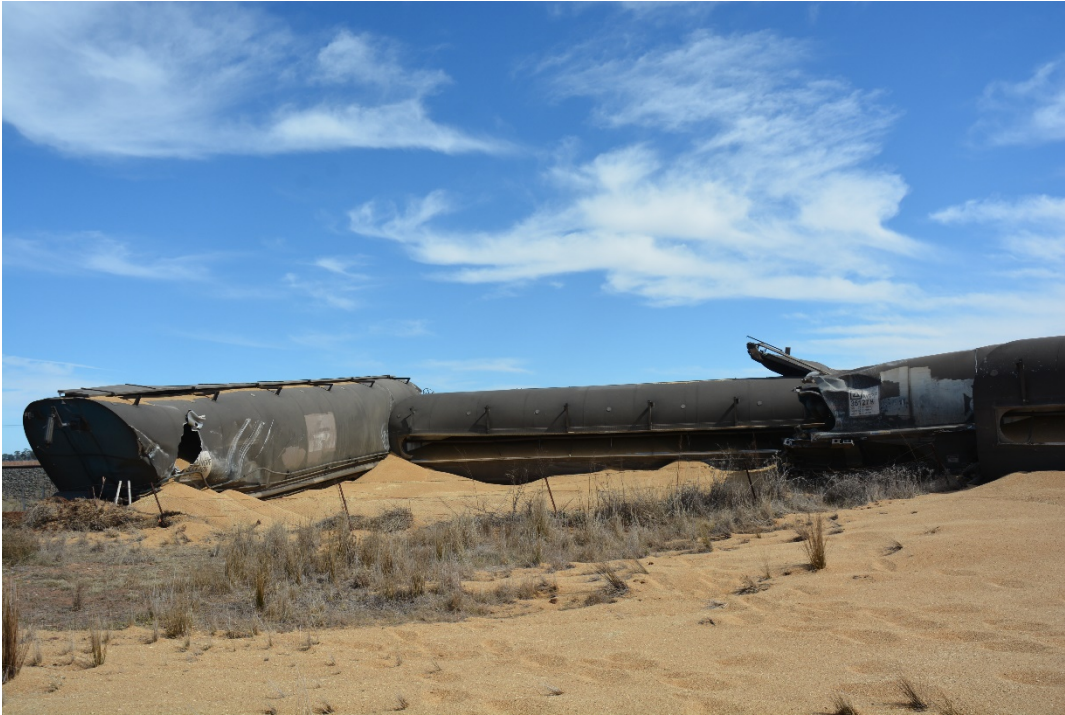
Figure 2: Derailed wagons and grain spillage

At 1145, the driver and the assistant driver inspected the derailment site and found the 12th to the 22nd wagon in the consist derailed. Nine wagons had derailed and were on their side and two wagons had derailed but remained upright. The last wagon, the 23rd wagon, did not derail.

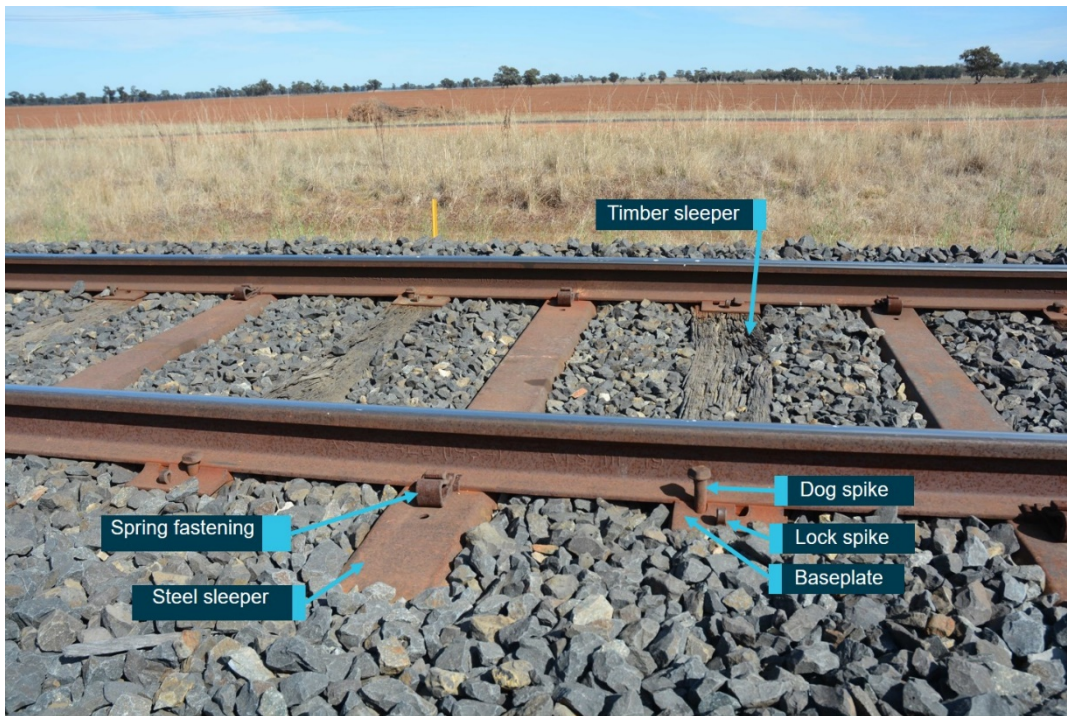
Figure 4: Track structure

The condition of the timber sleepers in the vicinity of the derailment was fair to poor. The tracks were supported by baseplates which were affixed to the timber sleepers with dog spikes. Some spikes were loose or missing from the timber sleeper fastenings (Figure 4). The poor condition of the timber sleepers was likely to have contributed to track instability in this area.

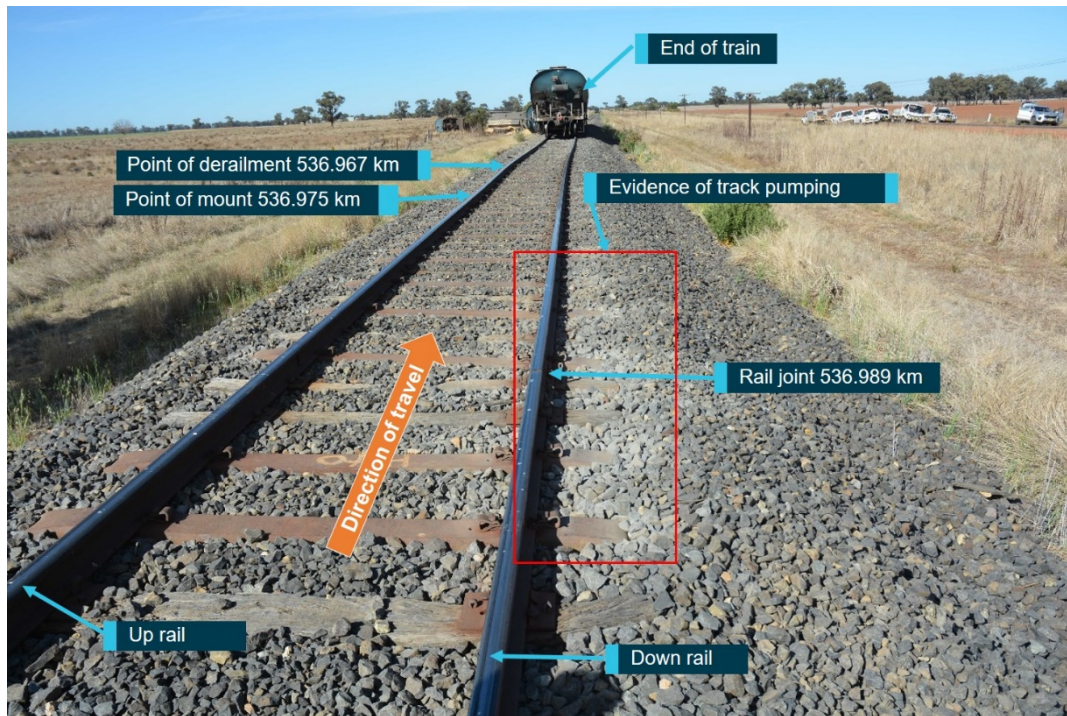
Figure 5: Derailment mechanism

This load testing revealed a short twist defect of 22 mm at the point of mount (536.975 km). At the rail joint on the down rail (536.989 km), the load testing also identified another short twist defect of 13 mm.

The derailment sequence likely commenced at the rail joint on the down rail. As the wheels on the rear bogie on the 14th wagon traversed the rail joint, the wheels on the front bogie were approaching a 22 mm change in superelevation.¹⁰ This likely caused the wagon (NGFP 35911 S) to roll and the left wheel on the lead axle of the leading bogie to unload. Wheel marks on the rail head showed that the flange of this wheel climbed the up rail and travelled on the top of the rail head for approximately 8 m and then dropped to the left side of the up rail. The opposite wheel dropped into the four foot¹¹ and the derailment of this wheelset precipitated the other ten wagons travelling behind to derail (Figure 5). The track defects, in the vicinity of this rail joint, likely contributed to the initiation of the derailment.

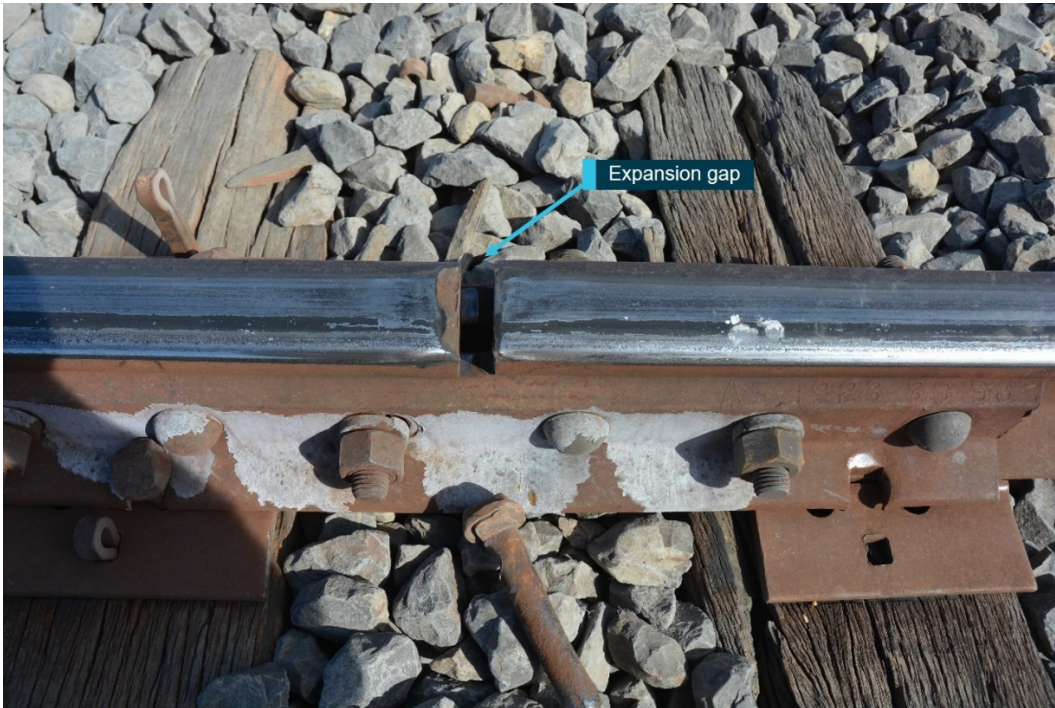
Figure 6: Rail joint

The track was inspected and measured immediately following the derailment. The ATSB made the following observations at the rail joint on the down rail (536.989 km):

- Evidence of the down rail pumping vertically around the joint
- Movement of the timber sleepers around this joint
- Loose or missing dog and lock spikes
- Damage to the face of the joint
- A joint gap of approximately 20 mm.

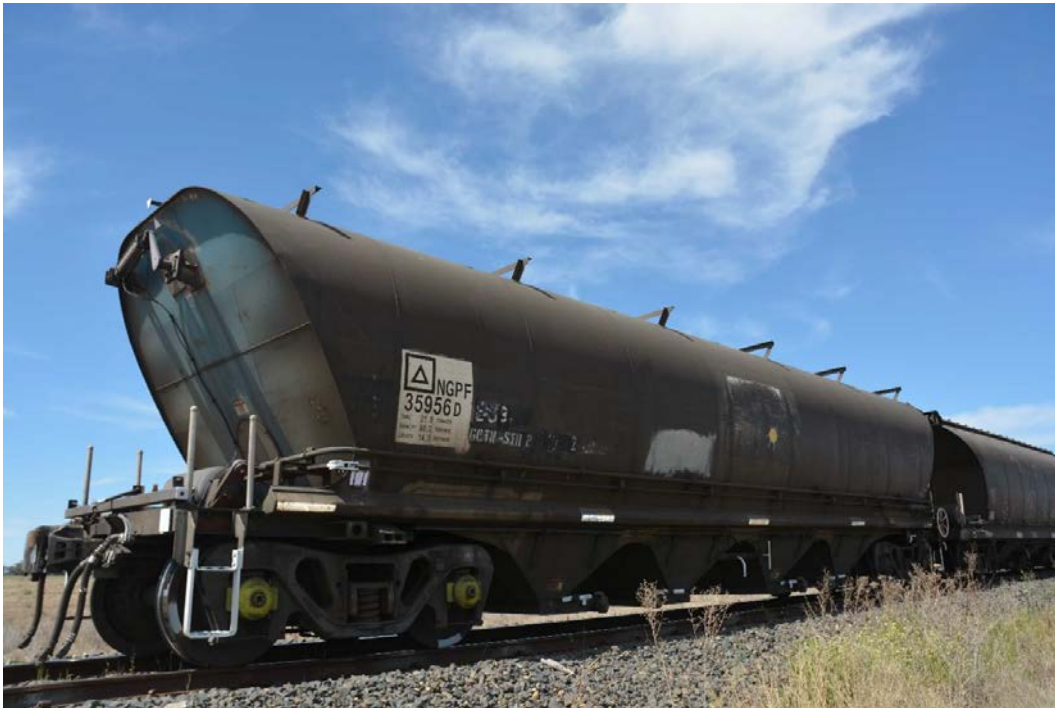
Figure 8: NGPF wagon

The wagons were inspected following the derailment. Apart from the damage sustained as a result of the derailment, the wagons, bogies and wheels were in good condition. The wheel rims of the first wagon to derail (NGPF 35911) were checked on site and no defects were observed. Wheel rim thickness, wheel tread and flange height were all within specification.

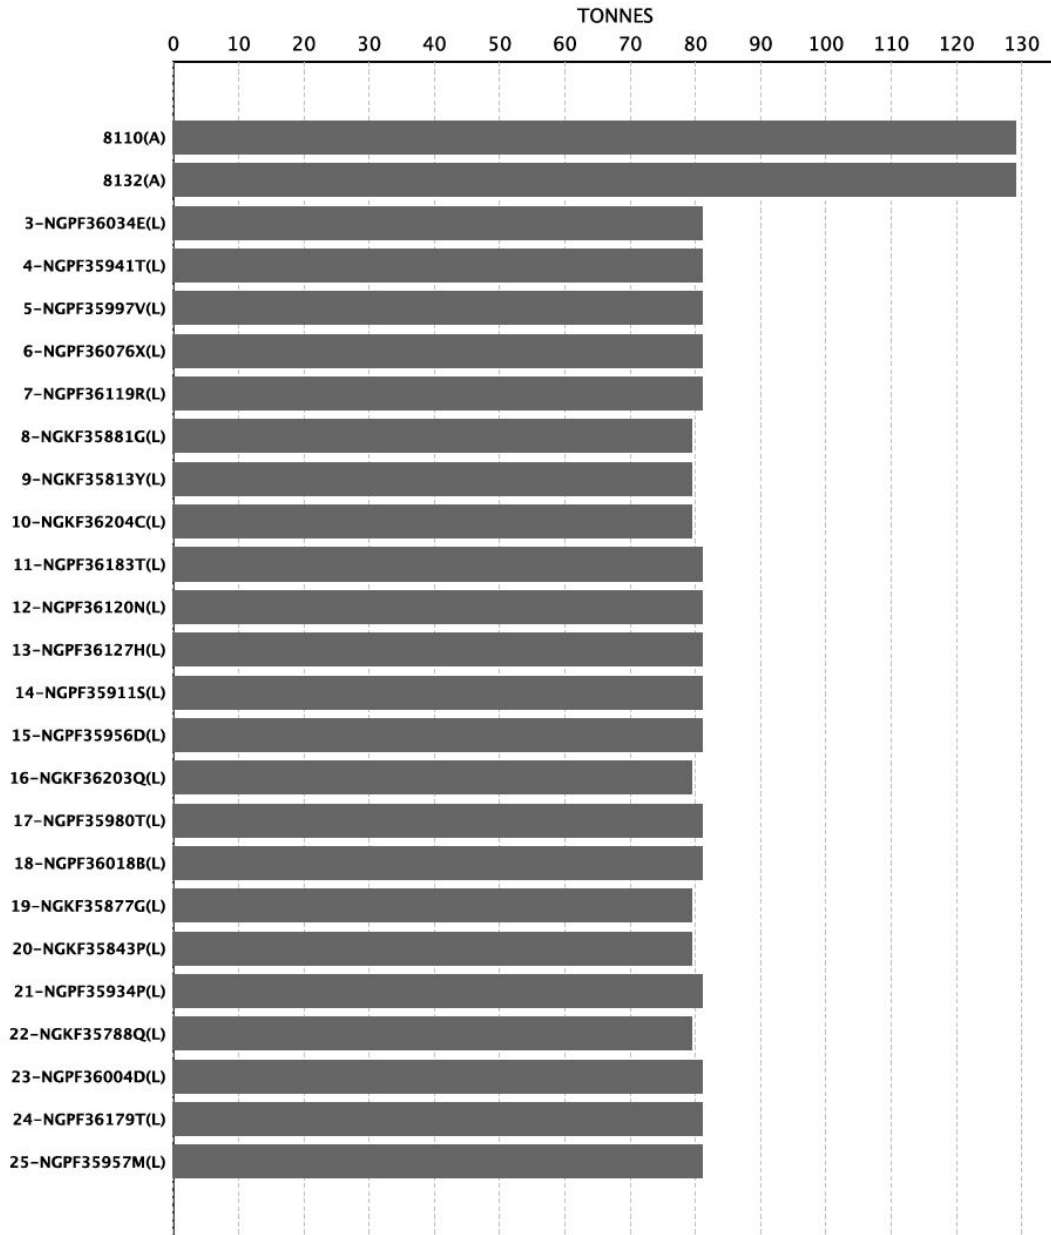
Appendix B – Load diagram 8838N

The actual weight for two of the three wagons was found to be higher than the recorded consist mass of 81 t (Appendix B). The consist shows wagon NGPF35997 as having a weight of 81 t while its actual measurement was 83.74 t. Wagon NGPF35941 was also over the recorded consist weight by one tonne, while NGPF36034 was approximately two tonnes under the consist weight. Variation between the wagon mass and the mass recorded on the train consist has been an issue in past rail investigations.¹⁷ As this was only a sample of three wagons, it is unknown if the other wagons had an issue with wagons being loaded more than the consist.
