Separation issue involving Airbus A320, VH-VQG, and Aero Commander 500, VH-UJS

near Sunshine Coast Airport, Queensland, on 4 November 2019

ATSB Transport Safety Report
Aviation Occurrence Investigation
AO-2019-062
Final – 4 June 2020

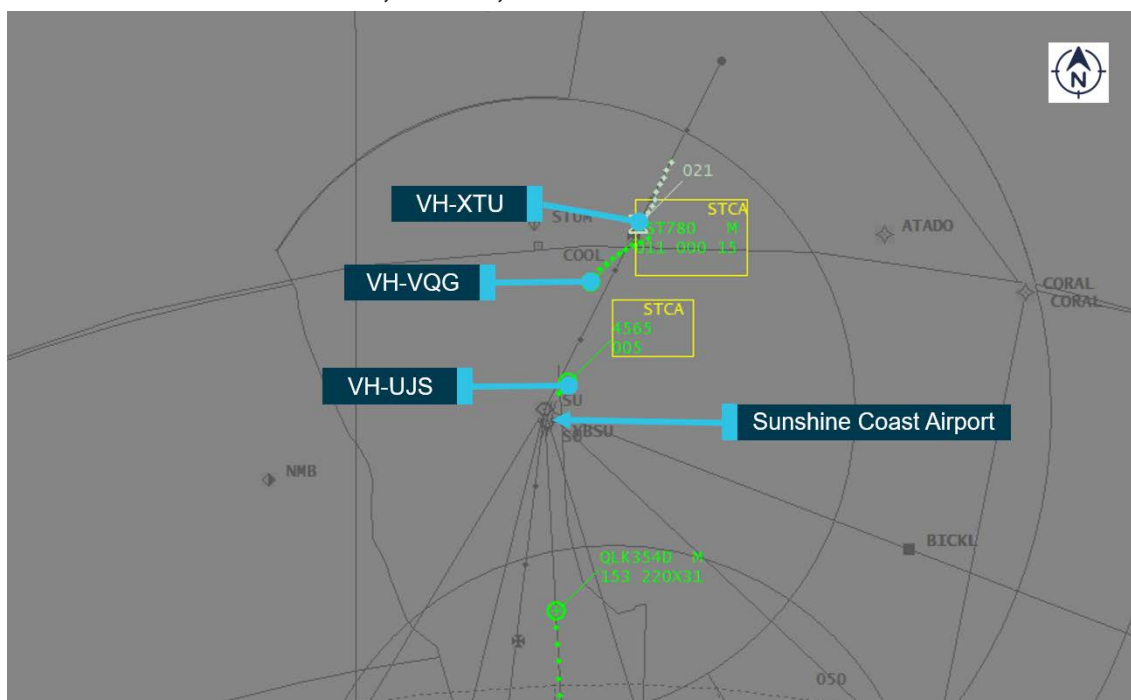
Within seconds, a short-term conflict alert (STCA) for the two aircraft was presented on the Brisbane Centre display (Figure 1). The two aircraft passed each other with a recorded separation of 0.7 NM horizontally and 265 ft vertically.

Figure 1: The position of the aircraft in the area in relation to Sunshine Coast Airport, and the alerts that were displayed to Brisbane Centre for the two aircraft VH-UJS and VH-VQG. The aircraft to the north, VH-XTU, is also shown.
