Derailment of train 7MP7

Coonana, Western Australia on 19 August 2018

ATSB Transport Safety Report

RO-2018-012

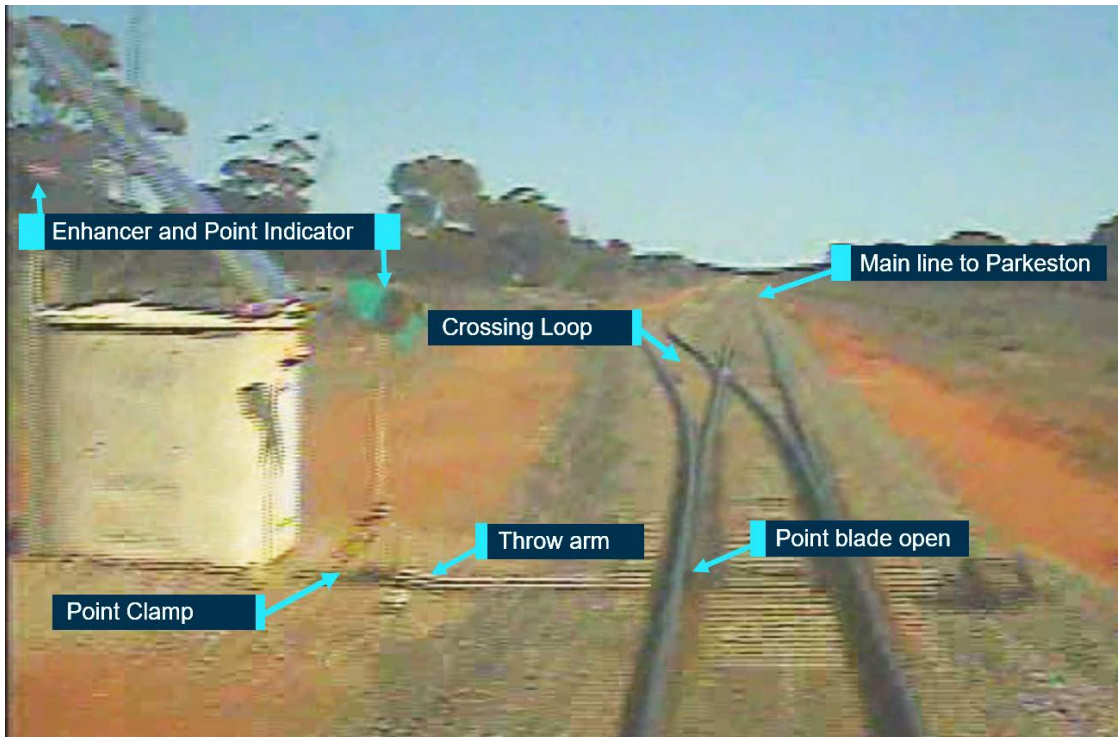
Figure 2: 7MP7 approaching Coonana eastern end indicators and points.

The indication on the enhancer was still unsighted, but the trainee recalled the point indicator appeared to display a green arrow as they approached. Around 500 m from the points, the supervising driver saw a red light displayed on the enhancer. Shortly after, the supervising driver saw that the points were not fully set for the main line and warned the trainee to brace for a derailment (Figure 2).

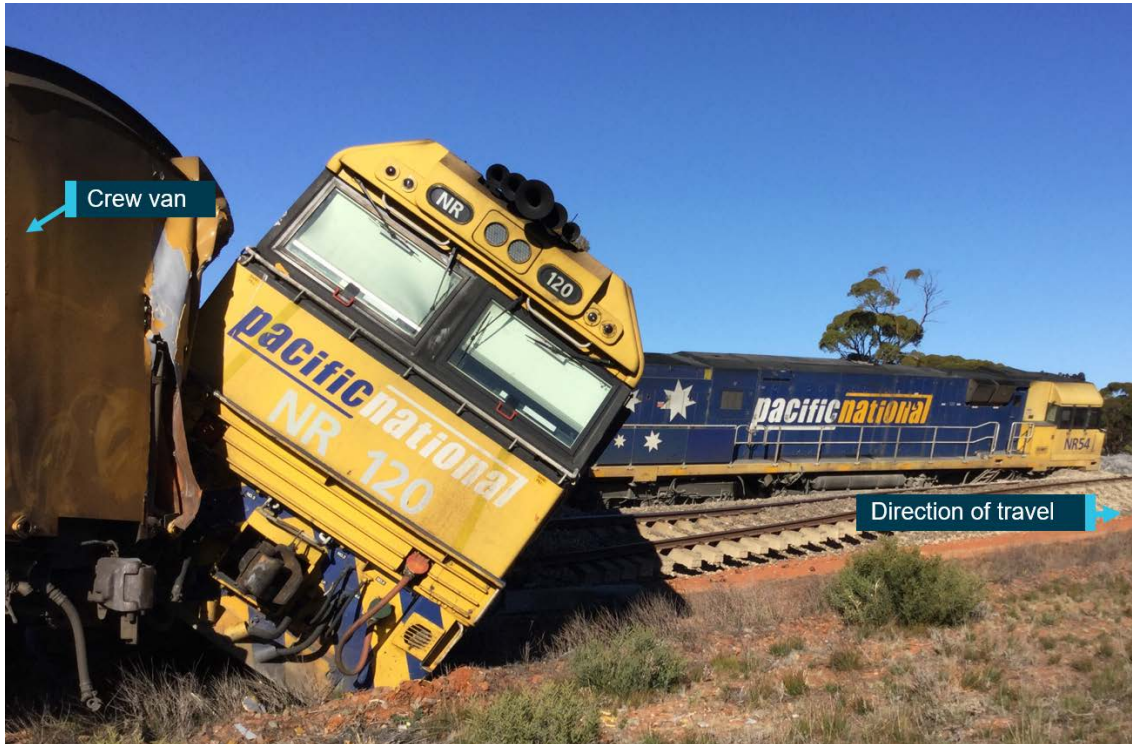
Figure 3: Derailed locomotives NR 54 (lead) and NR 120 (trailing).

At about 1045, train 7MP7 traversed the eastern points travelling at 44 km/h and derailed, destroying around 200 m of the main and crossing loop tracks. The two lead locomotives, an unoccupied crew car and wagons RQFY 58G and RRQY 733K-platforms 4 and 5 derailed all wheels (Figure 3). The train crew were uninjured.

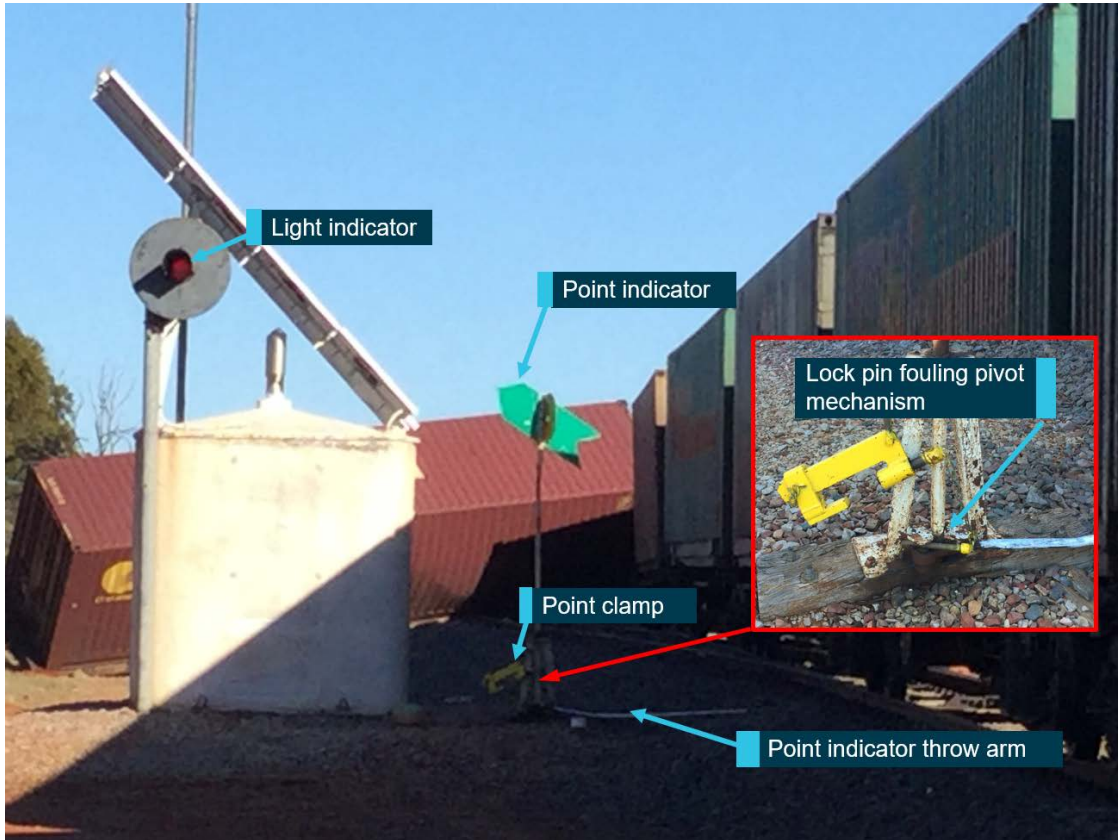
Figure 4: Light and point indicators at eastern end of Coonana post-derailment.

The points were in an unsafe condition for the passage of rail traffic, causing the enhancer to display a red light (stop indication). The fouled pivot mechanism also prevented the point indicator from rotating fully to display a complete green arrow target. (However, it did rotate enough for the green arrow to be a prominent display to the driver.)

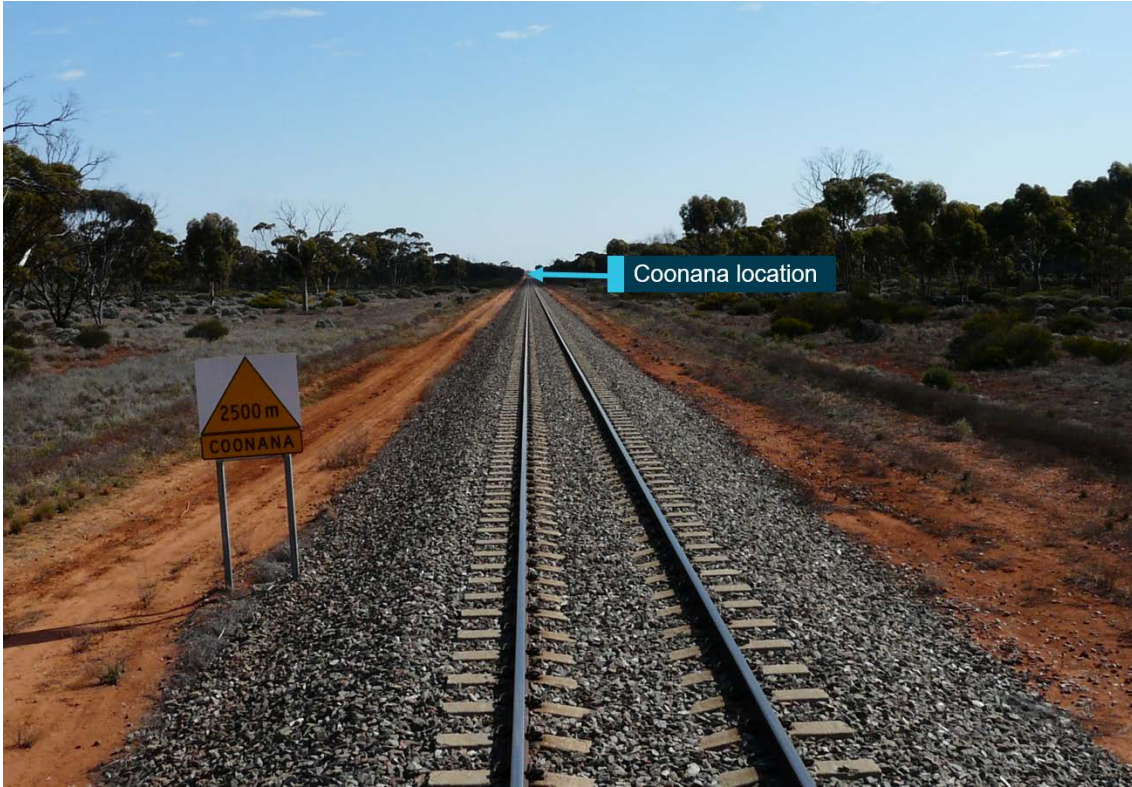
Figure 6: Coonana eastern approach Location Ahead sign.

The layout of Coonana was typical of all train order locations between Malbooma and Parkeston. ARTC provided a location ahead sign at 2,500 m (nominal braking distance) and an enhancer that theoretically should be visible by crew at a distance of around 2,500 m. The drivers stated that due to the trees adjacent to the corridor combined with variations to ambient conditions and the luminaire type (incandescent globe) used at Coonana, made sighting the enhancer more difficult and first sighting of the indication would usually be from the observer's position at around 2,000 m from the points. The enhancer at Coonana displayed a red light, which the crew stated did not come into view until train 7MP7 was around 500 m from the points, after the trainee driver could see the Points Indicator.

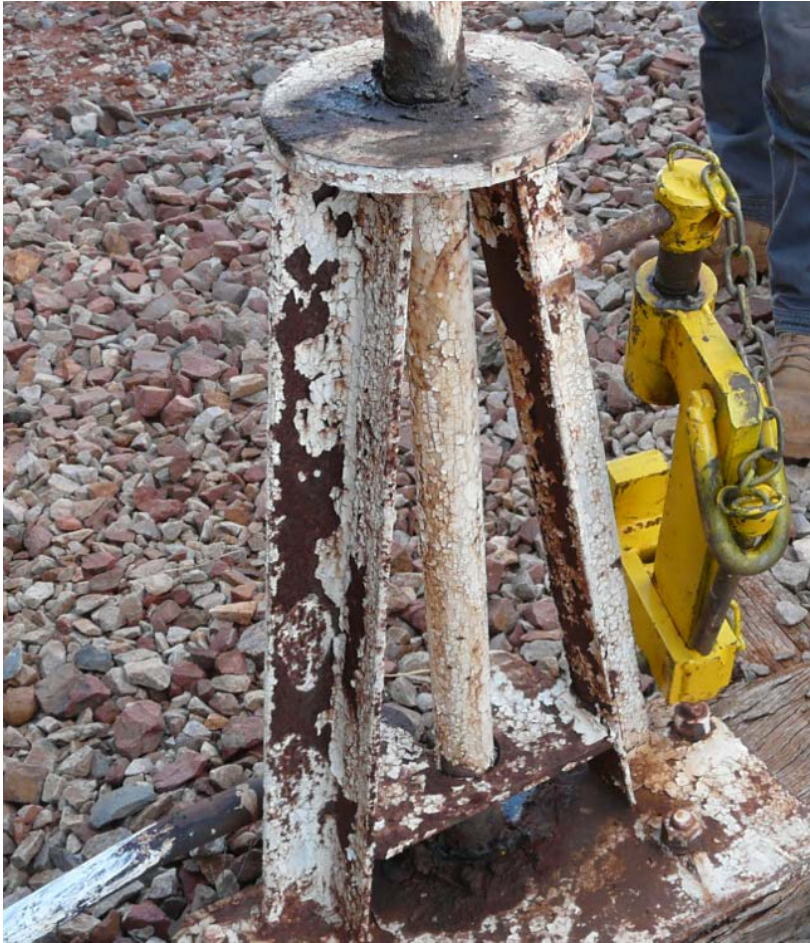
Figure 7: ARTC example of correct storage arrangement for a point clamp on a point indicator stand.

At some time prior to the passage of 7MP7, the point clamp at the eastern end of Coonana was placed on the spigot incorrectly: it was not secured by a 'S' type lock and the locking pin was stored in a manner that allowed it to hang loose at the end of its attachment chain. The practice of storing the point clamp on the point indicator stand increased the risk of the point indicator throw arm pivot mechanism becoming fouled.

There was no record of a recent point failure where the NCO authorised the use of point clamp by train crew. ARTC maintenance records indicate the last electrical maintenance inspection of the points occurred on the 22 June 2018. There was, however, no requirement within the electrical maintenance or other inspection procedures for a routine check of point clamp positioning or security.

Post the derailment of 7MP7, Australian Rail Track Corporation (ARTC) removed all point clamps from the point indicator stands and relocated them to the adjacent equipment huts at each location between Malbooma (South Australia) and Parkeston (Western Australia). Additionally ARTC have replaced all K3 searchlight units with long-range LED luminaire type units between Malbooma and Parkeston.

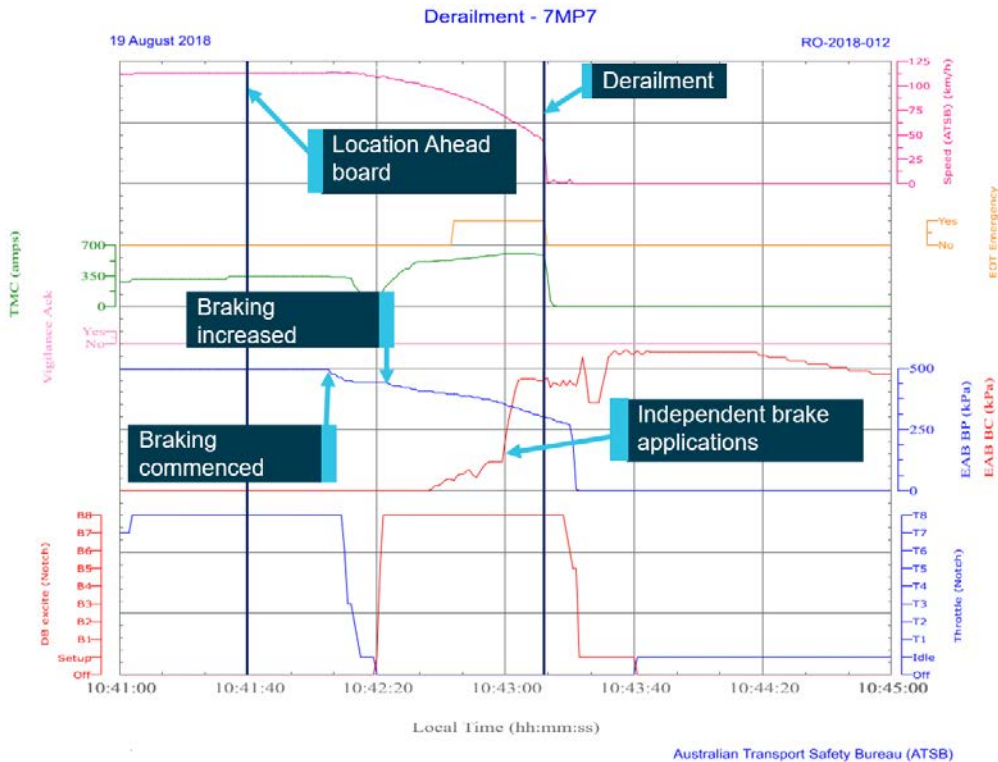
Figure 9: Event logger locomotive NR54.

Data extracted from the Wabtec event logger on locomotive NR54 displayed the timing of control inputs and braking application during the approach of train 7MP7 to Coonana (Figure 9).

At about 10:41:40, around 2,500 m from the eastern end points at Coonana and passing the Location Ahead sign, the throttle control of locomotive NR54 remained set to full power (Notch T8) and train 7MP7 was travelling at 115 km/h. Around 25 seconds later, a minimum service brake application (50 kPa reduction in brake pipe pressure) commenced. The brake application was likely in response to the supervising driver’s instruction to ‘brake’. The absence of an increase in the locomotive’s brake cylinder pressure, which would typically occur with an automatic brake application, indicated the trainee likely bailed-off using the independent brake handle control.
