Derailment of freight train 6CM3

Junee, New South Wales, on 7 June 2019

ATSB Transport Safety Report

RO-2019-011

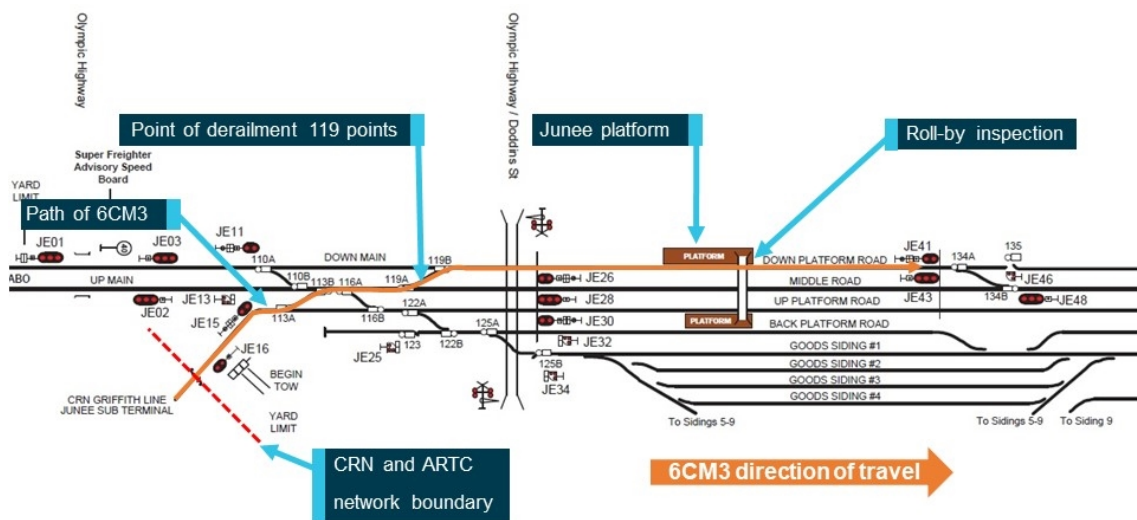
Figure 1: Junee network diagram

The path of train 6CM3 is shown in orange and depicts the train crossing from the Country Regional Network to the Australian Rail Track Corporation network by crossing points 113 and 119.

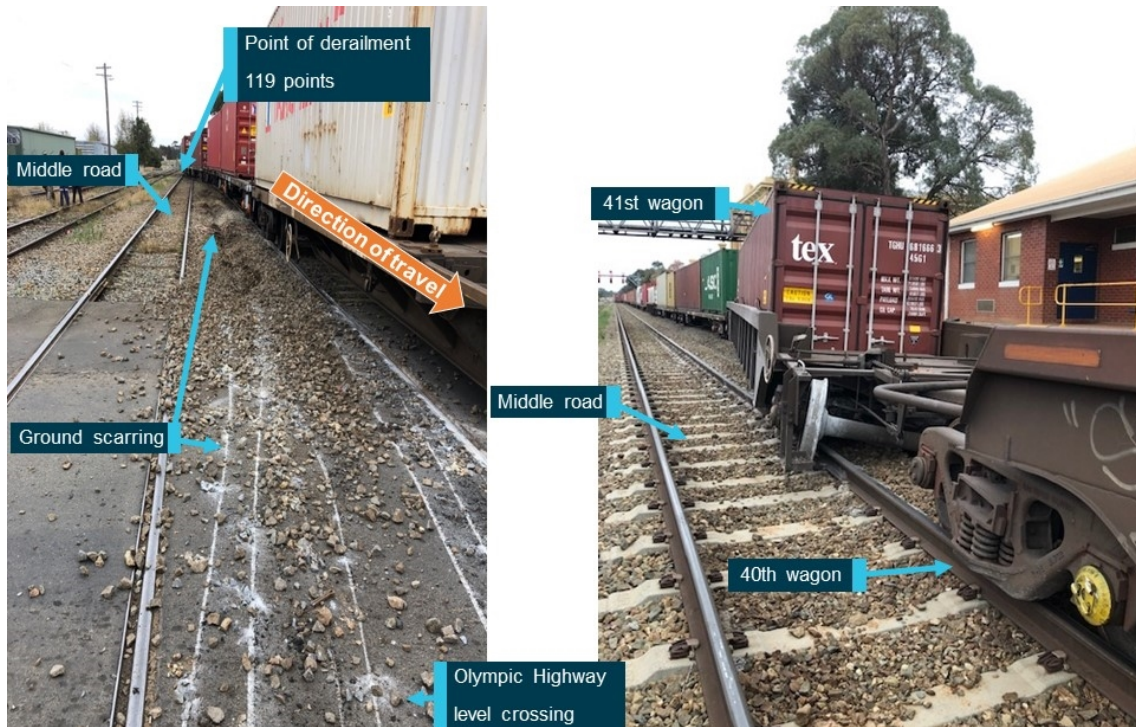
Figure 2: Derailment site

The ARTC network control centre south was advised of the incident, and safeworking protection was applied to protect the site. Inspection of the derailment site identified that the 40th and 41st wagons had derailed. The two wagons had run in a derailed state from near 119 points at 485.348 km⁵ to alongside the platform at 485.688 km (Figure 2).

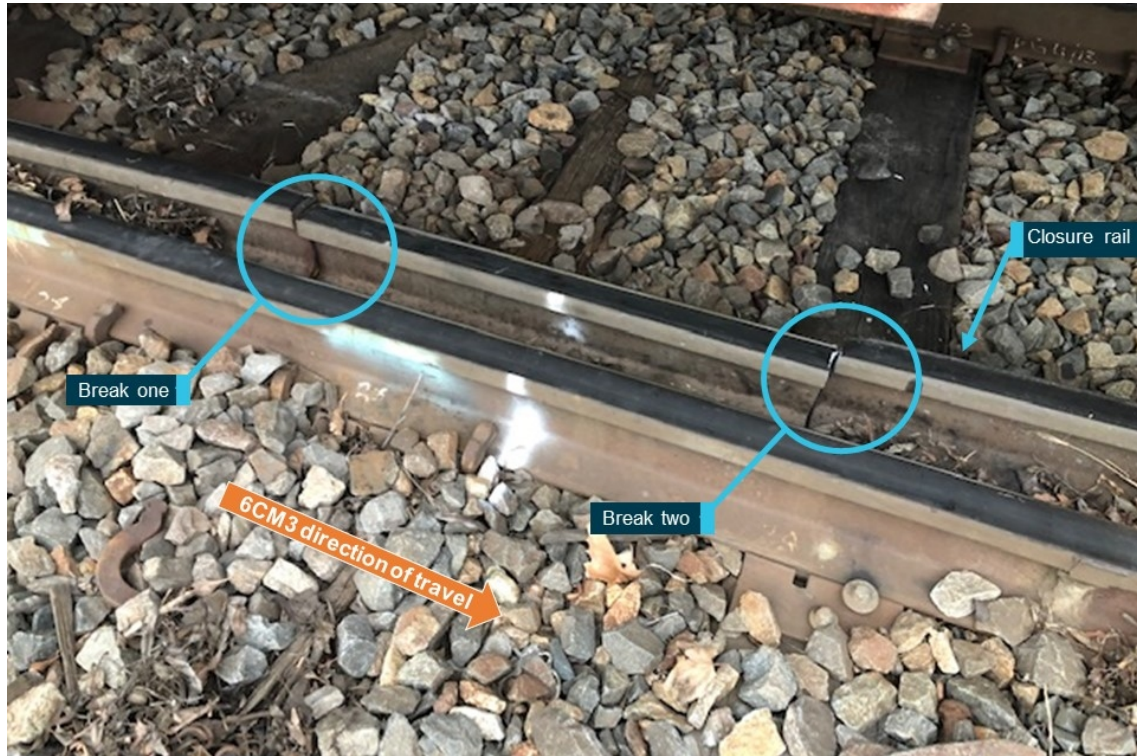
Figure 3: Broken rail segment

The rail was found to be broken in two places in the closure rail⁷ between 119A and 119B points at 485.348 km (Figure 3). The two rail breaks showed different failure characteristics indicating the likely failure sequence (Figure 4):

There was deformation and evidence of flange marks (point of mount) at break two, with witness marks to the point of drop approximately 4.5 m from the point of mount. A total of eight wheels derailed on the 40th and 41st wagons, although the first wheel to derail could not be established.

Turnouts between main lines not previously subjected to continuous ultrasonic testing have been identified and included in ARTC's maintenance asset register. Ultrasonic testing of turnouts not tested previously has been completed. The ultrasonic testing contractor has included these identified assets in the annual testing program.

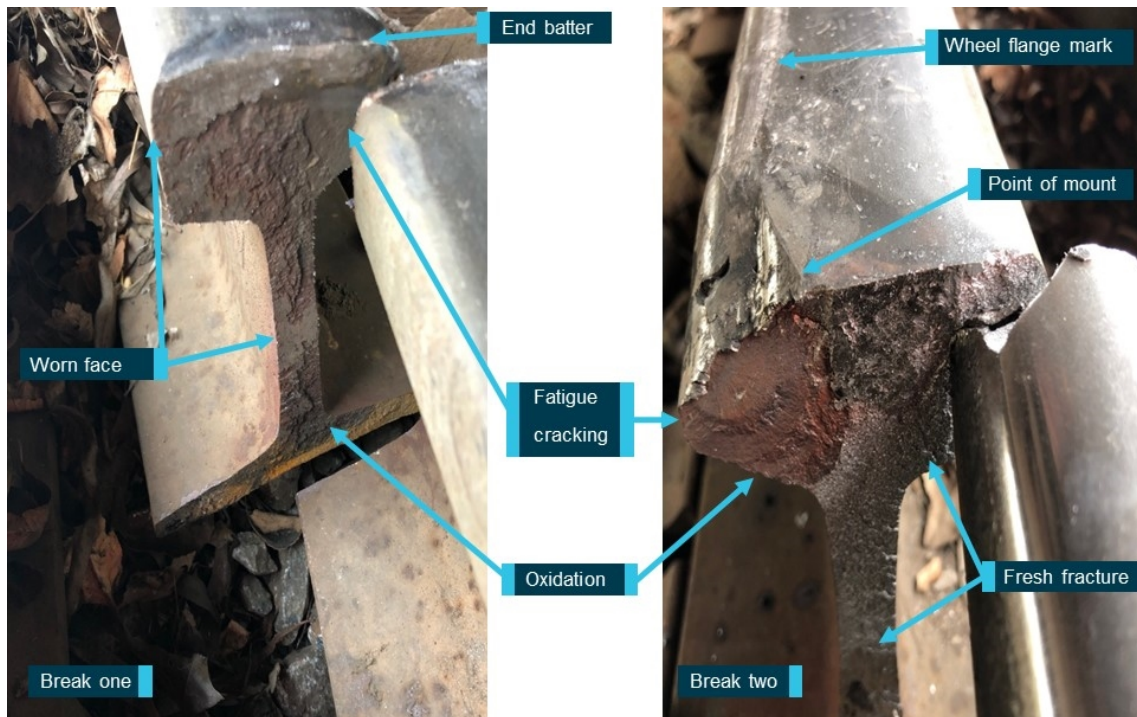
Figure 4: Broken rail analysis

- Break one exhibited signs of oxidation across the full face of the rail, end batter⁸ and some worn areas on the fracture face. A small section of the rail head showed signs of fatigue cracking that likely initiated from rolling contact fatigue (RCF)⁹ at the gauge face. The smooth areas of the fracture face indicate wear between the two faces as a result of vertical displacement of the broken rail.
- Break two exhibited light oxidation at a fatigue crack that likely initiated from RCF. The remainder of the fracture face showed signs of a brittle overload fracture, with no visible oxidation.

Oxidation across the full fracture face of break one indicated it had occurred sometime before break two. The weight of the wagons passing over the broken rail likely created a bending moment,¹⁰ causing increased stress in the rail head. The increased stress likely led to the progression of the fatigue crack (break two). While train 6CM3 was crossing through points 119A, the rail likely broke (break two) with sudden brittle fracture.

Maintenance records indicated that there were no known faults with points 119A prior to the derailment. It is very likely that the rail was visibly broken (break one) at the time of the track patrol¹¹ performed on 3 June 2019 but the break was not detected. Track patrols provide a level of assurance but are limited to large or obvious defects. It is also likely the manual detailed ultrasonic testing of turnout inspection completed on 10 April 2019 did not test the closure rail at the location of the break.

Maintenance standard *ETE-01-03 Non-Destructive Testing of Rail (for Internal & Surface Defects)* is currently under review.
