Aircraft loading-related occurrence involving Airbus A330-303, VH-QPD

Sydney Airport, New South Wales, on 17 December 2017

ATSB Transport Safety Report

AO-2018-003

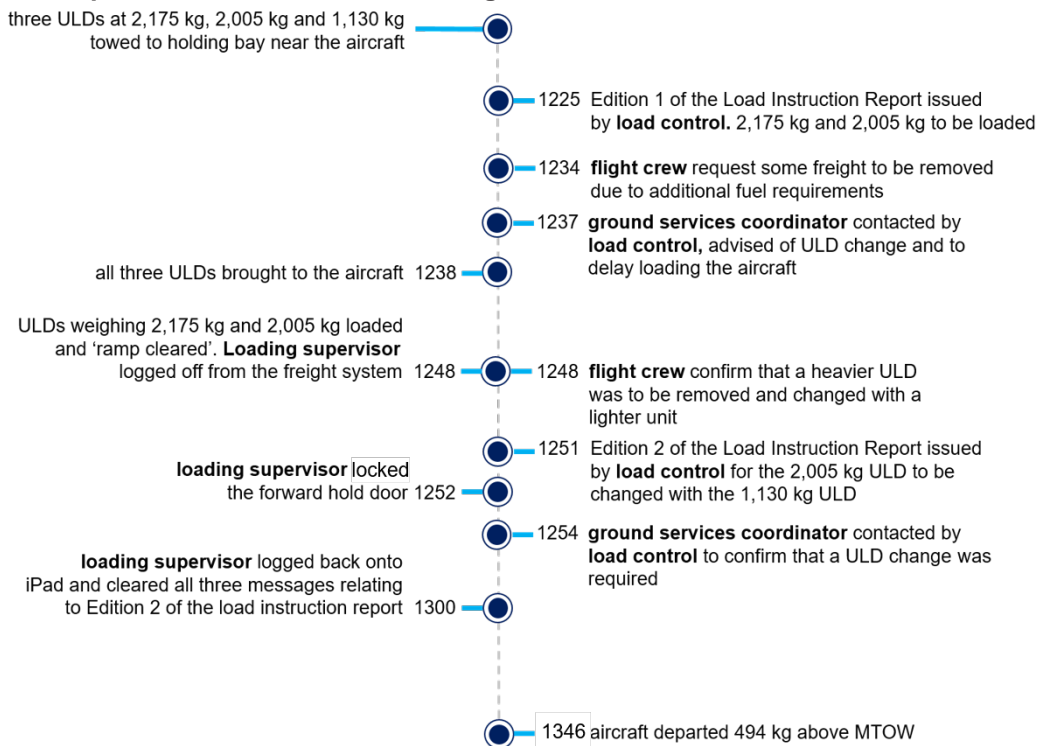
Figure 2: Sequence of events for this loading event

The following sequence of events describes the primary actions and decisions during the freight-loading process prior to the departure of QF107 from Sydney. The sequence of events is further summarised in Figure 2.

1. *Flight Locked by Load Control. Please contact Load Control.*
2. *Edition has changed*
3. *24P has changed Ref: PMC41566QF to PMC42559QQ
Cargo Weight: 2005 to 1130*

At 1300, the loading supervisor at the aircraft logged back into his iPad and resumed using the freight management software. All three messages advising that Edition 2 of the LIR had been issued, that a ULD change was required, and that he was to contact Load Control, were displayed on the tablet device. The supervisor acknowledged the electronic messages and tapped the ‘OK’ button, clearing them from the system. Despite the electronic acknowledgement, the supervisor did not change the ULD configuration at Position 24P.

The final load sheet provided to the operating flight crew incorporated the ULD change from Edition 2 of the LIR, where the 1,130 kg ULD had been loaded to Position 24P, when in fact the heavier 2,005 kg ULD remained on the aircraft. Calculations showed that with the heavier unit in place the aircraft take-off weight was 233,494 kg, which was 875 kg above the planned take-off weight and 494 kg above the aircraft’s MTOW.

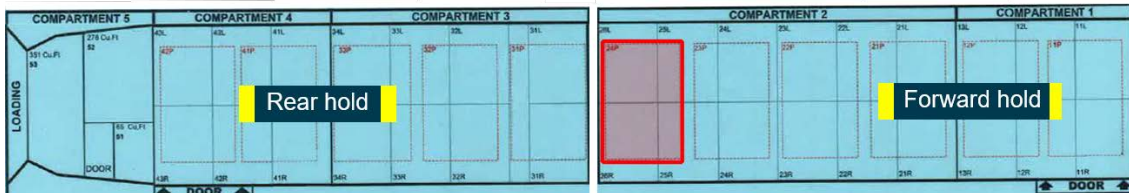
Figure 5: A330-300 series cargo hold showing the position of location 24P (shaded red) within the forward hold

- PMC42476QF at 2,175 kg was to remain as originally planned and to be loaded within the rear hold of the aircraft at position 31P.
- PMC41566QF at 2,005 kg was to be removed and replaced with the lighter weight unit, PMC42559QQ at 1,130 kg, within the forward hold at position 24P.

The heavier freight was positioned in the underfloor hold close to the aircraft's centre of gravity. This limited the potential for control of the aircraft to be affected. Further, the flight crew did not report any control or performance anomalies. While the outcome was benign in the case of QF107, the operational risk level is increased when any significant addition of freight and/or passengers remains unaccounted. Continued operation of an aircraft that has exceeded its certificated weight may lead to unaccounted structural damage and pose a safety risk.
