Aircraft preparation occurrence involving BAe 146-300, VH-NJZ

Sydney Airport, New South Wales, on 22 January 2019

ATSB Transport Safety Report
Aviation Occurrence Investigation
AO-2019-006
Final – 23 June 2020

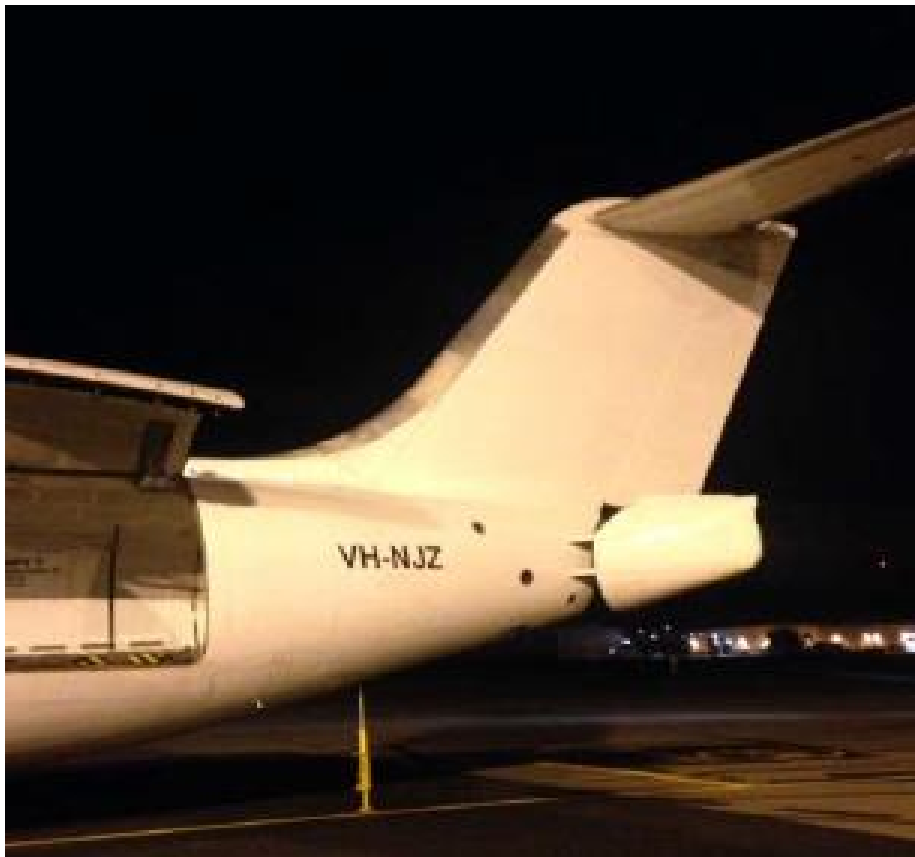
Figure 1: Example of a tail strut fitted to NJZ and showing opened freight door

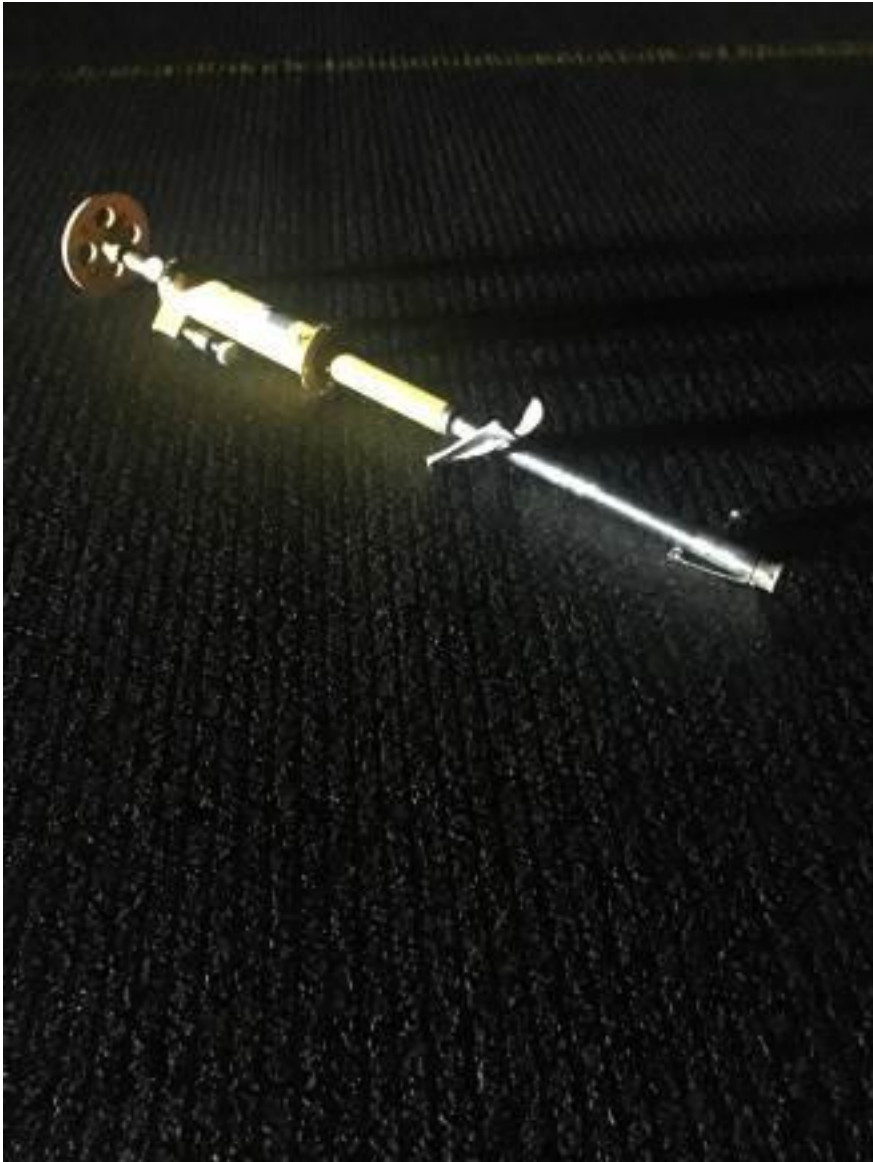
Following the aircraft's departure, Sydney Tower closed Taxiway Bravo and runway 16R to allow a visual inspection to take place. A Sydney Airport ground safety worker subsequently located the tail strut, took photographs, and recovered the multiple components (Figure 2). The photographs of the recovered tail strut components were sent to the engineer's mobile phone and the engineer confirmed that the entirety of the tail strut had been recovered. The engineer relayed this information to National Jet Express Maintenance Watch, who passed it on to the captain. The captain, satisfied that the entire tail strut had departed the aircraft, continued the flight to Brisbane.

Figure 2: Tail strut as found on Sydney runway 16R post NJZ departure

Following this occurrence, on 23 January 2019, Cobham Aviation Services issued a Safety Alert to relevant staff that highlighted the despatch procedure including the cockpit to ground checklist requirements.

Cobham also provided appropriate control tower telephone numbers to engineering staff at all operating bases. This allows staff to immediately contact the tower if a need arises.

Cobham also emailed all company pilots, further highlighting the despatch procedure. This included the requirement that when the aircraft's tail strut was not used, the local ground support equipment tail strut was to be visible to the flight crew prior to aircraft despatch.
