Flight below minimum altitude involving Boeing 787, registered 9V-OJC

Near Perth Airport, Western Australia on 4 December 2015

ATSB Transport Safety Report
Aviation Occurrence Investigation
AO-2015-144
Final – 26 June 2020

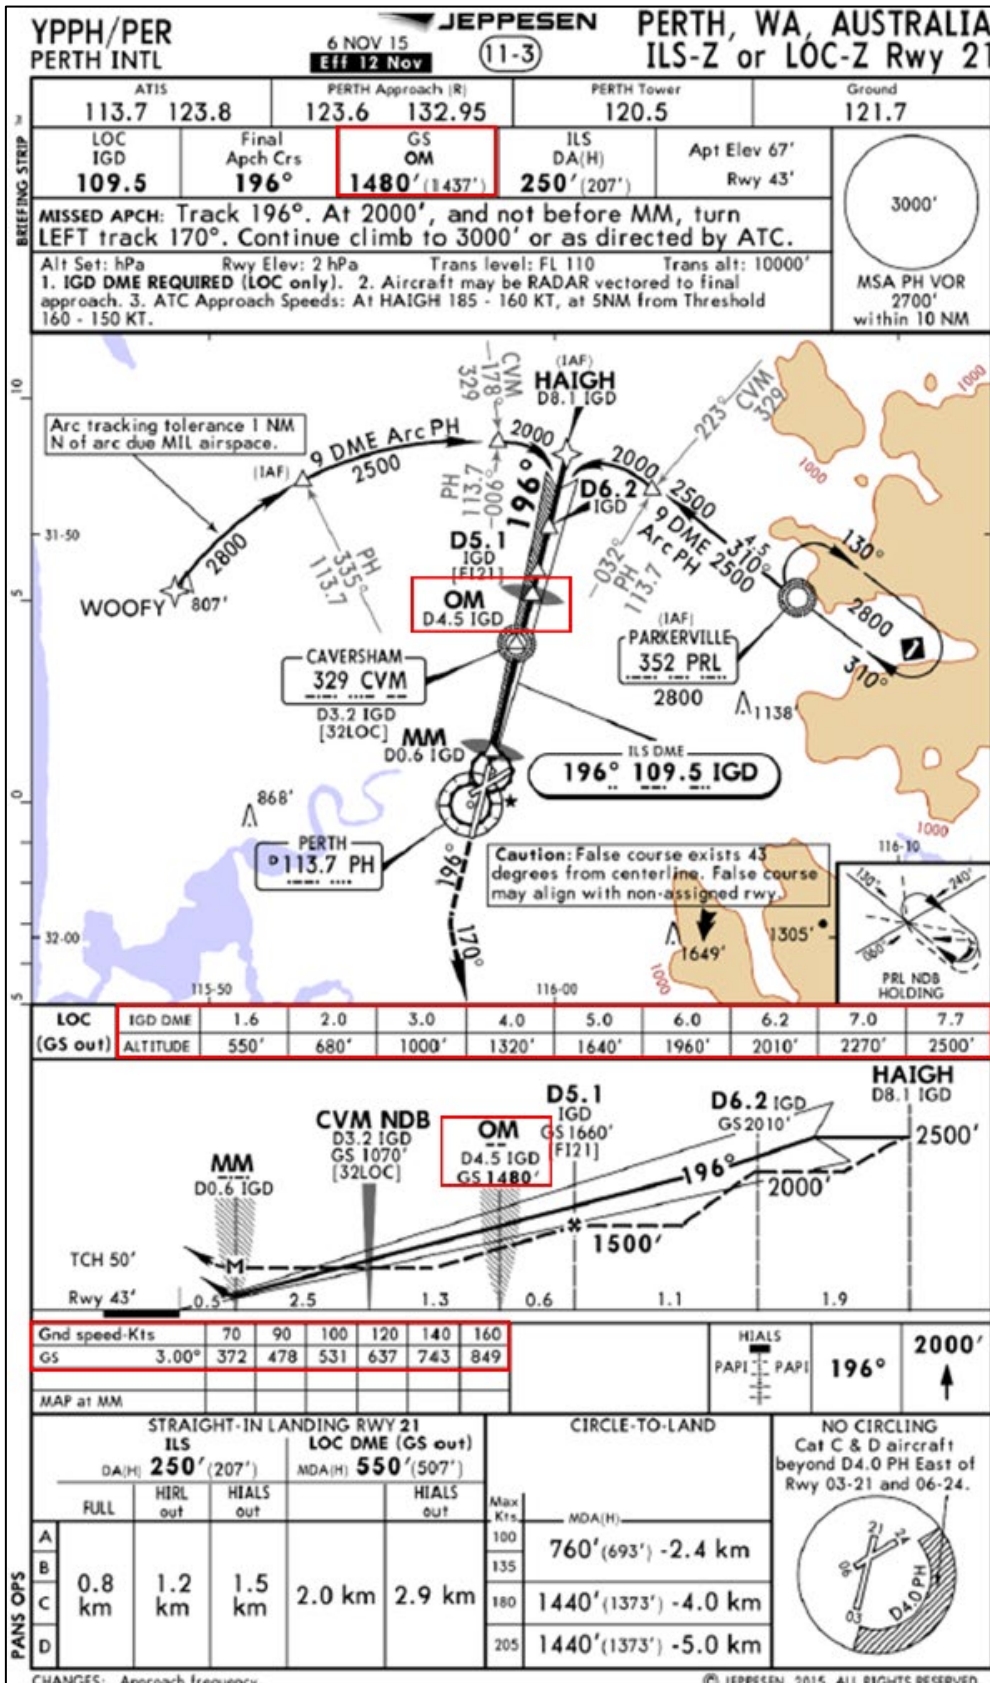
Figure 1 - Perth runway 21 ILS approach chart used by Scoot flight crew

Red boxes show the expected height at the outer marker (1480 ft when 4.5 nm from runway threshold), required altitudes to maintain the three degree glideslope for the approach, and the expected decent rate in feet per minute to maintain the glideslope for a range of approach speeds.

As the aircraft passed over the OM, it descended through 930 ft with an airspeed of 180 kt, and a descent rate of 1,700 fpm. The required height at this point was 1,480 ft, the target approach speed was 156 kt, and a descent rate of about 850 fpm. The procedural approach speed limit was 160 kt. At this time, the captain took control of the aircraft with the intention of arresting the descent rate, correcting the flight path, and continuing the approach. However, the first officer advised the captain that the approach was outside the company's stable approach criteria and recommended they conduct a go-around. As this was occurring, the flight crew visually observed that the precision approach path indicator (PAPI)⁶ lights were all red, indicating the aircraft was significantly lower than required for the approach, and commenced a go-around.

A minimum altitude of 590 ft (520 ft above the ground) was recorded at 1744:47, when the aircraft was at 3.5 DME (5 km) from the runway, at a position where the glideslope height was 1,160 ft. The time between the first aural 'GLIDESLOPE' caution and commencement of the climb in the go-around was 23 seconds.

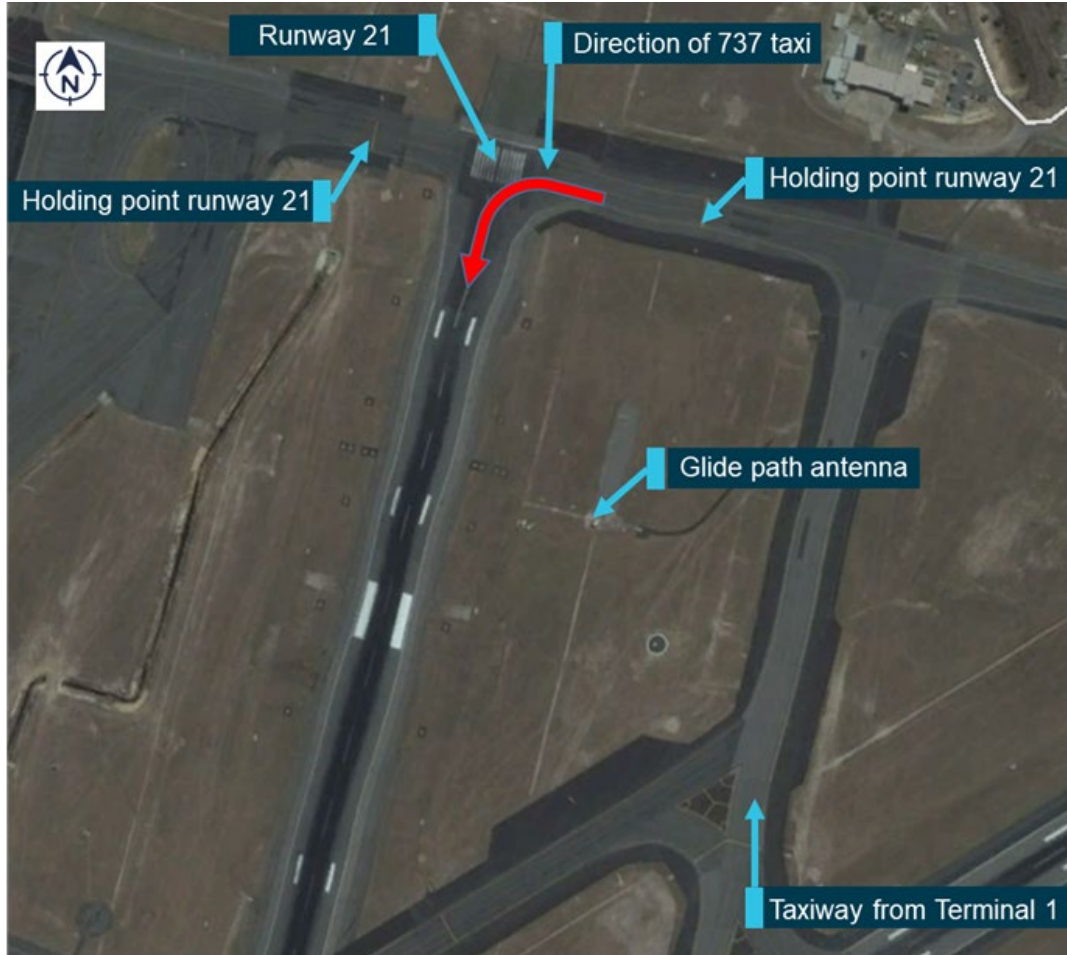
Figure 3: Perth Airport runway 21 showing location of glide path antenna, holding points and path of taxiing aircraft prior to take-off.

Around the time of the glideslope disruption experienced by OJC, a Boeing 737 taxied from Terminal 1 and took off on Runway 21 (Figure 3). The ATSB assessed that the movement of that aircraft likely caused the signal disruption.

Image shows the holding points for runway 21 at Perth. Between the holding points is the critical area which may be disrupted by an aircraft or vehicle movement. The red arrow shows where the 737 taxied onto the runway, likely causing a disturbance to the glideslope. Source: Google, annotated by the ATSB.

The glideslope signal disturbance occurred at about the same time that a Boeing 737 aircraft taxied and departed on runway 21. As the movement of that aircraft was in the vicinity of the ILS critical area, it was likely that this aircraft's proximity to the antenna as it entered and lined up on the runway caused the interference to the glideslope signal.
