Ground handling event involving Kavanagh B-400 balloon, VH-LNB

near Coldstream, Victoria on 16 March 2019

ATSB Transport Safety Report
Aviation Occurrence Investigation
AO-2019-014
Final – 29 June 2020

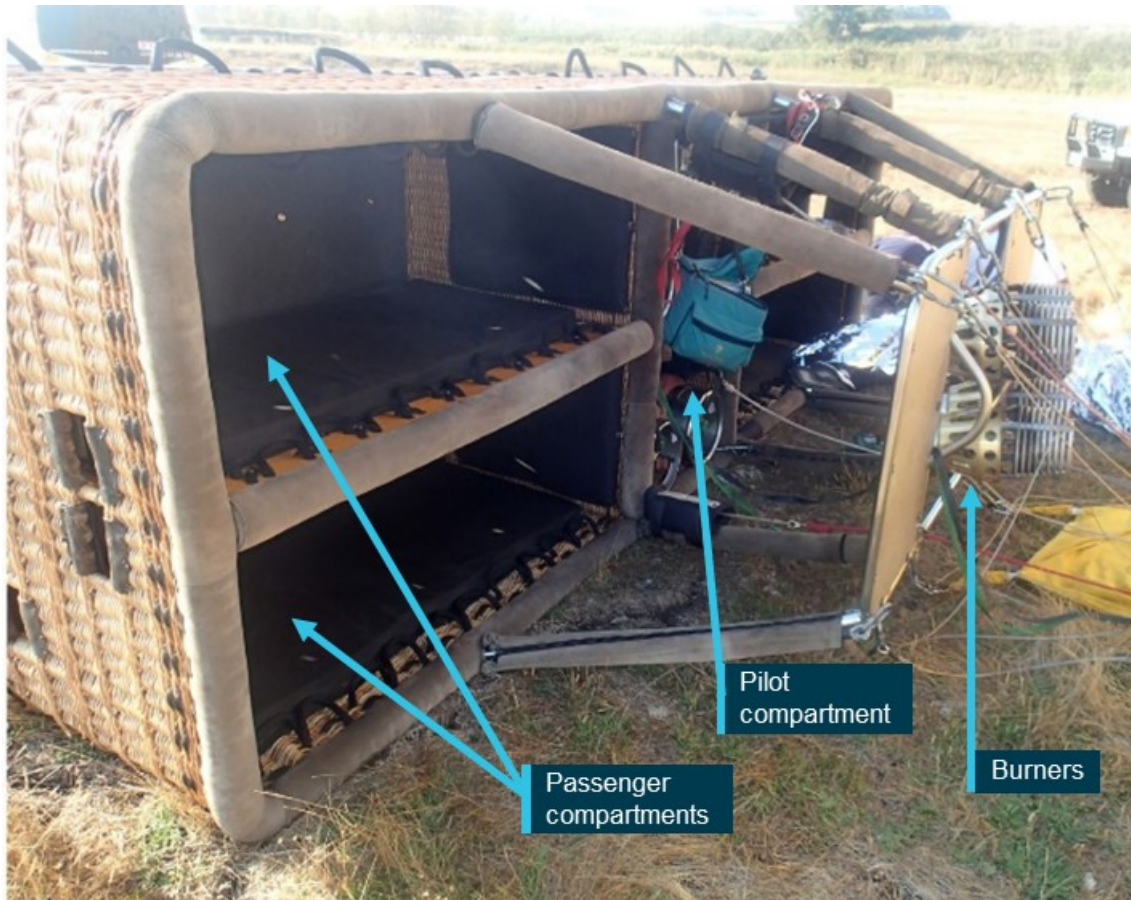
Figure 1: VH-LNB basket final resting position

Shortly after, at around 0830 (10 minutes after landing), the basket began to tip (Figure 1). The pilot instructed the passengers to ‘hang on as best they could’ and did not have the opportunity to use the radio to command the driver to stop.

Two of the 16 passengers were seriously injured⁵ when they were propelled out of the basket as it tipped over. One of the passengers sustained two broken ribs and another was knocked unconscious for around 10 minutes.
