Derailment of SCT Logistics freight train 6MP9

near Cook, South Australia on 6 January 2019

ATSB Transport Safety Report

RO-2019-001

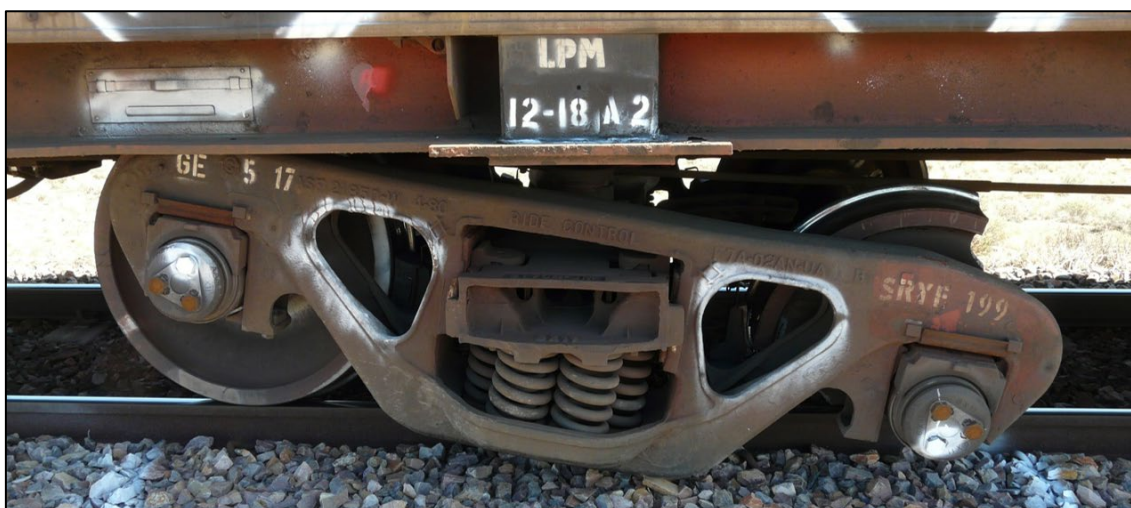
On 6 January 2019, SCT Logistics freight train 6MP9 derailed near Cook, South Australia, while travelling from Melbourne, Victoria to Perth, Western Australia. The number 36 vehicle on the consist, wagon ARFY 2198T, experienced a ruptured wheel, resulting in the derailment. No other wagons derailed in the occurrence and there were no injuries.

Figure 1: The ruptured and derailed wheel in situ

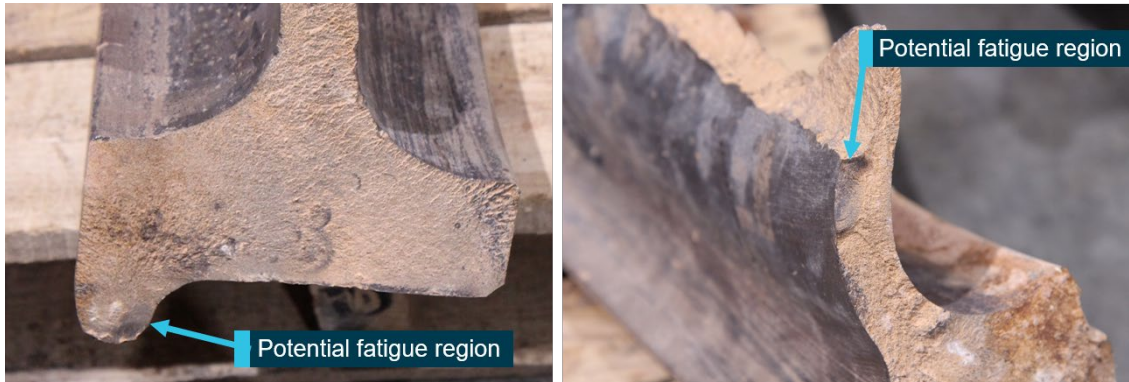
A visual examination of the wheel found two potential fatigue regions on the ruptured wheel. One of these was within the flange of the wheel, while the other was within the plate (Figure 2). The wheelset and fragments were then provided to Bureau Veritas for an independent metallurgical examination, in order to determine the nature of, and possible reasons for, the failure.

Figure 2: Two fatigue regions in the flange (left) and the plate (right)

Bureau Veritas reported that the fatigue crack in the plate region may have initiated at non-metallic inclusions found in that part of the wheel. However, this could not be confirmed due to damage at the fracture region because of the wheel failure.

Following the release of Bureau Veritas’ examination report, the wheel manufacturer reviewed and provided comment on the included observations/findings. The manufacturer assessed that the inclusions observed near the plate fatigue cracking were innocuous, and unlikely to provide a suitable site for the initiation of a fatigue crack. They also asserted that the size of the inclusions was within the acceptable range under AAR standards. The manufacturer believed that the fatigue crack likely initiated after the flange crack propagated into the plate, and the wheel lost its rigidity.

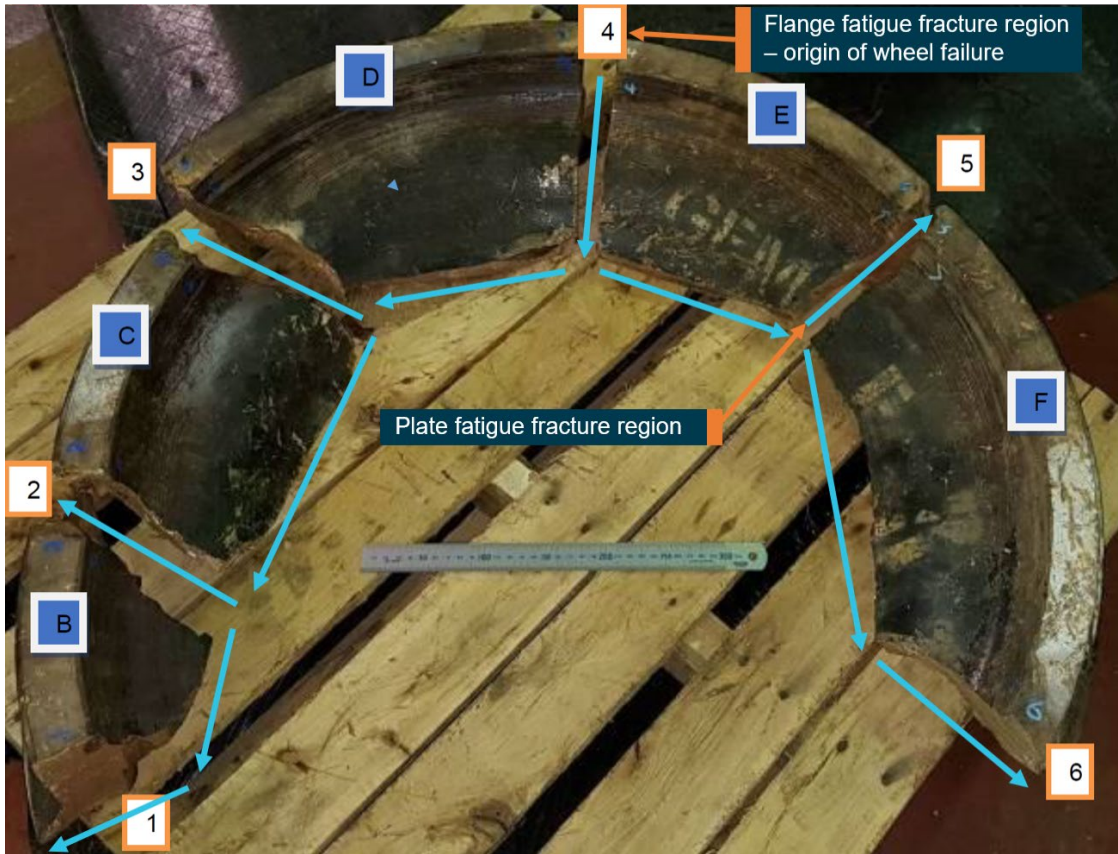
The examination confirmed that two regions of fatigue cracking were present in the wheel. The wheel failed as a result of cracking that initiated at the wheel flange. The fatigue crack on the flange propagated into the rim, and the mode of cracking changed from fatigue to brittle fracture. The crack then propagated into and around the wheel plate, connecting to the second fatigue crack within the plate. The propagation continued through the plate, branching out into the rim at various locations and resulting in the wheel rupturing into multiple pieces when it finally failed. This fracture sequence is illustrated in Figure 3, where blue arrows indicate the direction of crack propagation.

Figure 3: Recovered wheel fragments with direction of crack propagation.

The fatigue crack on the flange (crack 4 in Figure 3) was determined to be a thermal crack, 20 mm in length at the surface, formed in a white etching layer. Thermal cracks are caused by rapid changes in the temperature at the surface of the wheel. The presence of a white etching layer confirms a rapid temperature change occurred, as these layers are regions where the steel has transformed into martensite. Martensite is a brittle form of the metal created by heating and rapid cooling, and is more susceptible to cracking than the original flange material.

The white etching layer observed on the flange fatigue crack indicated that the wheel was exposed to abnormally high temperatures at some point, probably due to sliding contact with the rail. Exposure to such temperature altered the material property of the steel and facilitated initiation of a fatigue crack, which propagated from the flange into the rim and then the plate. The Class C wheel type may have increased the wheel’s susceptibility to fatigue cracking compared with the softer Class B wheels on the adjacent wheelset.

The crack progressed through the plate and joined with a second fatigue crack. The reason for this second crack’s initiation could not be determined, nor could it be determined whether it initiated as a result of the flange crack or if it was already present in the wheel. However, given the extent of cracking at this point, it did not appear to have a significant effect on this wheel failure. Cracking then continued propagating around the plate, branching out to the rim, resulting in the wheel failure and ultimate derailment of the wagon.

As a result of this occurrence, SCT Logistics worked with Gemco to develop an improved inspection process for wheels exhibiting issues with brakes (e.g. sticking brakes) – as these issues can lead to the development of thermal cracks.

SCT Logistics has also instructed Gemco to only install Class B wheelsets when replacements are needed, so that Class C wheelsets are phased out of the fleet through attrition.

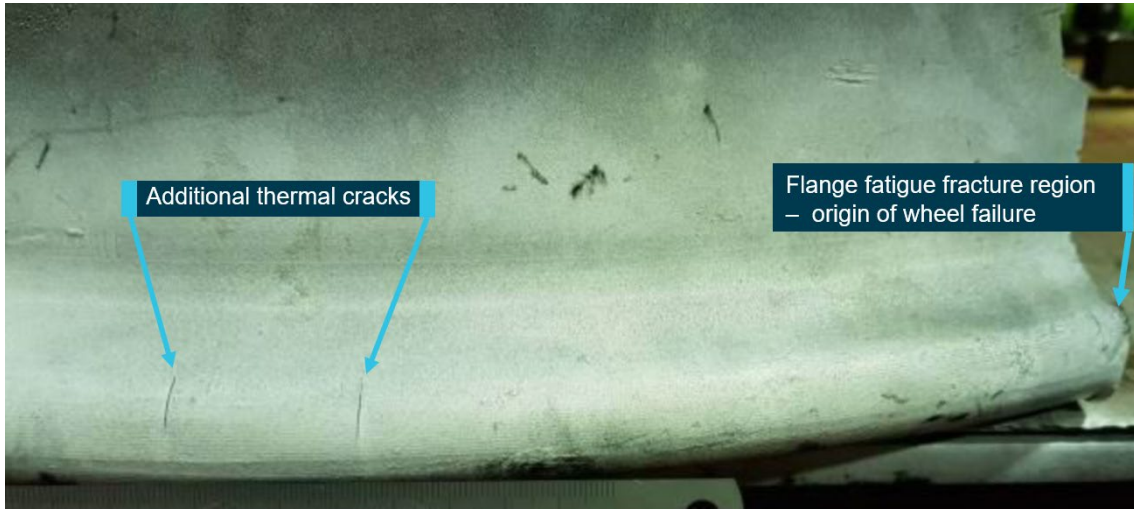
Additional thermal cracks were identified near the crack on the flange (crack 4), although these did not propagate into the rim or the plate. The two largest additional cracks measured 12 mm and 15 mm in surface length (Figure 4). Bureau Veritas reported that the cracks in Figure 4, including the one that propagated into the plate, occurred in a region with evidence of sliding, rather than rolling, contact. Sliding contact can lead to rapid temperature changes in the flange, and the resultant formation of a white etching layer.

Figure 4: Thermal cracks adjacent to the flange fatigue fracture region

Examinations following the derailment found that the flange fatigue crack and the adjacent thermal cracks were longer than the 10 mm stated in the work instruction. As an inspection for thermal cracks was carried out 27 days prior to the wheel failure and derailment, it is likely that one or more of these cracks were present at the inspection, but they may have been missed, or obstructed by the rail.

It is also possible that the cracks were observed by the inspector, but were visually assessed as smaller than 10 mm long. If the cracks had a surface length below 10 mm, then under Gemco’s work instruction they would not have required any action, and their presence would not need to be recorded.

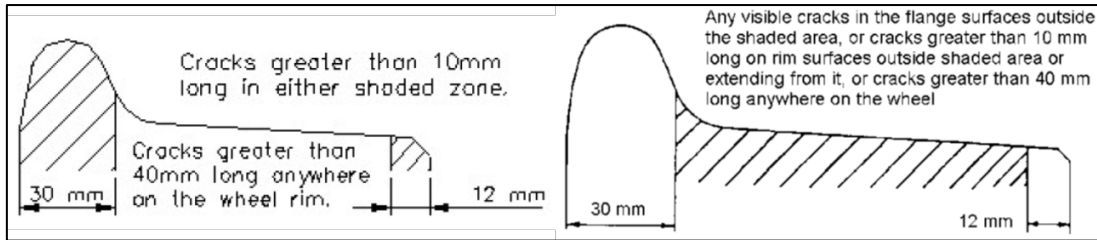
Figure 5 compares the definition provided by Gemco’s document with the one from the RISSB Code of Practice. The only difference between the two definitions was that Gemco permitted flange cracks up to 10 mm long, while RISSB did not permit flange cracks of any size. Under Gemco’s work instruction, flange cracks below 10 mm did not fit under any classification and therefore did not need to be recorded.

Figure 5: Definition of Class 4 thermal cracks provided by Gemco (left) and RISSB (right)

Without further details from the thermal crack inspection, it was not possible to determine whether or not the derailment would have been prevented if the work instruction prohibited all thermal cracks on the flange, as described in the more conservative RISSB Code of Practice.

- The flange crack that led to the wheel failure was likely present at the last inspection, but was either not detected, or was an allowable length based on the maintenance provider's work instruction.
- The maintenance provider's work instruction for classifying thermal cracks on the wheel flange was not as restrictive as the Australian Standard.
