Engine nacelle strike and continued operation involving Boeing 737-8FE, VH-YIW

Faleolo Airport, Apia, Samoa on 23 April 2016

ATSB Transport Safety Report
Aviation Occurrence Investigation
AO-2016-042
Final – 30 June 2020

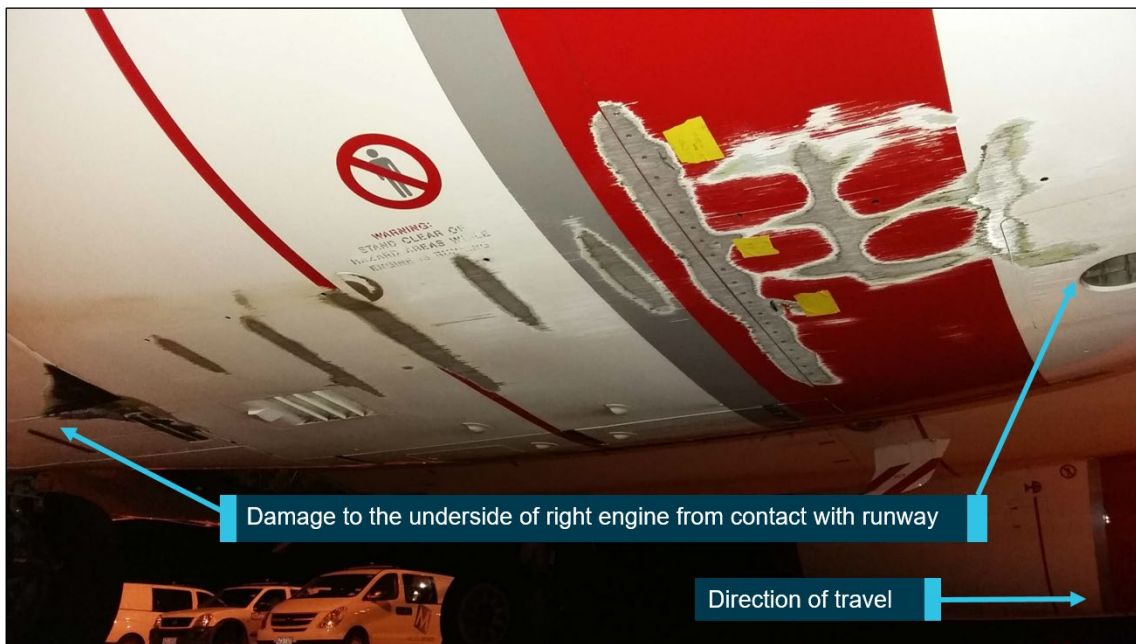
Figure 1: VH-YIW No. 2 engine nacelle

The right engine nacelle was damaged by briefly contacting the runway during the touchdown in an incident known as a 'nacelle strike' (Figure 1). The landing gear tyres also sustained some lateral or sideways wear damage during the event. Detailed inspection of the right engine identified that the:

- lower right engine nacelle skin was holed by abrasion damage
- lower surfaces of the right engine fan and reverser cowlings were damaged
- right engine fan path abrasion lining was worn (Figure 2).

...the very minimal damage to the inner liner indicates that the energy of the impact was primarily absorbed by the cowl structure buckling as the initial contact occurred.

...the continued flight with damage to the engine cowling posed no critical aerodynamic, structural or mechanical safety risk to the aircraft.

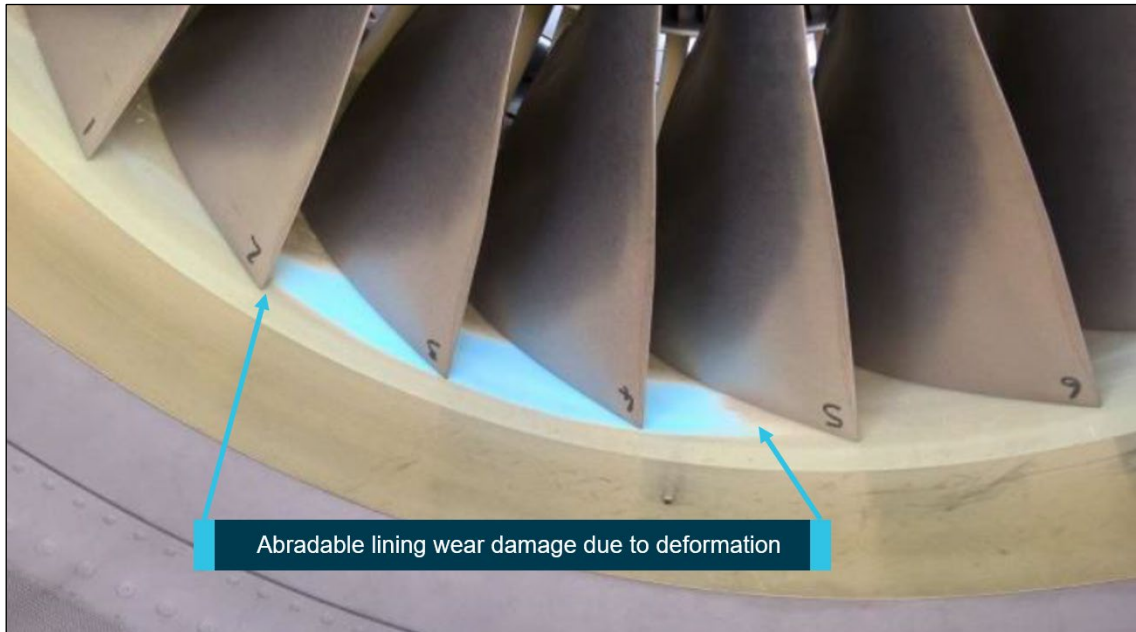
Figure 2: VH-YIW right engine abradable lining.

The blue area shows where the rotating engine blades have contacted the abradable lining

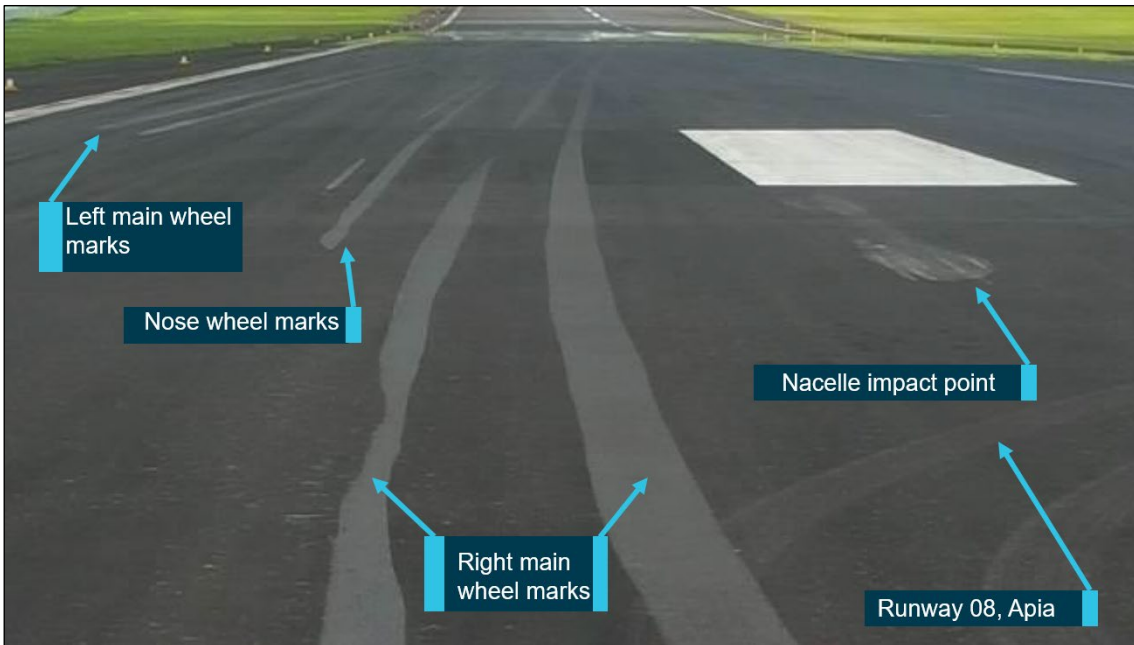
Figure 7: Runway 08 surface marks and nacelle paint transfer

The impact damage visible on the runway due to contact with the nacelle was mostly due to paint transfer over a relatively localised area, and consisted only of superficial damage to the runway surface (Figure 7).
