# Near miss with rail safety worker by trains 89-K and 88-C

Near Redfern, New South Wales, on 8 September 2018

**ATSB Transport Safety Report**

RO-2018-021

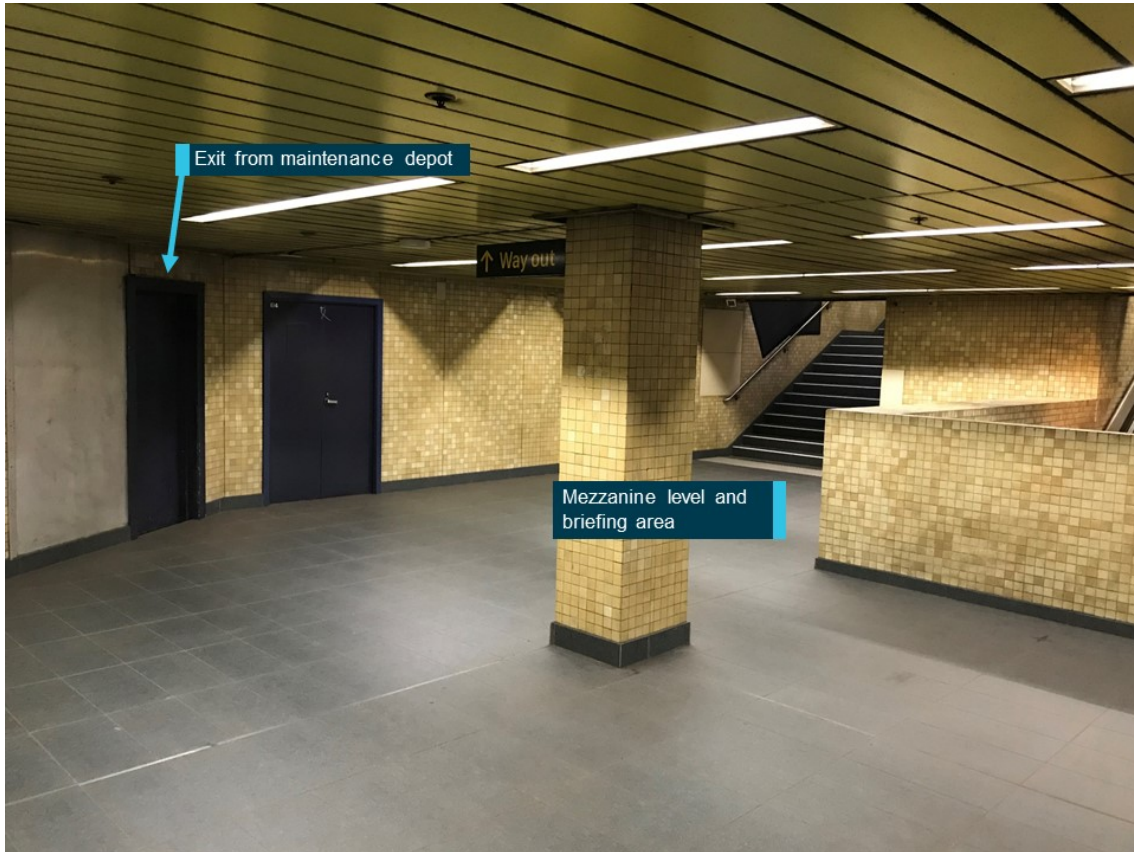
**Figure 3: Mezzanine level and briefing area**

Workers were required to undertake a specific project site induction briefing prior to conducting work within the worksite at Redfern. This project site induction provided the project scope and detailed the hazards and risk controls for the project, and was separate to the worksite protection brief for the LPA. The project site induction was delivered on the mezzanine level at Redfern; this level is only accessible via the stairs from the platform or via the disused maintenance depot (Figure 3 and Figure 4). All workers entering the worksite from Marian Street walked past this location before accessing the platform level.

The location of the amenities were listed within the brief as 'Toilets are located at the station', but provided no details on how to access this location.

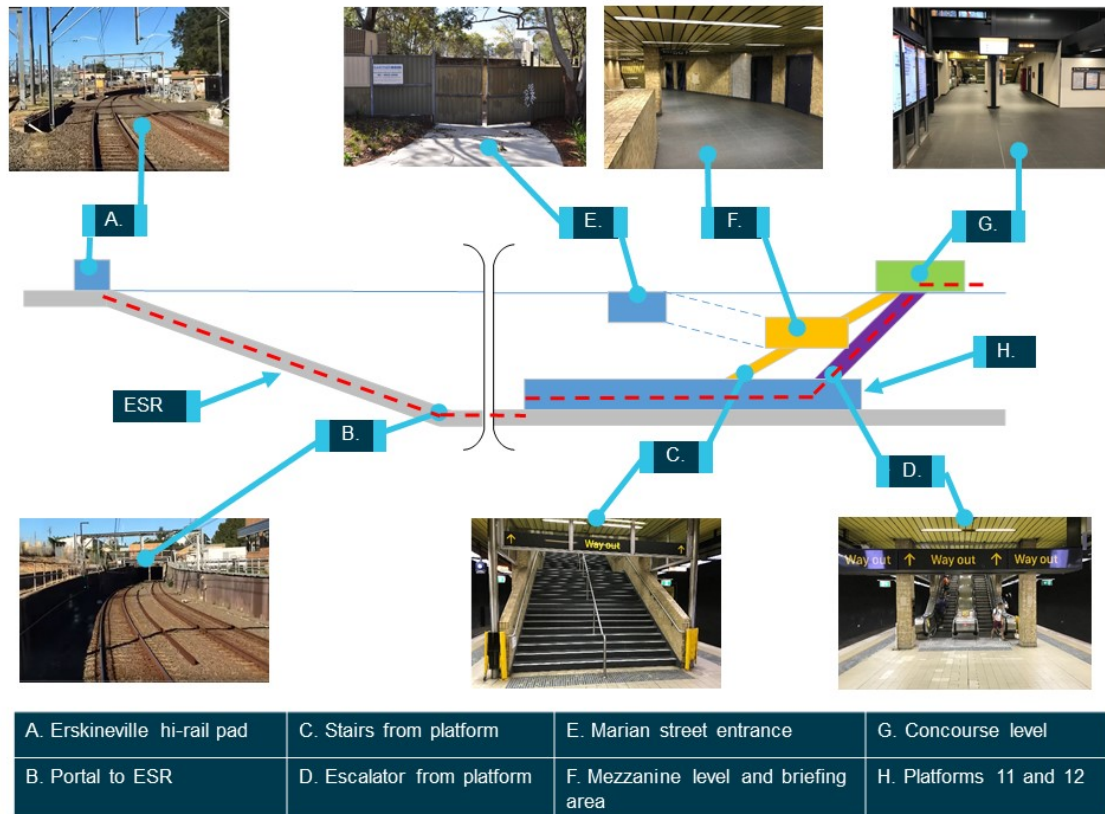
Figure 4: Path taken by the RSW between Erskineville and Redfern

After using the public toilet at Redfern Station, the RSW entered the danger zone at the city side of Platform 10 (Figure 5) before entering the APL tunnel.

Following the near misses, the RSW returned to Platform 10, exiting via the stairs before locating the entrance off Marian Street and returning to the worksite (Figure 6).

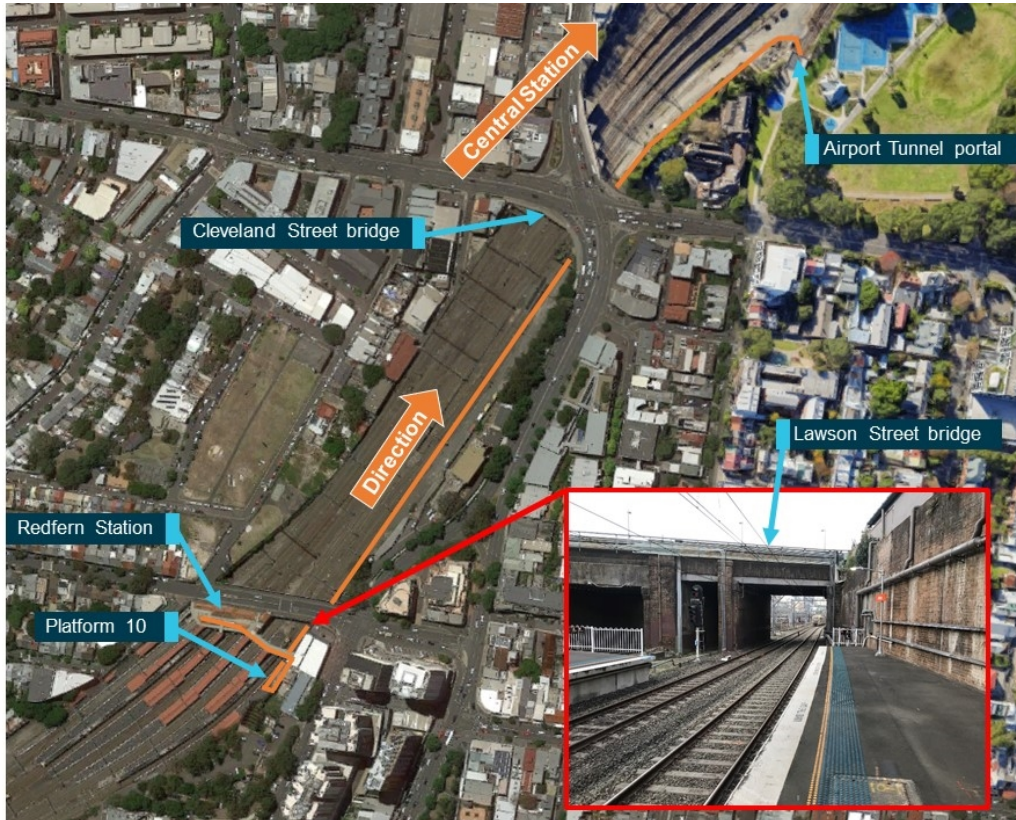
Figure 5: Path taken by the RSW from Redfern to entering the Airport Tunnel

The RSW was unable to return to Platform 11 via the same path taken, due to the concourse level worksite. At approximately 0857, the RSW entered the danger zone at the city end of Redfern Platform 10 at 1.213 km. The RSW walked in an Up direction, attempting to locate the portal<sup>7</sup> of the ESR tunnel to return to the worksite. The RSW walked approximately 550 m along live track and access roads, before entering what they believed was the ESR portal. In fact, the RSW had entered the portal of the Airport Line (APL) tunnel at 0.626 km. The RSW walked in a Down direction in the tunnel believing that they could return to their worksite.

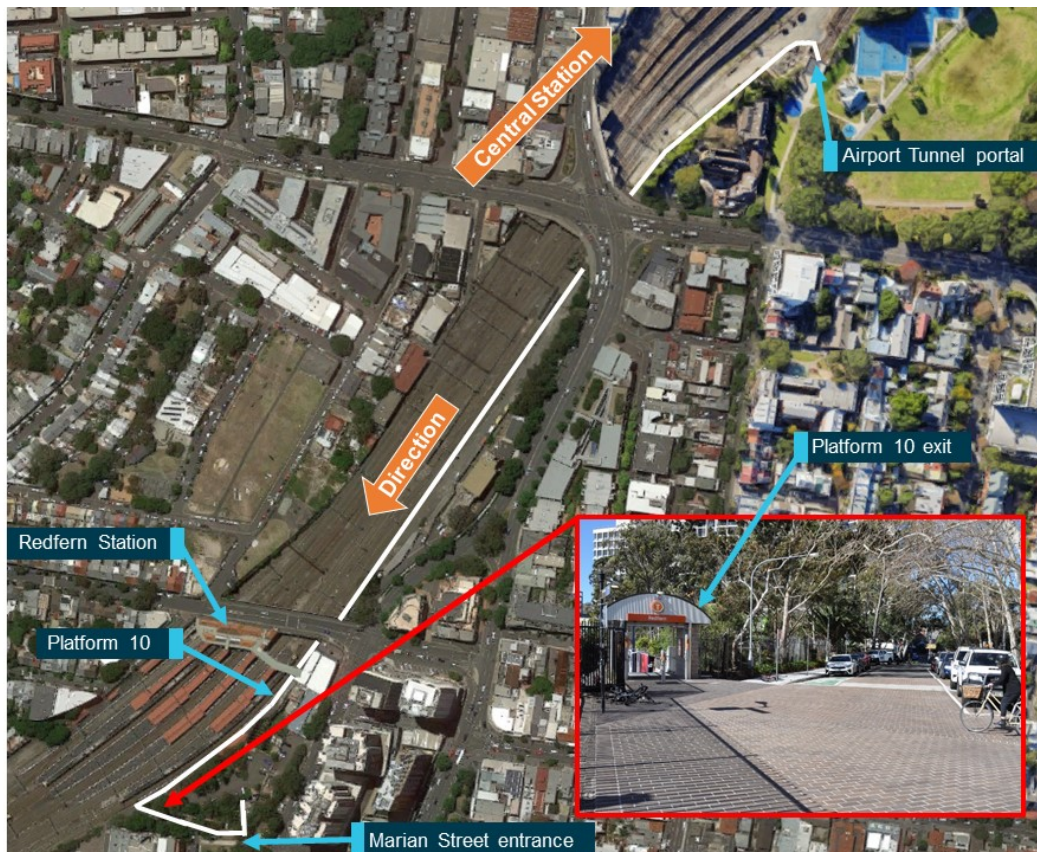
Figure 6: Path taken by the RSW from the Airport Tunnel to return to the ESR worksite

At 0915, the RSW returned to Redfern Platform 10 and exited the country end of the platform via the stairs to Marian Street. The RSW then located an entrance to access the ESR through an old maintenance depot located off Marian Street.
