Collision with floodwater involving freight train 6792

Little Banyan Creek, Queensland, on 7 March 2018

ATSB Transport Safety Report

RO-2018-007

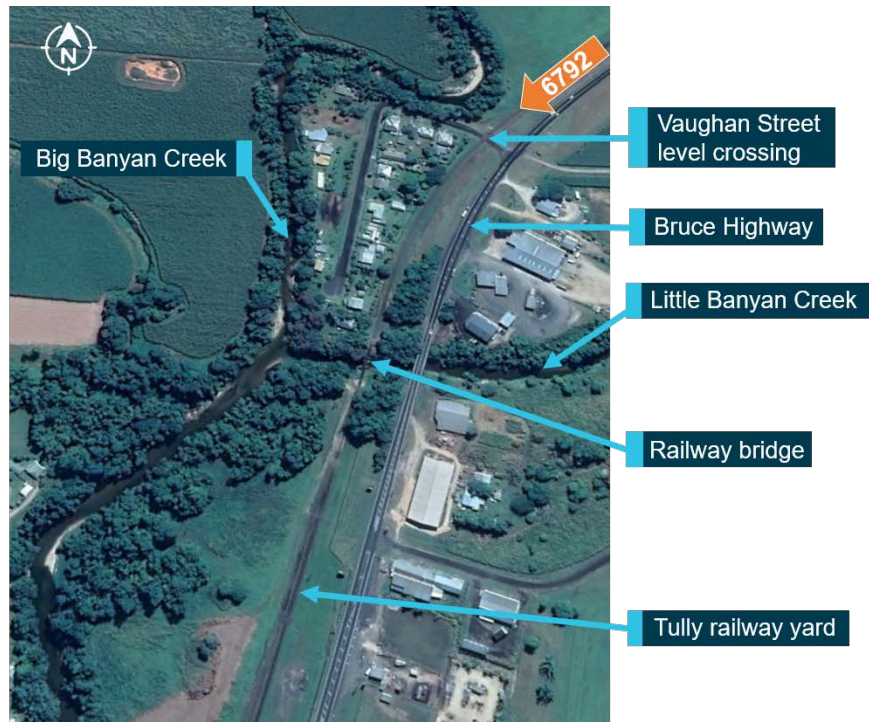
Figure 3: Train 6792's route on approach to the Little Banyan Creek rail bridge

At 0611:35, the train rounded the left curve on the approach to the rail bridge over Little Banyan Creek (Figure 3). The train's speed was about 50 km/h, with the maximum permitted speed in normal conditions being 70 km/h. The driver saw floodwater covering the bridge and he immediately attempted to stop the train by applying the emergency brake. The train was unable to stop in the distance available, and it entered the water at 0611:50 (Figure 4).

Approaching Little Banyan Creek and Tully yard from the north, the rail track curved to the left on a 502 m radius curve after the Vaughan Street level crossing and dropped down to the bridge (Figure 3). Trains were permitted to run at a maximum speed of 70 km/h around the left curve and over the bridge. At the southern side of the bridge, the maximum speed limit changed to 60 km/h.

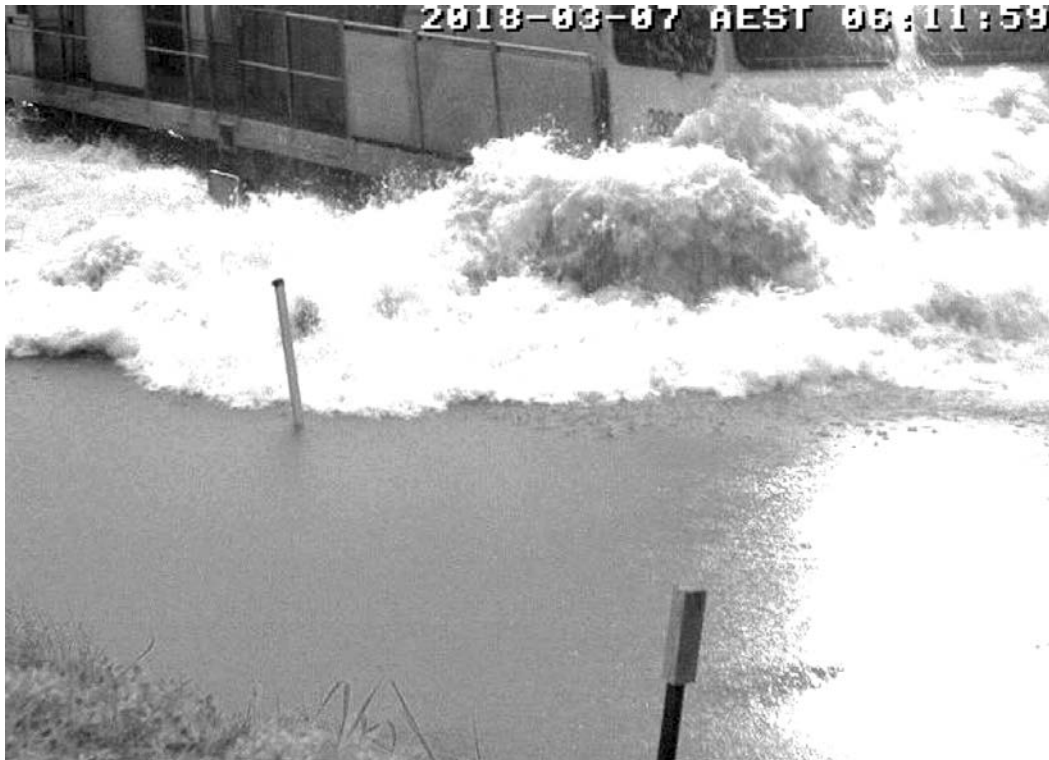
Figure 4: Train 6792's locomotive passing over the flooded Little Banyan Creek rail bridge

The distance from brake application to the train stopping was 294 m. After it stopped, the train was on the bridge with the locomotive and first three container wagons partially submerged in about 0.6 m of water (Figure 5). Neither of the train crew were injured.

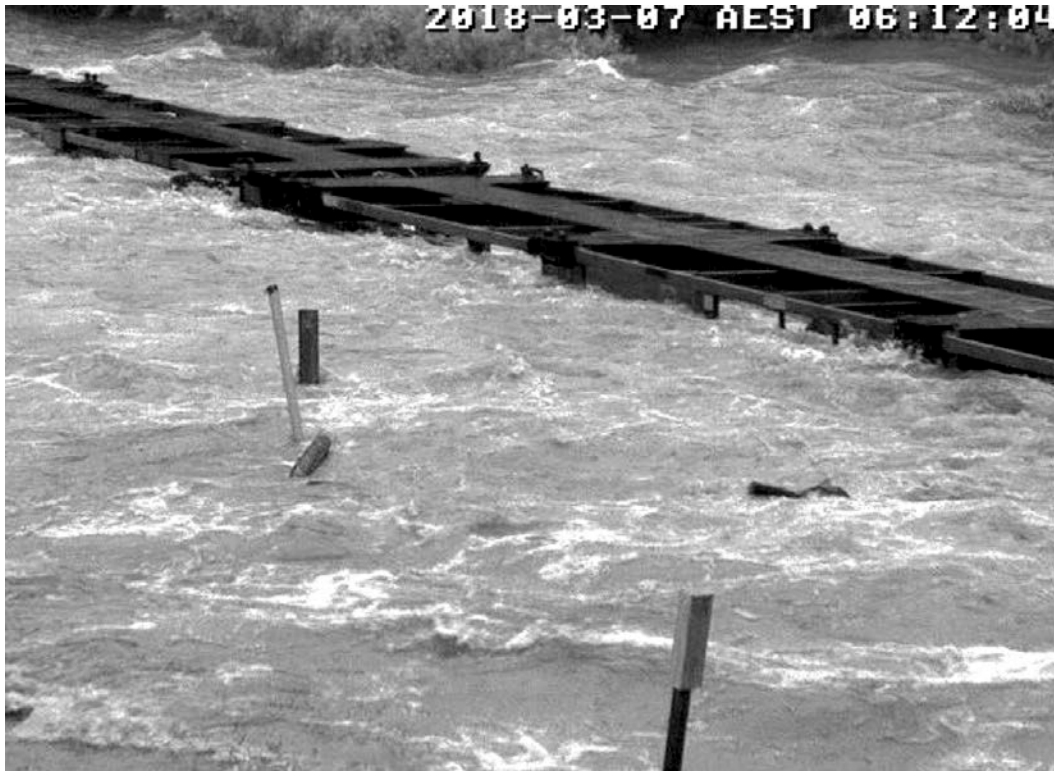
Figure 5: Empty container wagons behind train 6792’s locomotive, standing on the flooded Little Banyan Creek rail bridge

Train 6792’s crew were replaced by a relief crew. Following discussions between train crew and the rollingstock defect coordinator, the coordinator understood that the water ingress to wheel bearings was minimal. On this basis the relief train crew was authorised to continue to the nearest servicing depot at Townsville. At about 1730 on 7 March, the relief train crew restarted the train and continued south. After running 43 km, the locomotive failed and the train was unable to continue any further. Aurizon subsequently reported that, following a detailed inspection of the train, it identified water damage to the traction motors and all wagon wheel bearings that had been submerged in water.

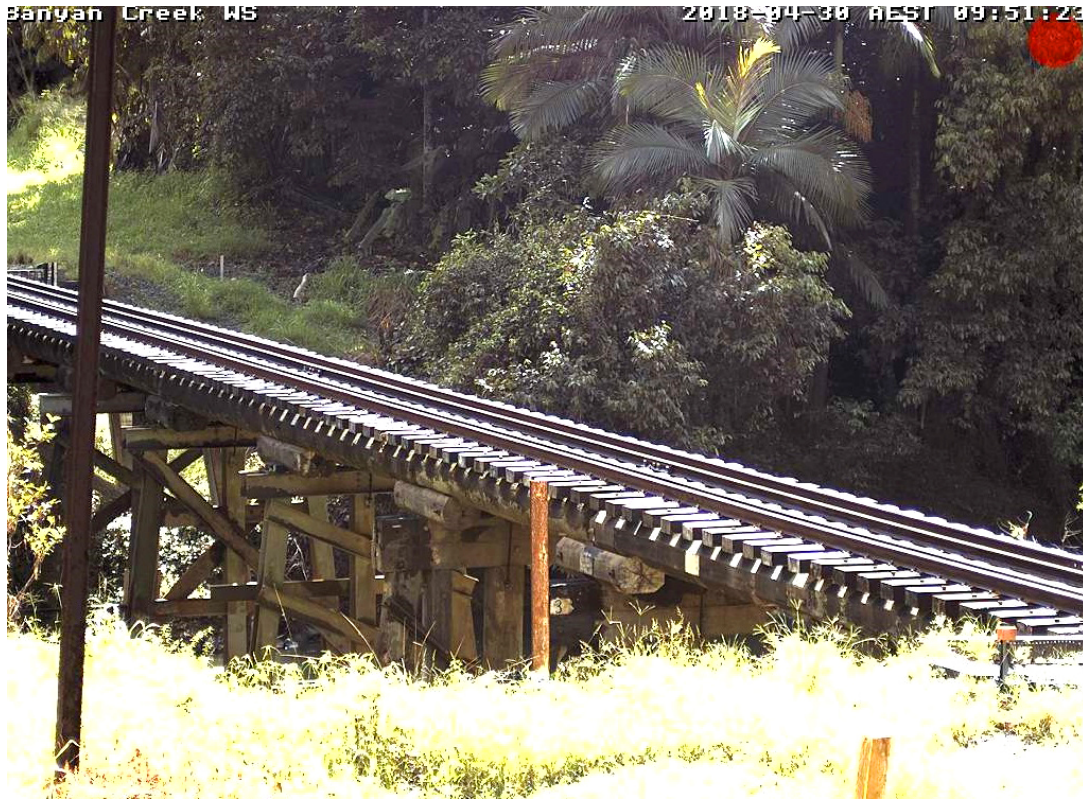
Figure 6: Little Banyan Creek rail bridge

QR's North Coast Line crossed Little Banyan Creek at 1,546.100 km, about 80 m from the confluence with Banyan Creek. The timber trestle bridge was about 40 m long (Figure 6).

On 10 January 2018, while working on the Little Banyan Creek rail bridge, a QR maintenance gang damaged a cable running from the water level sensor. A technician attended the site and identified that repairs were required.

On 18 January 2018, a QR engineer, who was monitoring cameras at the site, noted the water level in Little Banyan Creek had risen to the top of the sleepers on the bridge, but the flood alarm had not activated. A new water level sensor was ordered, and a technician attended the site in mid-February to install it. However, the technician was unable to calibrate the sensor. At the time of the occurrence on 7 March 2018, the water level sensor had not been calibrated and it was still offline.
