# Serious injuries on board *Berge Daisetsu*

Portland, Victoria 11 January 2018

**ATSB Transport Safety Report**  
Marine Occurrence Investigation  
338-MO-2018-001  
Final – 30 October 2019

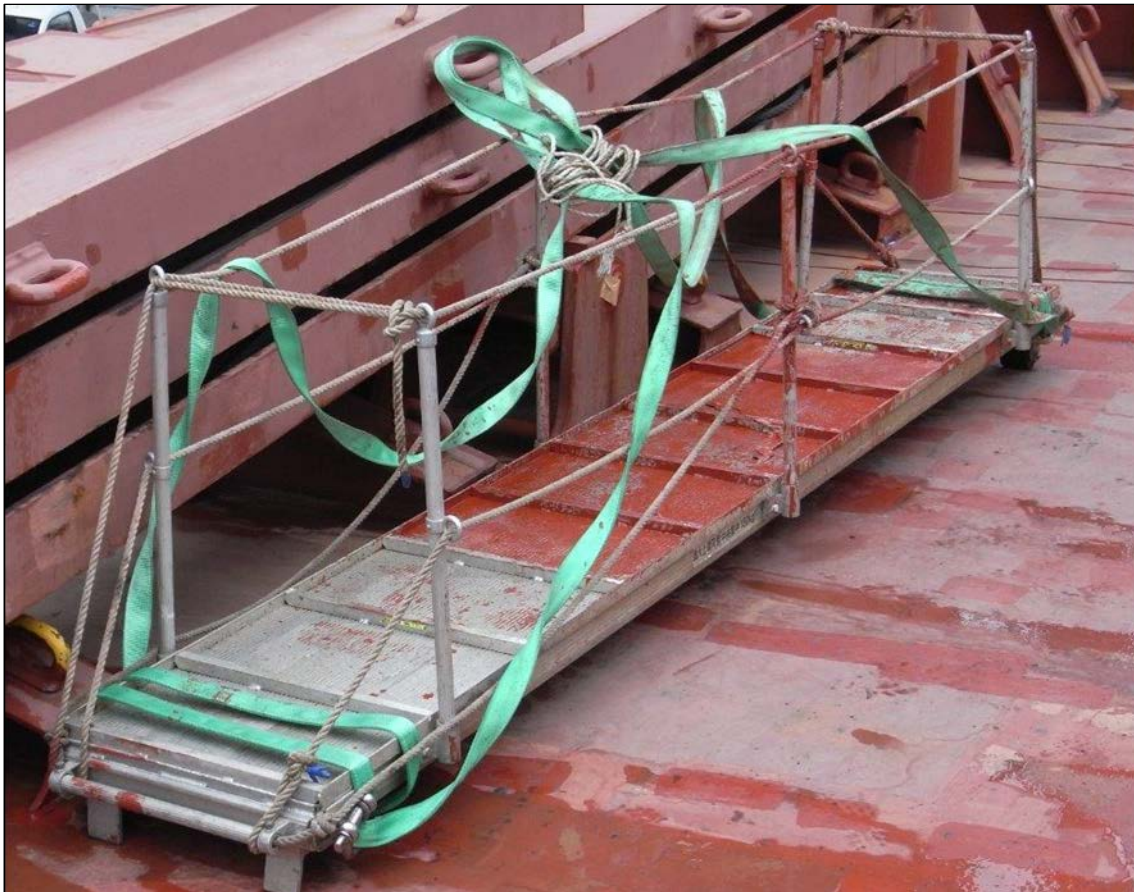
The gangway (Figure 2) comprised an approximately 0.6 m wide by 4 m long aluminium base with stanchions and rope side rails. As a gangway it was designed to be supported at its ends only, with a safe working load of 150 kg. In preparation for the painting task, the gangway was rigged with additional ropes to secure the open ends and then with slings at either end for lifting and suspending from the crane. Tag lines were connected to the underside of each end of the gangway and run to the hold bottom where they were used to control the motion of the suspended staging.

**Figure 2: Portable ship’s gangway as rigged for use as the suspended painting platform**

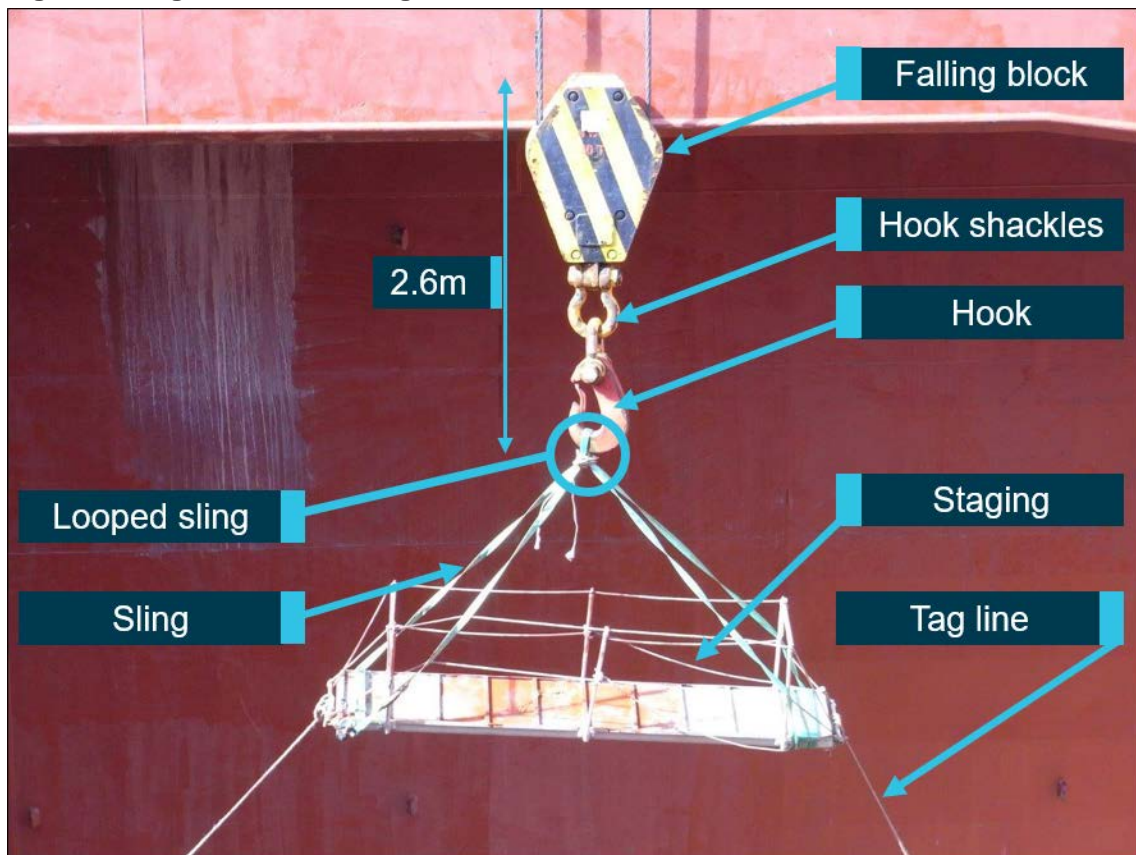
In preparation for accessing the upper hold sections, the staging slings were placed over the hook and bound together to form a tight loop around the hook (Figure 4). AB2 and AB3, donned the safety harnesses and attached themselves one to each of the fall arrest line's lanyards. Once readied, with rollers, extended handles and 20 litre buckets for paint, the ABs boarded the staging on the main deck. The free end of the fall arrest safety line was then tied off to one of the crane hook shackles, clear of the staging slings and the hook itself. Because the improvised arrangement had limited stability, the ABs stood one at each end of the staging to balance it. They were to work from these positions and limit their movement so as to not upset the staging and equipment on board.

**Figure 4: Stage and hook configuration**

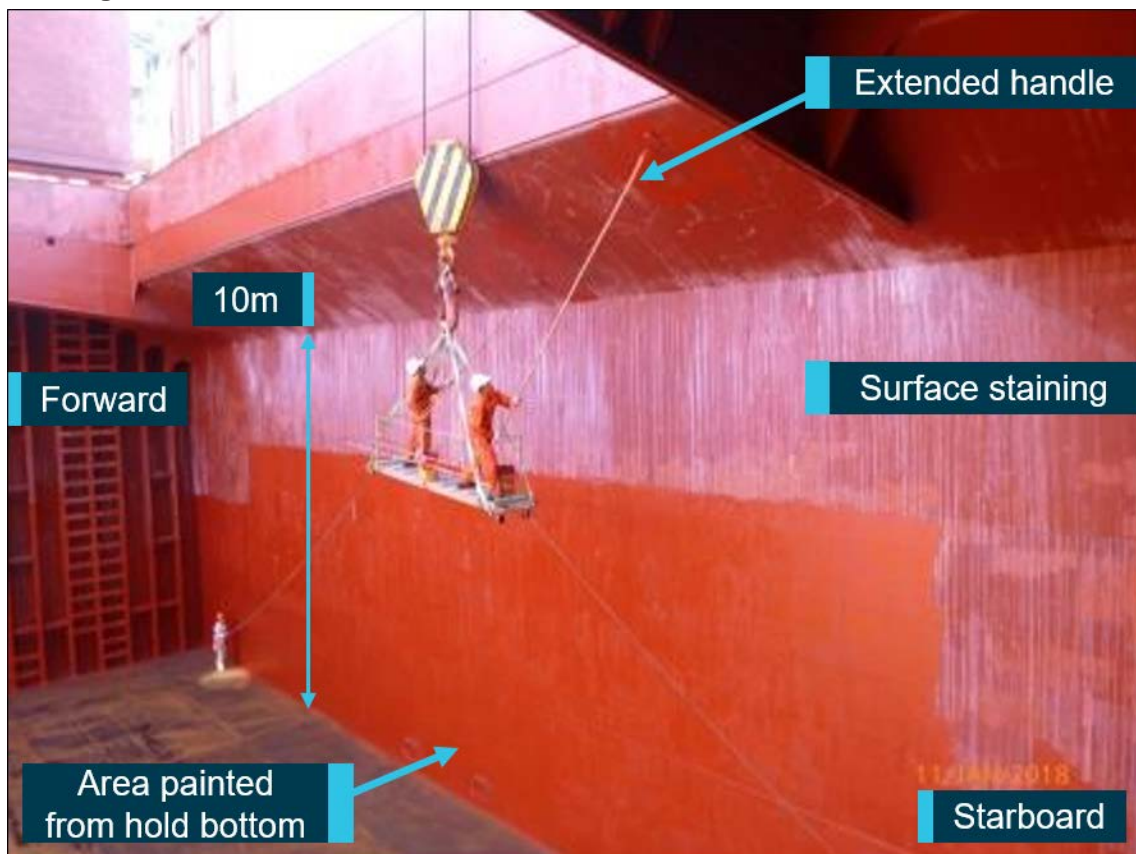
**Figure 5: Photograph, taken by the master, of work in cargo hold number 4 during the morning**

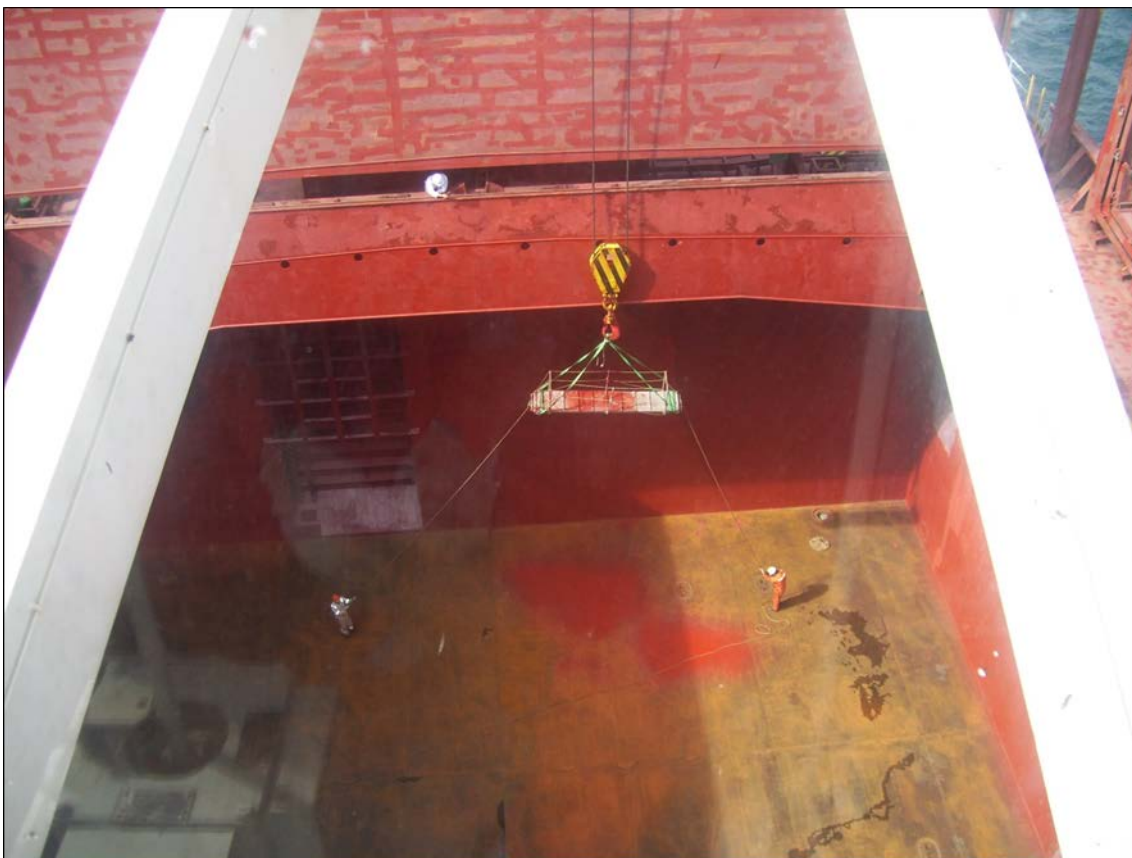
Utilising crane number 3, the team commenced painting on the port side aft area of the hold bulkhead in the same manner as they had earlier in the day – AB2 and AB3 boarded the staging on the main deck, it was lowered into the hold and the OS and cadet took control of the tag lines from the hold bottom (Figure 6). AB1 was on the main deck providing assistance to both the painting team and to the chief mate as required.

**Figure 6: Re-enactment of the approximate staging position at the time of the incident, looking aft from the crane driver's position**

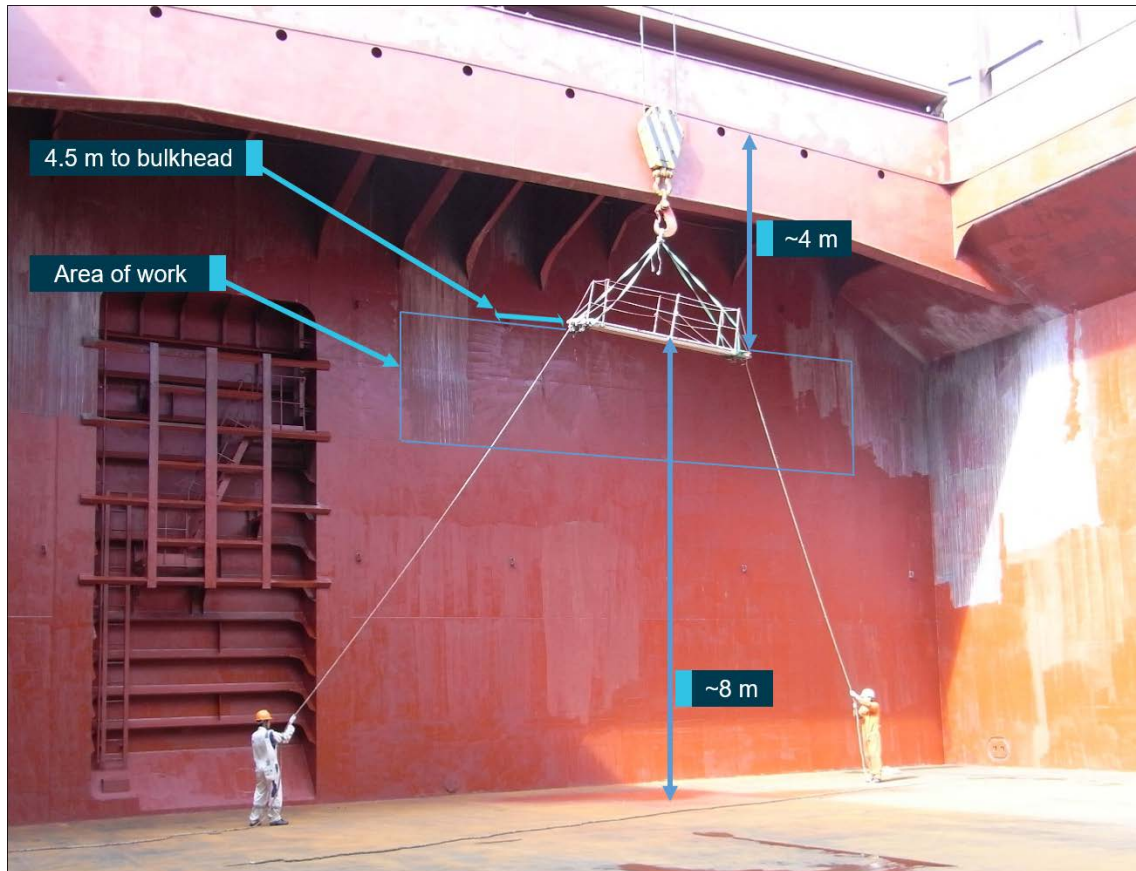
**Figure 7: Re-enactment of the painting stage in the cargo hold**

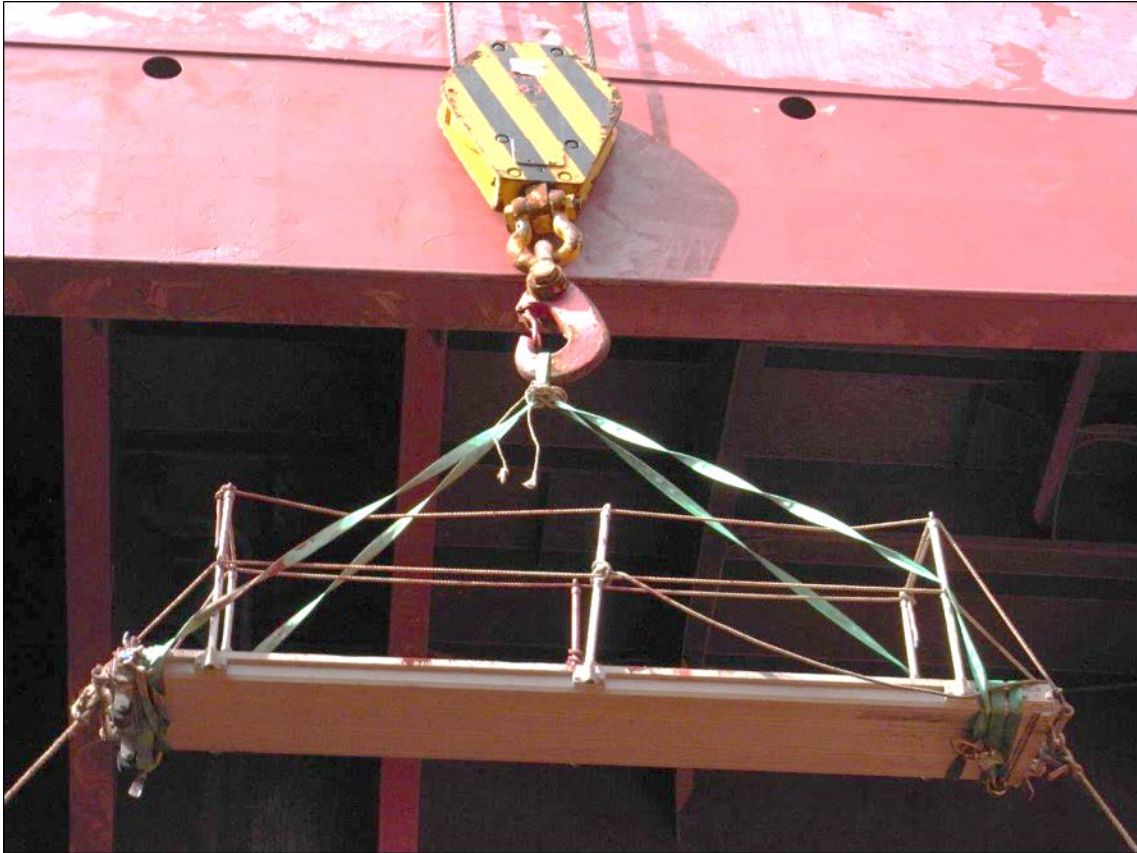
At about 1510, as the bosun raised the crane jib, the falling block caught on the lower edge of the hatch coaming. This went unnoticed by the work team and, as the jib was raised further, the block suddenly came free of the coaming sending an unexpected heavy shock into the staging,

**Figure 8: Re-enactment of the approximate location of the platform and falling block at the time of the accident**

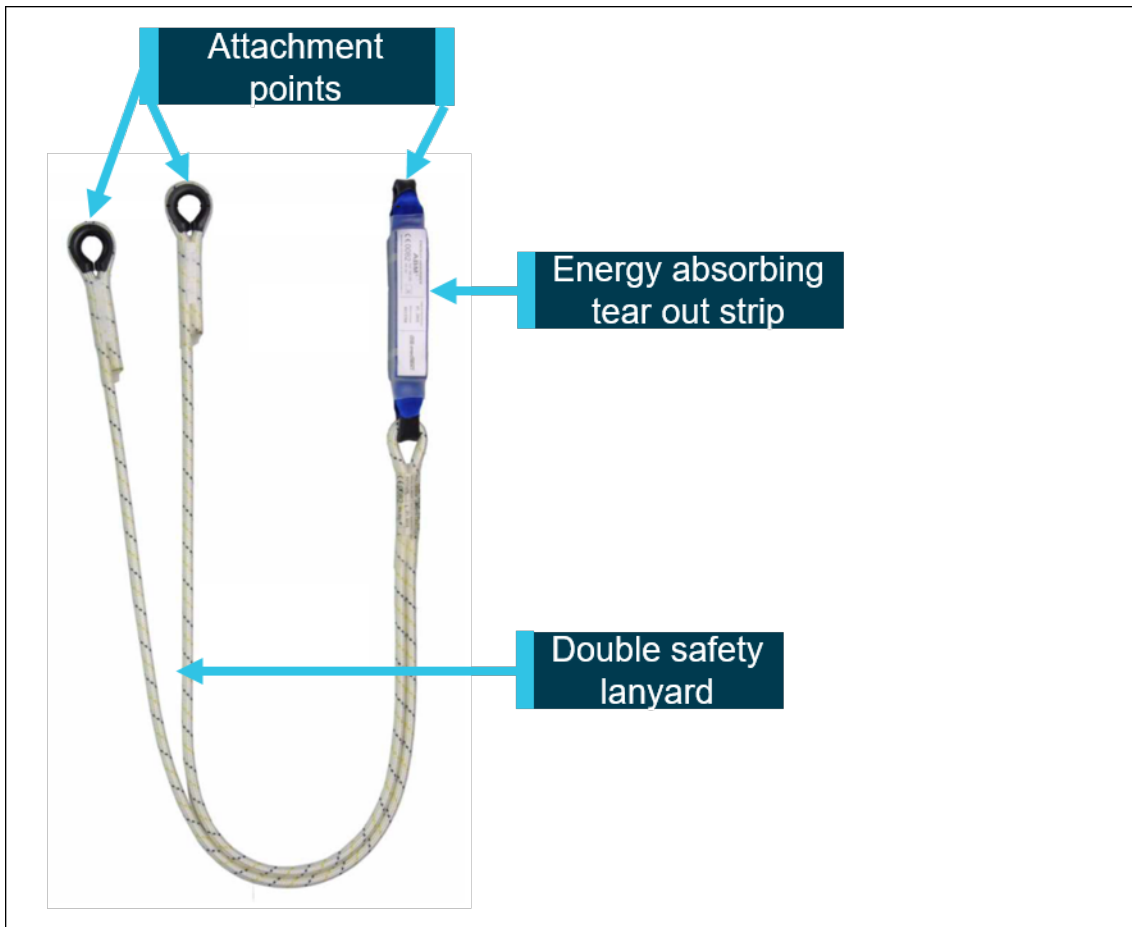
**Figure 9: Energy absorbing double lanyard fall arrest equipment in use at the time**

This type of lanyard<sup>9</sup> comprises a 'Y' configuration – the body of the 'Y' has the tear out energy absorbing component and the two legs have safety lanyards and attachment loops (Figure 9). The energy absorber loop is to be connected to the safety harness of the user and the lanyards are then used for attaching to strong points. One lanyard is attached to one point, and the second can be moved and attached to a second point some distance away. The first can then be disconnected and moved to another point, and so on. This arrangement allows a user to move about a worksite without ever being unhooked from a strong point.

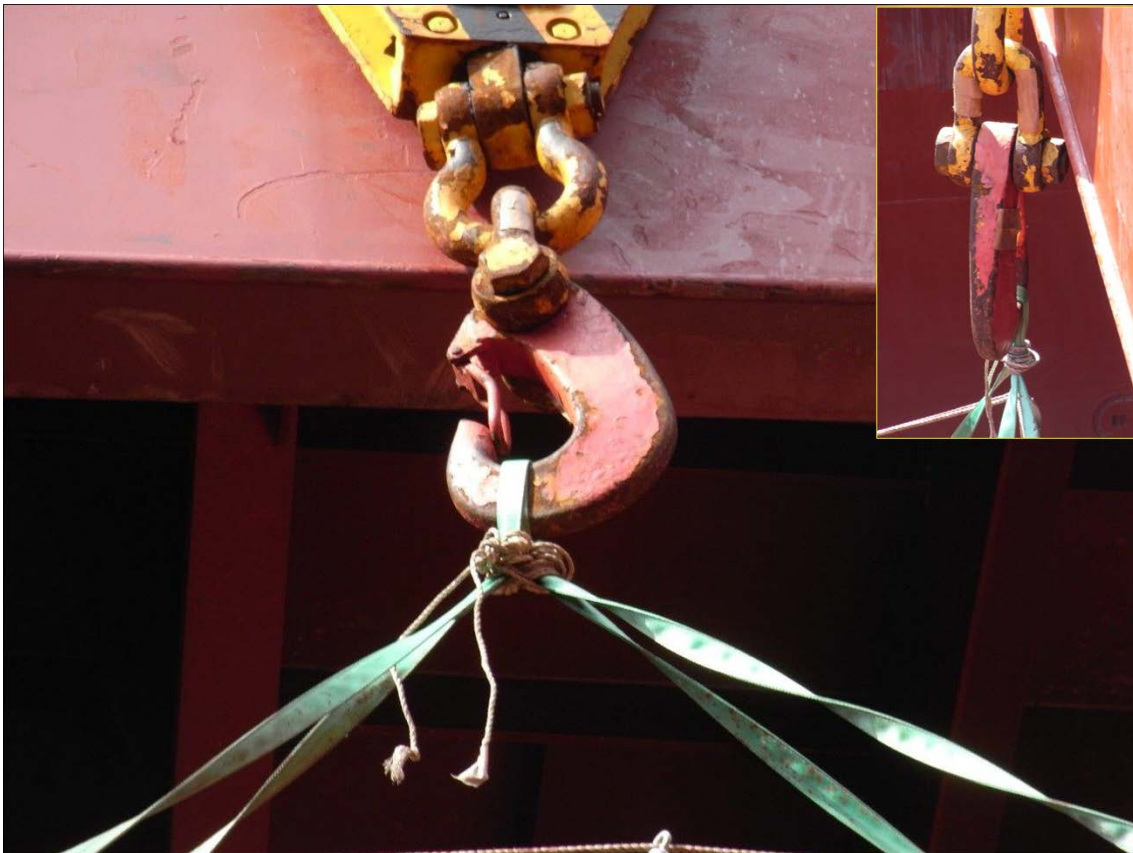
In a decision probably motivated by efficiency, *Berge Daisetsu's* crewmembers elected to paint the stained areas of the ship's cargo holds, rather than clean them, in order to meet the requirements to pass inspection and obtain a Certificate of Fitness to Load Grain. While painting the upper areas of the aft bulkhead of cargo hold number 4, the work platform was suspended from number 3 cargo crane with the crane falling block flat against the hatch coaming to position the painters as close as possible to the bulkhead being painted. In this location and orientation, one of the falling block shackle pins protruded fore-aft and extended under the lower edge of the hatch coaming (Figure 10). This presented as a catch point should the hook be lifted vertically.

**Figure 10: Crane hook and shackle in approximate position as at time of incident. Inset shows the view from the side with protruding hook shackle pin.**

To reach this location, the crane's lower luffing limit was bypassed. Bypassing the limit removed control protections from the crane including its level luffing function. Operating the crane in this

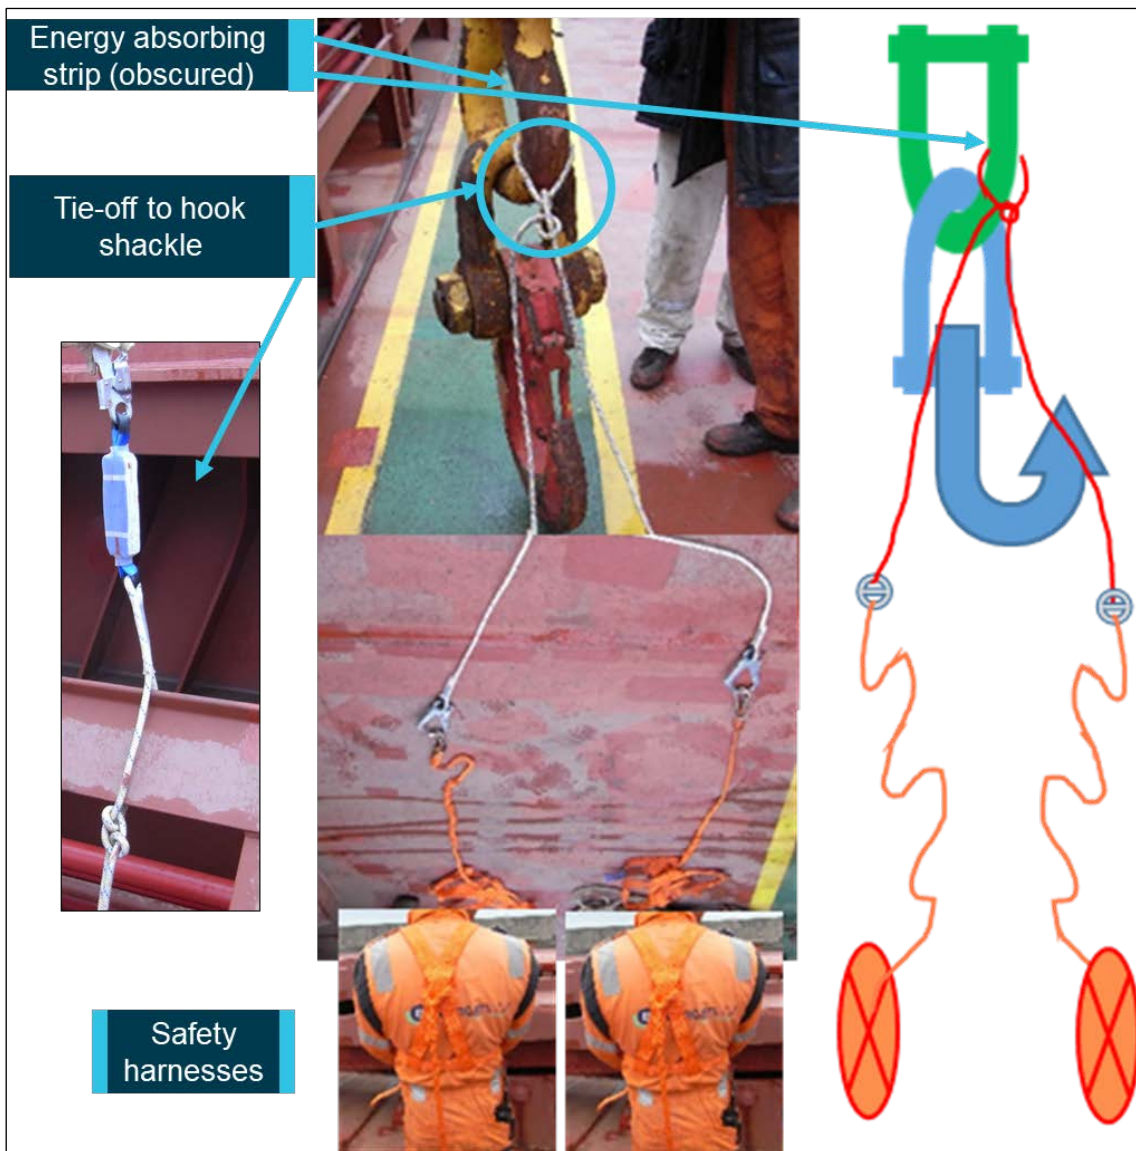
Had either of the ABs fallen from the work platform, the fall arrest lanyard would not have worked as designed. As the energy absorbing end of the lanyard was incorrectly connected it is possible that the lanyard may have failed completely and the user(s) fallen, unchecked, to the hold bottom.

**Figure 11: Composite image and sketch showing how the energy absorbing double lanyard was used and secured**
