Landing gear wheel failure involving Saab 340, VH-ZLX

Adelaide Airport, South Australia on 20 August 2019

ATSB Transport Safety Report
Aviation Occurrence Investigation
AO-2019-047
Final – 26 August 2020

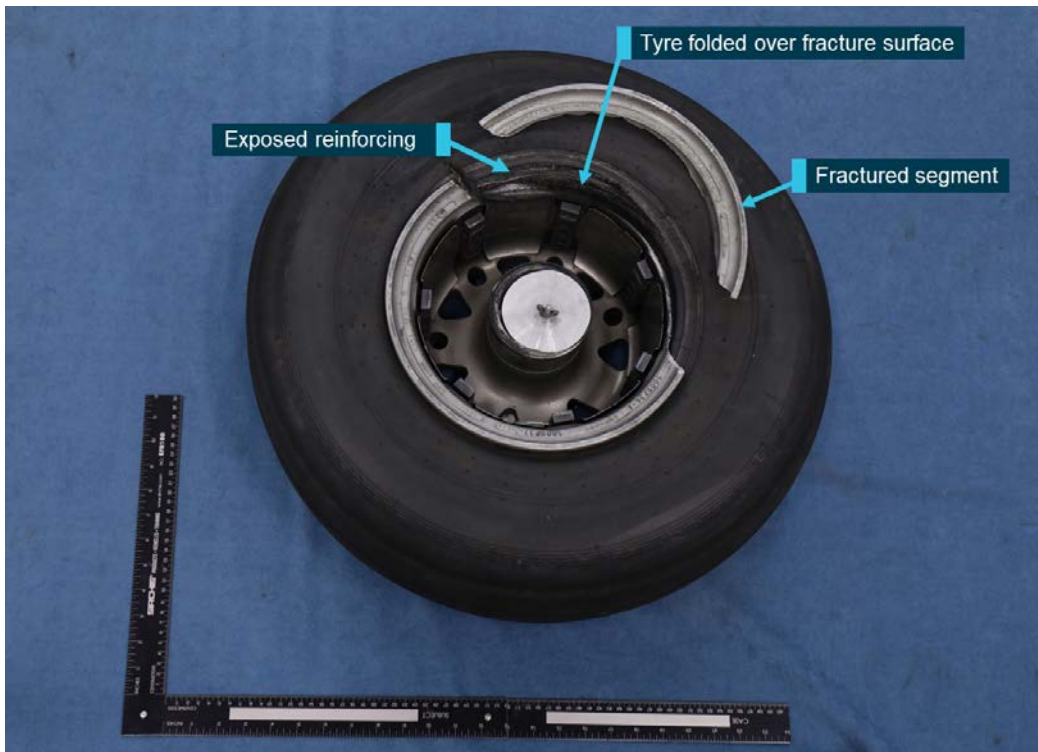
Figure 1: Wheel in as-received condition

On closer inspection of the wheel, the first officer noted that a piece of the wheel rim was missing (Figure 1). Ground staff were notified and the Port Lincoln aerodrome reporting officer (ARO) was contacted to conduct a runway inspection. The ARO's inspection did not reveal any foreign object debris or damage to the runway.

Initial inspections revealed that a section of the rim, comprising approximately one-half of the wheel’s circumference, had broken away with the fracture extending through the bead seat. The tyre had been damaged in the area of the fracture, with exposed steel reinforcing and some fractured wires. The tyre had folded over the fractured section of the rim and was caught on the edge of the rim (Figure 1).

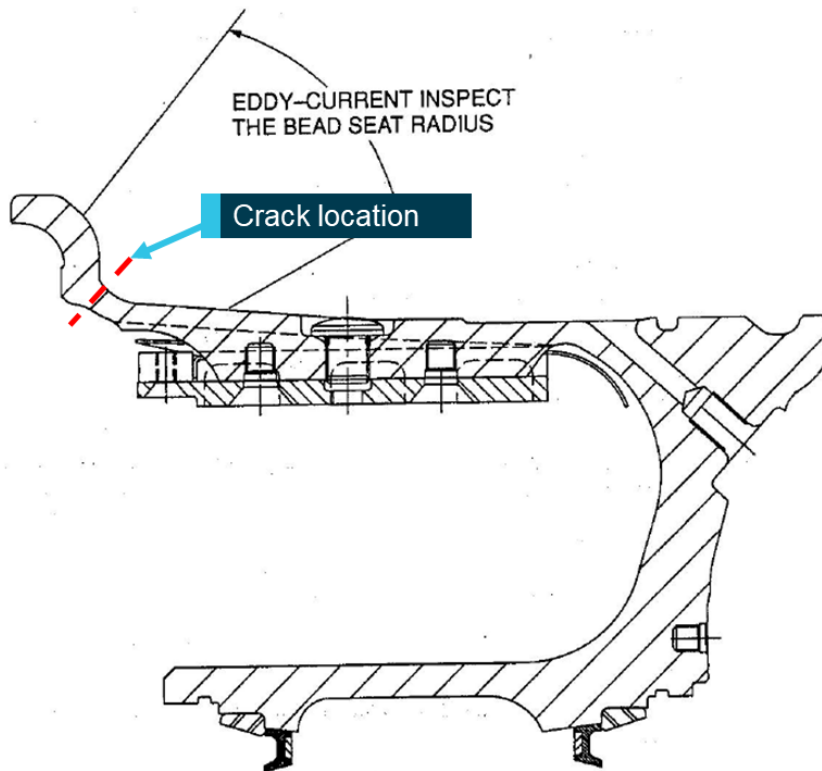
Figure 2: Cross-section diagram of the wheel hub showing the location of the fracture

The tyre was removed and the wheel disassembled to allow access to both sides of the fracture surface. The fracture followed a radial path through the wheel rim bead seat area (Figure 2).

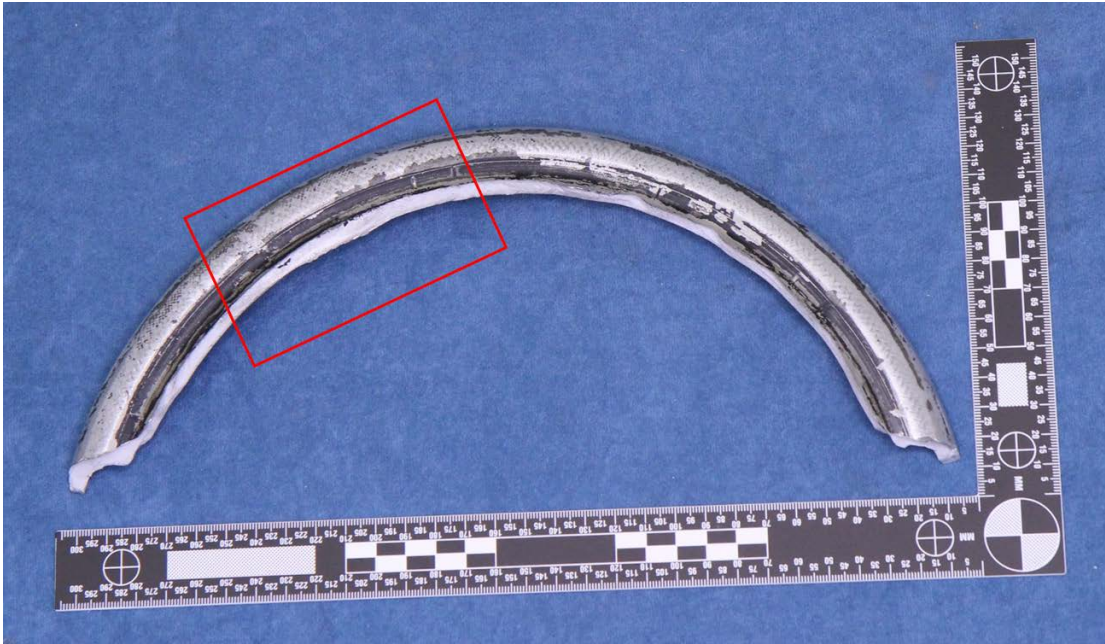
Figure 3: Excised portion of wheel rim with fatigue area highlighted

Beach-marks consistent with fatigue crack progression were evident across both faces of the fracture surface (Figure 3 and 4). These markings extended radially from the internal bead seat radius surface towards the centre of the exposed fracture face. The beach-marks extended circumferentially around the rim for approximately 86 mm. While several potential fatigue initiation points were examined on both faces of the fracture, the exact origin could not be determined. The outer surfaces of the fracture, beyond the area of fatigue, were dull grey in colour and rough/fibrous in appearance. These features were consistent with a ductile overstress failure in a heat-treated aluminium alloy.

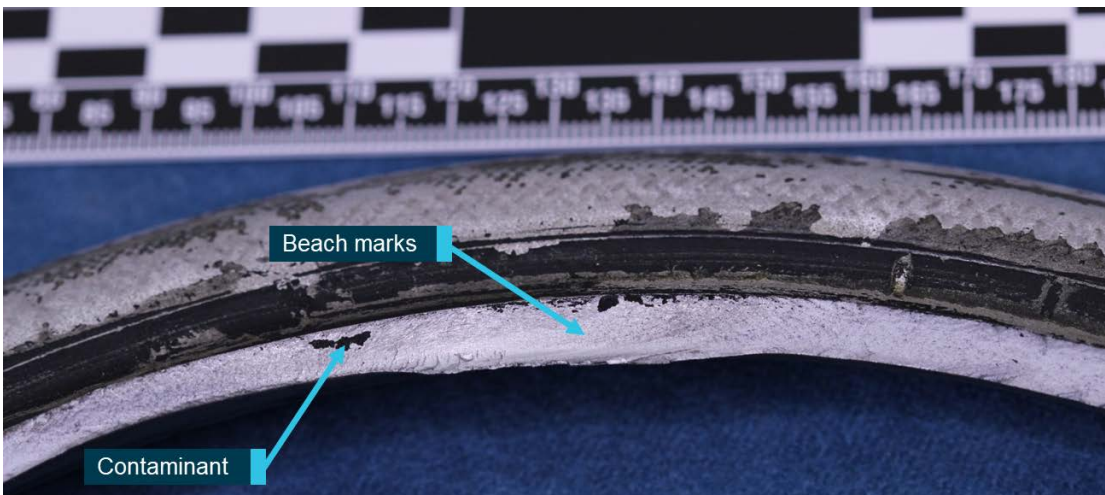
Figure 4: Magnified view of fatigue area showing crack progression along the bead seat and evidence of tyre contamination on the fracture surface

There was also black discolouration on the fracture surface. This was determined to be rubber debris from the tyre when it had been caught over the rim.

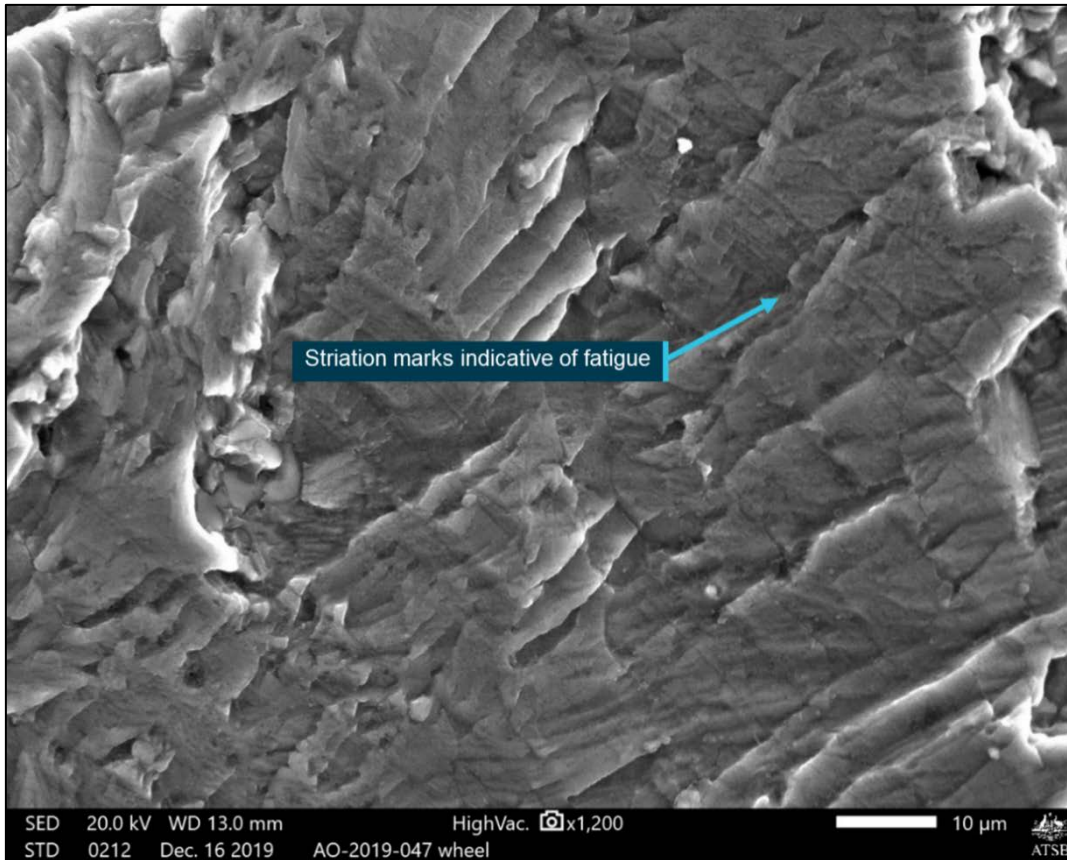
Figure 5: Area of fatigue surface showing step-wise crack formation

Scanning electron microscopy of the fracture surface revealed a relatively smooth fracture with evidence of non-uniform stepwise crack formation (Figure 5). This was further indication of a

fatigue crack propagation through the material. Due to the non-uniform nature of the steps, it could not be determined how many cycles of fatigue had occurred before the overstress fracture.

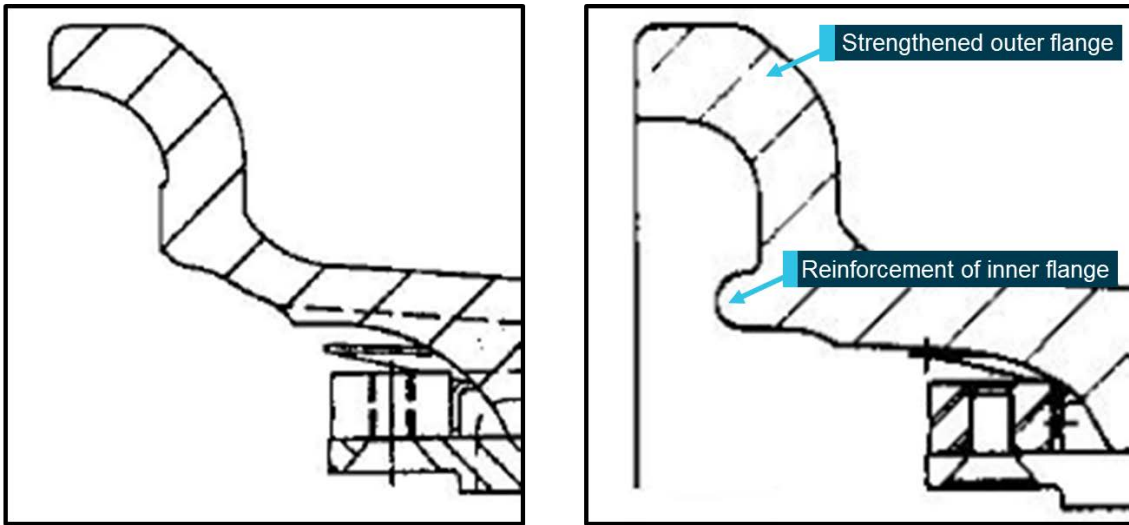
Figure 6: Diagrams showing the difference in the original and revised wheel designs

In December 1995, the manufacturer released an updated design (P/N 5010488-1) that included additional reinforcement in the bead seat region. Figure 6 and 7 show the differences between the two designs. The new design could not be retrofitted to existing wheels. The manufacturer’s advice to operators in the service bulletin that introduced the new design (*Saab 340-32-41*) was that the older wheels (serial number OCT95-1606 and earlier) could be used until stock depletion, provided the necessary maintenance and inspection standards detailed in *SL-GS-36* were maintained.

Bead seat area of the original wheel design P/N 5010488, image from SF340-32-24 Rev 1

Bead seat area of the revised wheel design P/N 5010488 - 1, image from SAAB 340-32-41
