Dewirement involving freight train YC77

Cooroy, Queensland, on 18 August 2018

ATSB Transport Safety Report

RO-2018-011

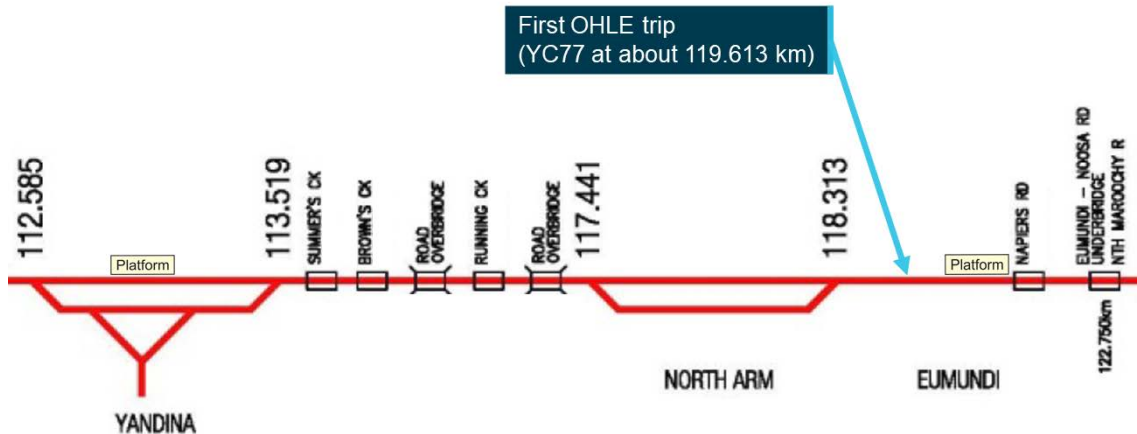
Figure 2: Approximate location of first OHLE circuit breaker trip

Given that train YC77 was in the estimated area of the circuit breaker trip at that time, the ECO requested the universal traffic control (UTC 7)¹⁰ network control officer (NCO) to confirm the status of the OHLE with the driver. At that time, the northside relief NCO was monitoring and controlling UTC 7 (see *Network control*). At 2052, the northside relief NCO contacted the driver of YC77, and the driver advised observing nothing unusual. After receiving this information, the ECO reset the OHLE circuit breaker, which held closed. The reset of the circuit breaker re-energised the high voltage OHLE. The ATSB subsequently identified that this first OHLE circuit breaker trip occurred at about 119.613 km, the location of YC77 at the time Figure 2 (see *Sequence of circuit breaker trips*).

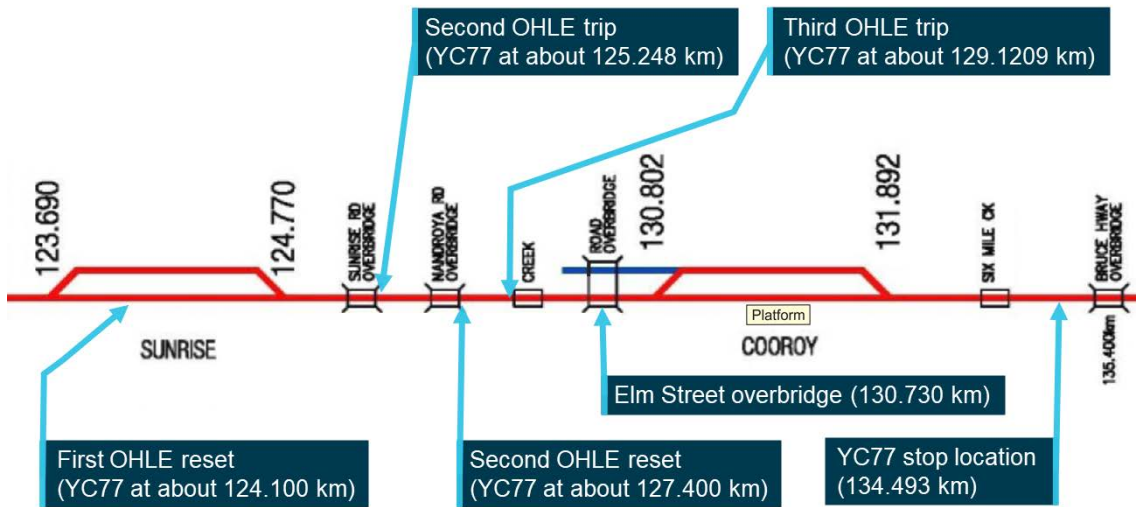
Figure 3: Approximate locations of second and third OHLE circuit breaker trips

At 2052, a track circuit showed 'occupied'¹¹ three track sections¹² behind YC77, followed at 2053 by a second trip of the OHLE circuit breaker (Figure 3). The ECO identified that the fault locator did not work on this occasion, which meant the fault could have occurred anywhere on the Woombye to Traveston electrical section. At that time, in addition to YC77, there were two other trains within this electrical section.

At 2101, a third trip of the OHLE circuit breaker occurred, and a telemetry¹³ failure occurred at Sunrise (124.230 km). The fault locator indicated to the ECO that the trip had occurred at 130.170 km, to the south of the Elm Street overbridge (130.750 km). The ATSB subsequently identified that this third OHLE trip occurred at about 129.1209 km,¹⁴ the location of YC77 at the time.

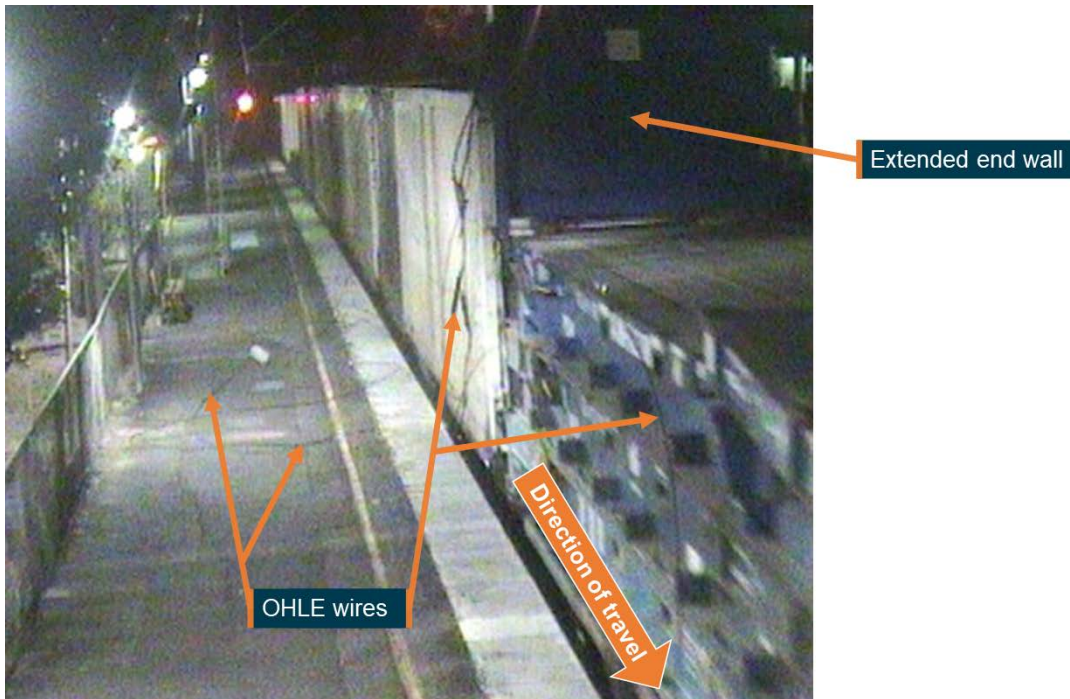
Figure 4: CCTV footage at Cooroy station showing the flat racks with the extended end wall and OHLE wires that had been brought down

At 2102, train YC77 was entering Cooroy. It passed under the Elm Street overbridge at a speed of about 42 km/h, which was under the maximum permitted speed of 50 km/h. Subsequent inspection found that the extended rear end wall of the top nested flat rack hit the underside of the bridge, and pulled down the high voltage OHLE wires (see *Site inspection*), resulting in a dewirement.¹⁵

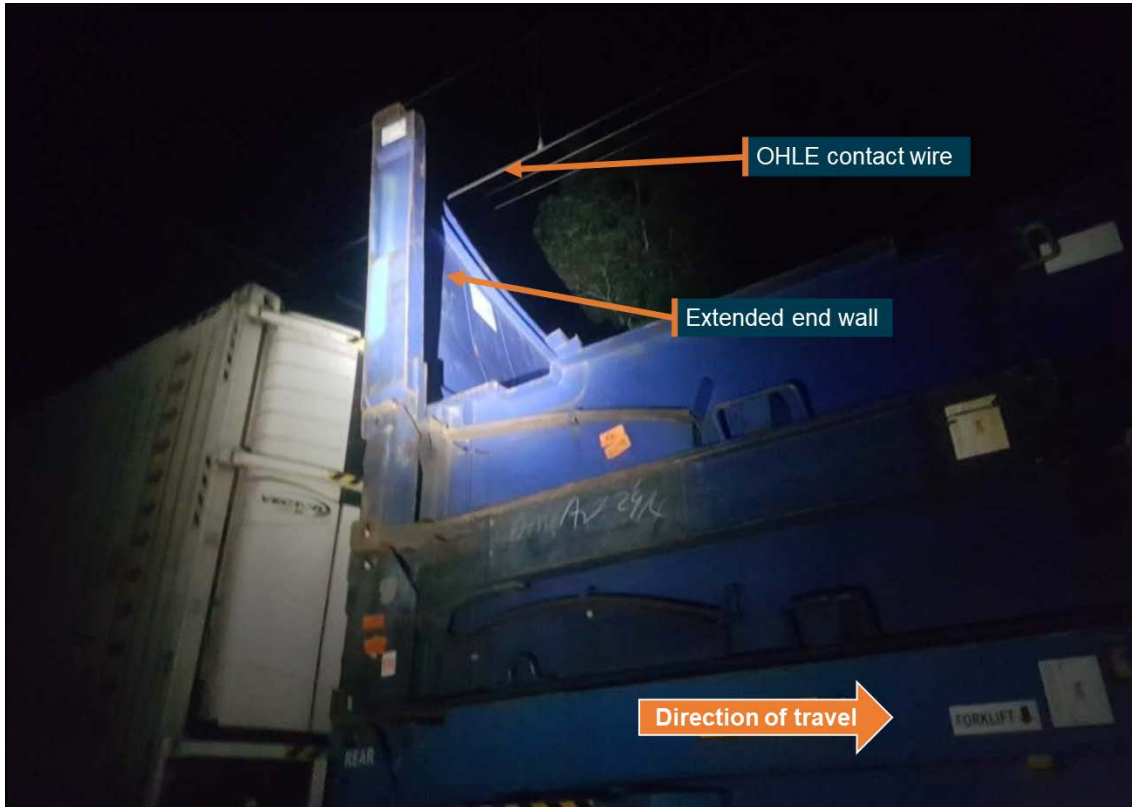
Figure 5: Flat rack end wall in the extended position in close proximity to the OHLE

Where the train stopped, the OHLE was still in place. However, the extended end wall of the top nested flat rack on YC77 was still extended upwards and in close proximity to the OHLE contact wire. Although the OHLE was de-energised, a potential hazard still existed.

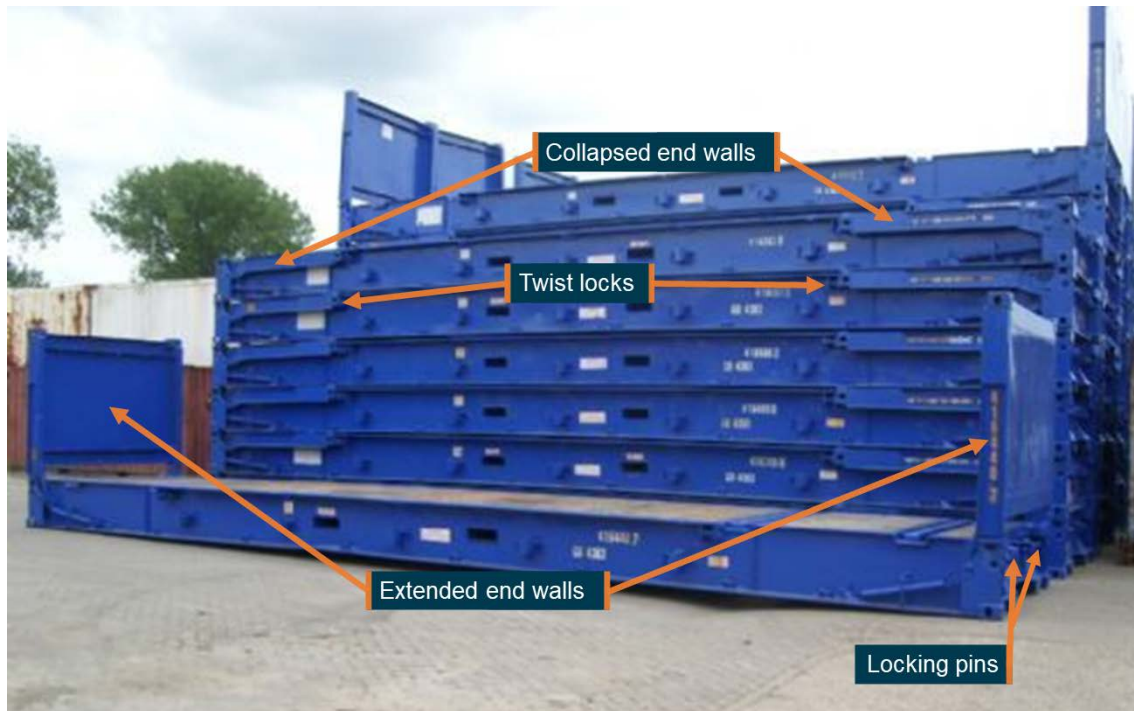
Figure 8: Flat rack containers

The flat racks on YC77 were Domino Seadeck 40 ft long type, similar to those shown in Figure 8. The collapsible end walls had leaf spring assist. A warning decal on the flat racks instructed the use of twist locks when a flat rack was travelling empty.

Image shows a flat rack with extended end walls (foreground) and flat racks with end walls collapsed (background) to enable stacking (nesting). Location of supplied securing methods when end walls were extended (locking pins) and collapsed (twist locks) are also shown.

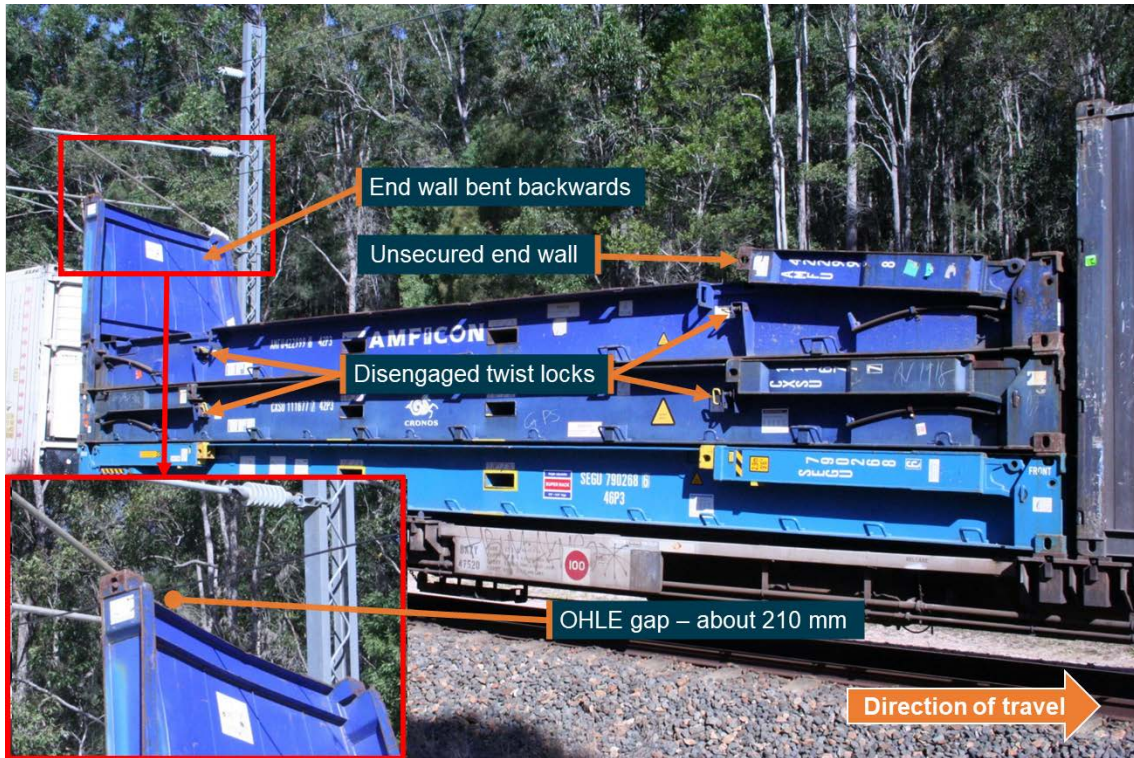
Figure 9: Nest of three flat racks on train YC77, showing the damaged extended rear end wall

An inspection of the train where it had stopped (134.493 km) found damage limited to that of the extended rear end wall of the top nested flat rack. The end wall had minor damage and had been

bent backwards, consistent with contact damage with the Elm Street overbridge. The height of the damaged extended end wall was 4,740 mm above rail level, slightly less than its expected undamaged height of 4,845 mm.

Analysis determined that the distance between the damaged extended end wall of the top flat rack and the OHLE contact wire at the location where the train stopped was about 210 mm (Figure 9).

No web straps or chains secured the end walls of the top flat rack on the nest of three flat racks or the end walls of the single flat rack. In addition, neither of the top two flat racks on the nest of three had their twist locks engaged. A significant amount of rust was present on the twist lock mechanisms, indicating they had not been engaged for a significant period of time. The spigots securing the bottom flat rack to the wagon, and each flat rack to the one below, were in place.

Image shows the extended end wall of the top nested flat rack, loaded on wagon BAZY 47520. The distance between the end wall and the OHLE contact wire is about 210 mm.

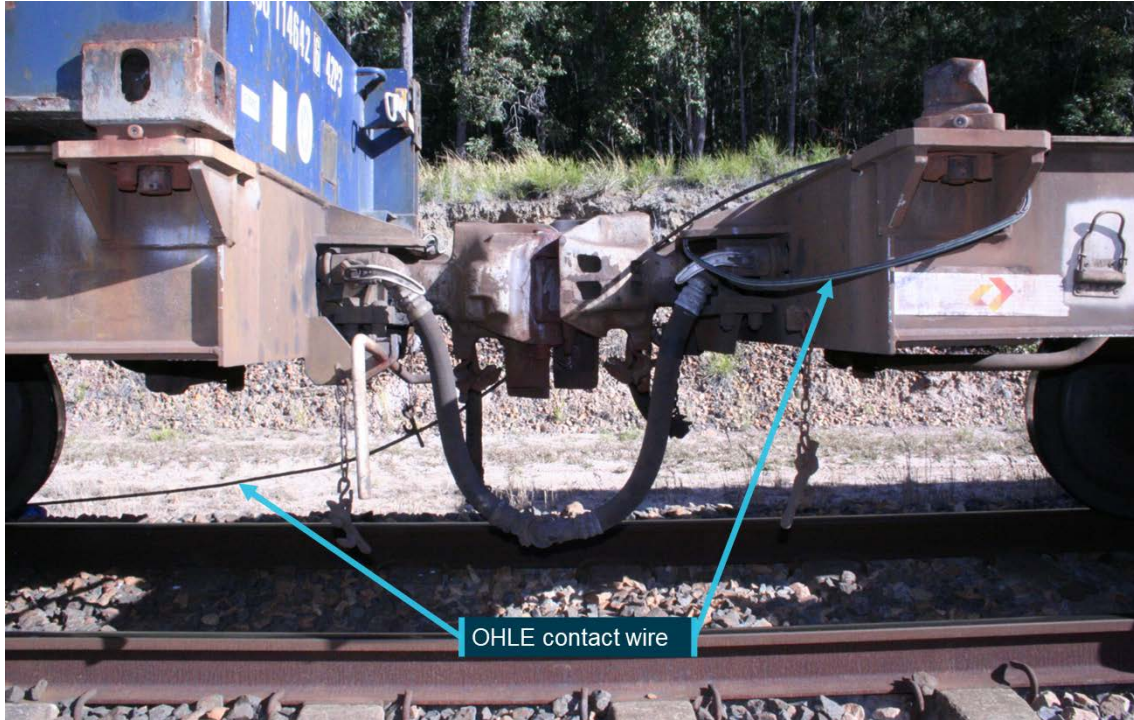
Figure 10: Part of train YC77 showing OHLE wires in contact with the train

Although the OHLE above the train was intact, some wires from the OHLE that had been pulled down were entangled in parts of the train, as shown in Figure 10.
