Grounding of *Bulk India*

Dampier, Western Australia on 11 March 2018

ATSB Transport Safety Report
Marine Occurrence Investigation
341-MO-2018-004
Final – 11 September 2020

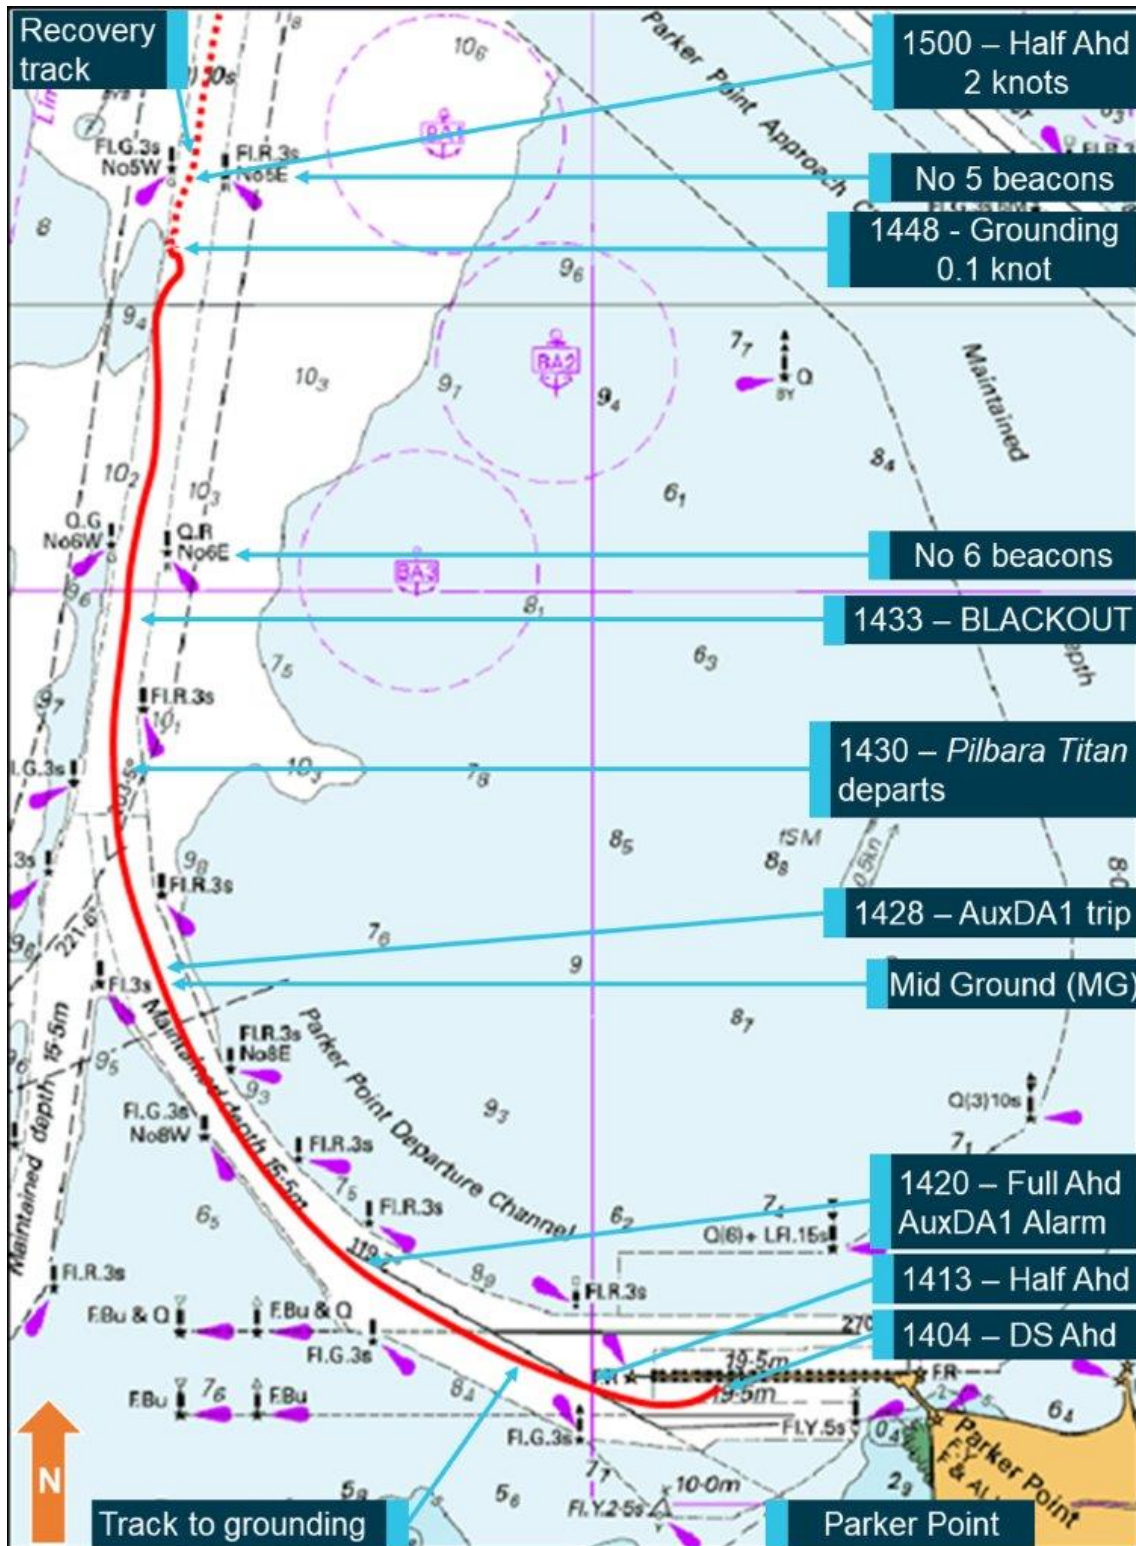
Figure 2: Bulk India's track from berth to grounding and recovery

The ship's speed began to slow while the RoT increased. At 1435:45, the peer pilot informed the PiC that the ship was going out of the channel—the ship had speed of 7.6 knots and a rate of turn to port of 5°/minute. The PiC directed *Pilbara Vulcan* to direct all power to slowing the vessel in order to reduce the severity of the imminent hull contact with the channel side. VTS was informed that the ship was departing the channel and running aground. At 1437, at 7.2 knots, on heading 355° and with a rate of turn of 10°/min to port, *Bulk India* took the bottom.

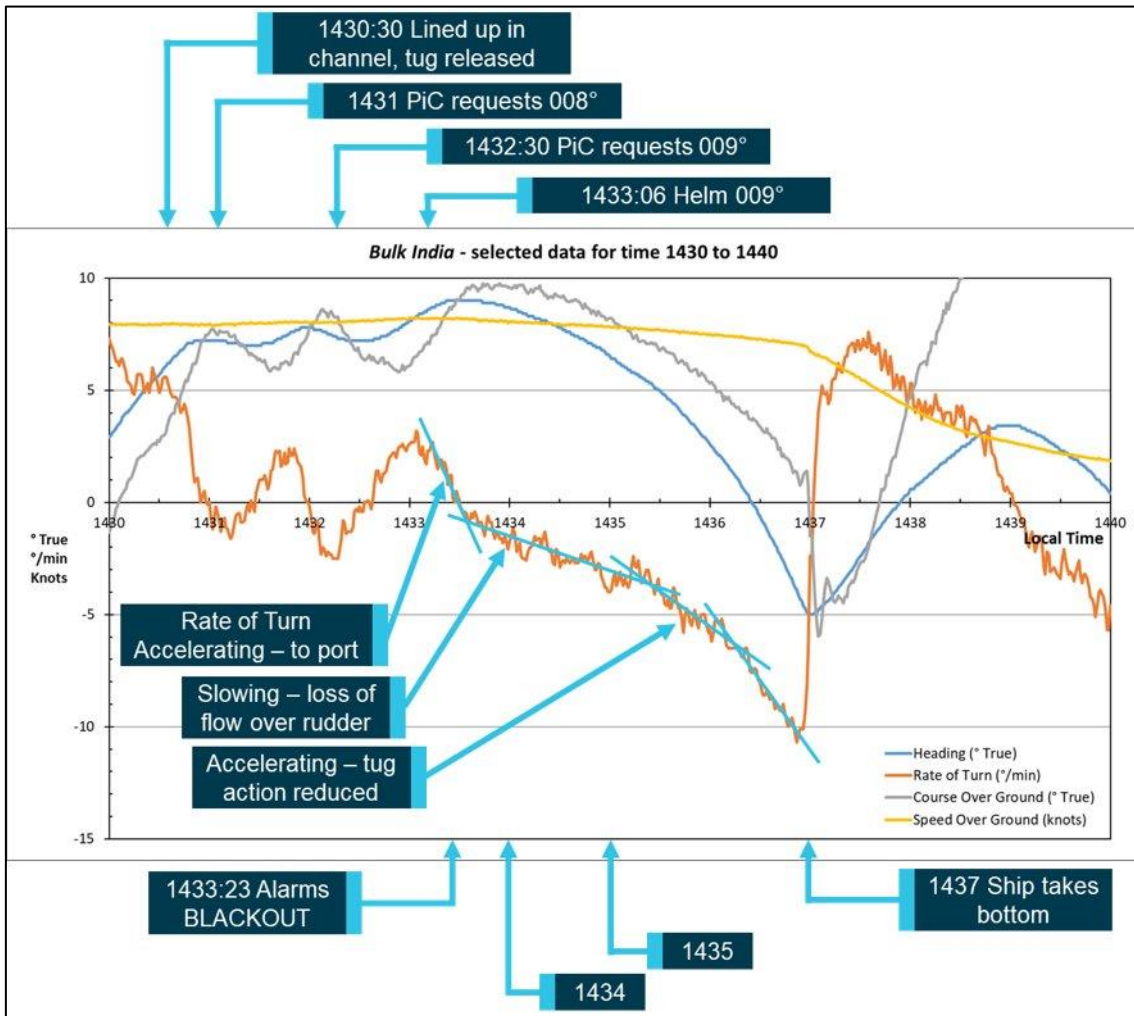
Figure 3: *Bulk India* movement data taken from PPU

Despite the loss of rudder effectiveness when the main engine stopped, and the efforts of the tug, the RoT to port increased from 2°/min at 1434, to 4°/min by 1435.

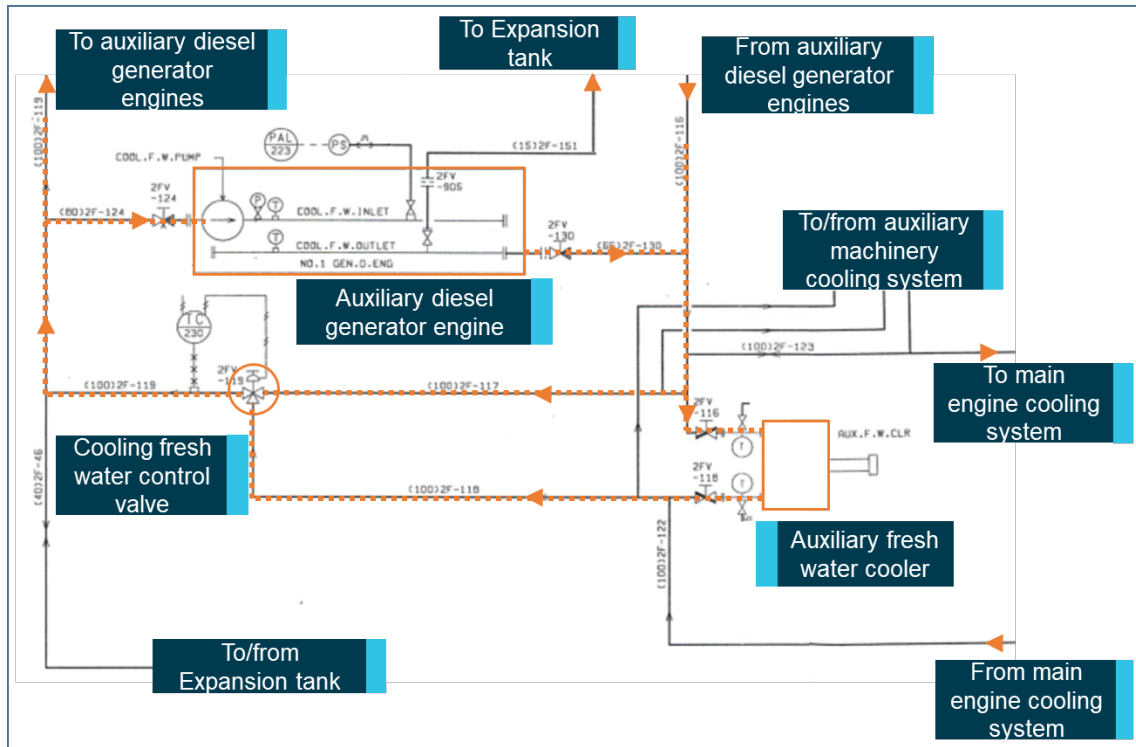
Figure 4: Auxiliary diesel generator engines cooling fresh water system

The main engine fresh water cooler could be used in place of, or to supplement, the auxiliary fresh water cooler if the need arose (during maintenance or for emergency cooling). However, this arrangement continued to rely on the auxiliary engine cooling water temperature controller and control valve. Therefore, the temperature of the cooling water for the ship’s main source of electrical power was reliant upon operation of the one controller and one control valve.

The exact cause of the cooling water temperature control malfunction was not determined. However, air pressure remained applied to the diaphragm until the engineers removed the air supply pipe. That is, the controller continued to supply air to the valve even though increasing temperature of the cooling water to the pumps should have led to the air pressure being reduced. It was therefore likely that this was caused by an air pathway blockage within the pneumatic controller.

As a single point of failure, this equipment should have been identified as critical and its associated systems understood by the crew and regularly tested. This would include maintenance of the valve, as well as the control air supply and system. It would also include understanding of, and familiarity with, auto-manual operation of the controller and the valve.

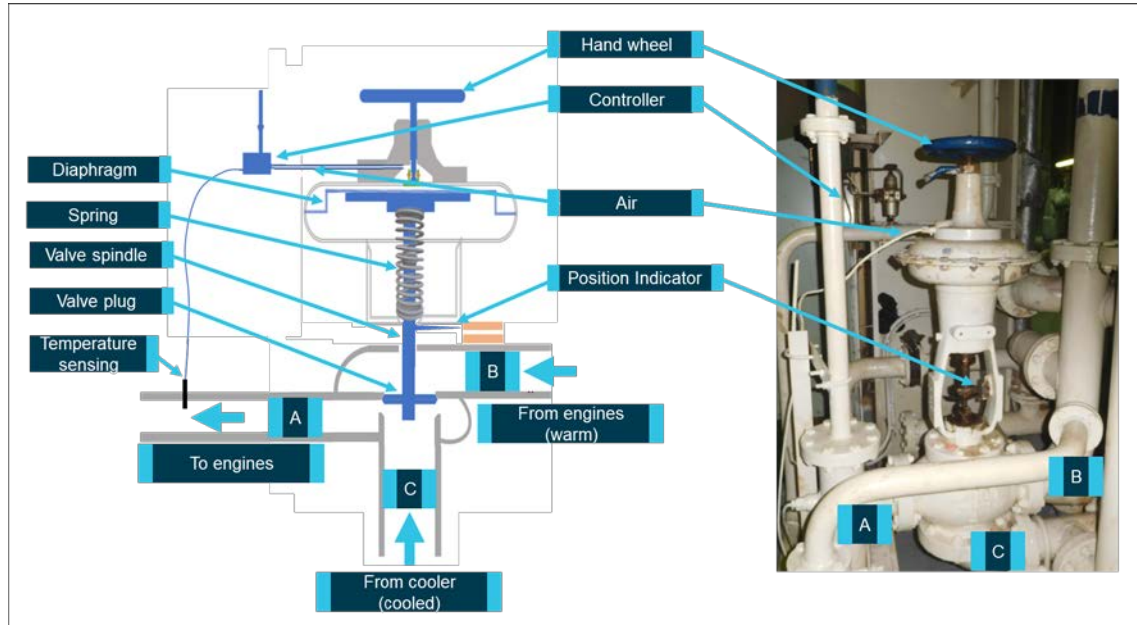
Figure 5: Three-way, single-acting pneumatic temperature control valve

The engineers dismantled the control valve actuator and found that the thrust bearing and disc fitted to the end of the manual operating hand wheel shaft had come adrift. The set screws normally holding these components in place had broken, allowing the assembly to fall off the shaft. The set screws were replaced and the control valve actuator reassembled.

pressure. The hand wheel was not physically connected to the diaphragm or the valve spindle. In automatic mode the hand wheel was in the fully up position (turned fully counterclockwise) so that it remained clear of the diaphragm and did not impede the full range of motion.

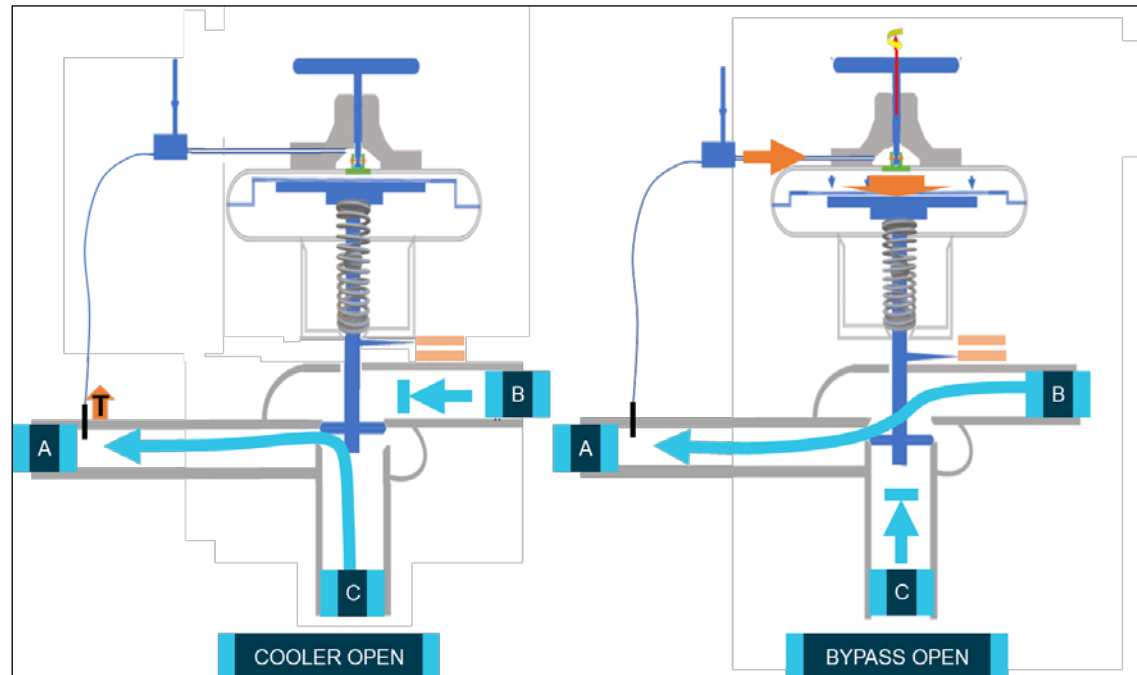
Figure 6: Control valve flow positions

In the non-energized condition (fail-safe with no air pressure applied), the valve allowed full flow from the cooler outlet to the pump suction (flow from the engine outlets was closed). All water flow from the engines was directed through the cooler (Figure 6 left). The valve body position indicator pointed to this as 'cooler open'.
