Uncommanded engine shutdown involving De Havilland Aircraft of Canada DHC-8, VH-LQD

77 km north-north-west of Brisbane Airport, Queensland, on 26 June 2018

ATSB Transport Safety Report
Aviation Occurrence Investigation
AO-2018-049
Final – 16 September 2020

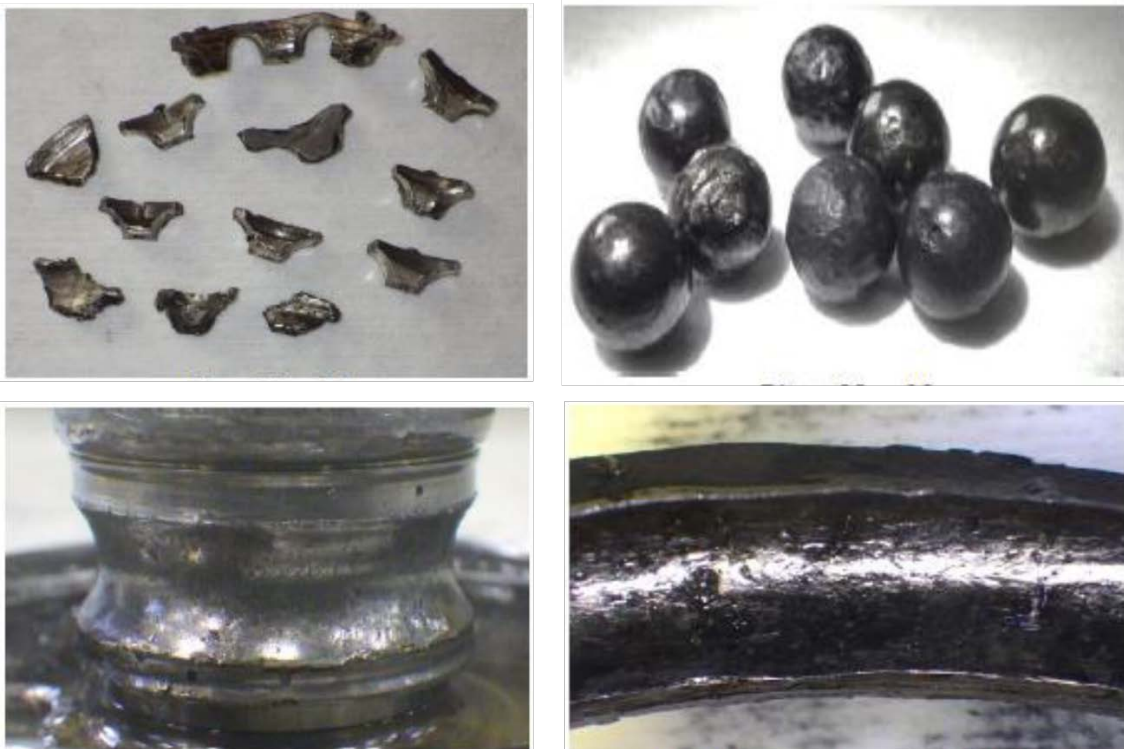
The aircraft was equipped with two Pratt & Whitney Canada PW150A engines, each driving a Dowty Propellers' six-blade R408 propeller system. The affected engine, serial no. PCE-FA0815, was sent to a Pratt & Whitney Canada engine facility in Canada for inspection. Their examination identified that the uncommanded engine shutdown was the result of a No. 30 bearing fracture. Due to the extent of damage, it was not possible to establish the bearing fracture mechanism.

Figure 1: No. 30 bearing broken cage pieces, damaged ball bearings and spalling on the inner and outer bearing races

During cruise flight, a bearing fracture within the intercompressor case resulted in an automated shutdown of the right engine. Due to the extent of the damage, and consistent with previous similar occurrences, it was not possible to establish the bearing fracture mechanism.

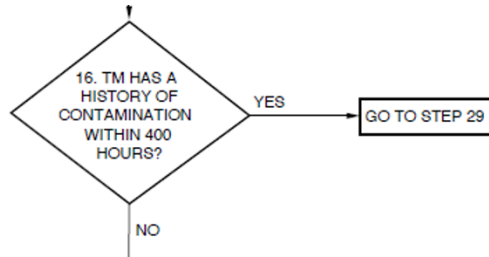
The aircraft maintenance manual directed the user to a flow chart that set out the steps to be taken when debris was detected on the turbomachinery chip detector and/or the main oil filter. Step 16 in the flow chart (Figure 4) asked if the turbomachinery had ‘a history of contamination within 400 hours?’. This step changed the term from ‘debris’ to ‘contamination’ and it also did not include the words ‘allowable’ or ‘non-allowable’.

Figure 4: Extracts of flow chart of decision-making map for debris on turbomachinery chip detector

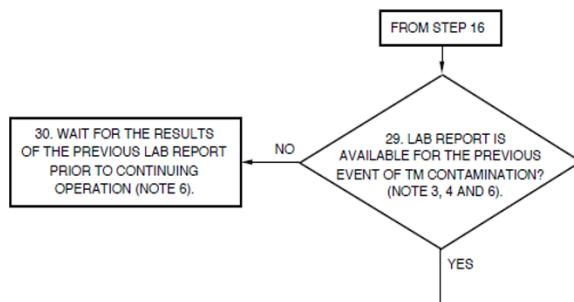
If the answer to step 16 was 'yes' then the flow chart directed the user to step 29 (Figure 5). This asked if a laboratory report was available for the previous event of contamination and if the answer was 'no', directed the user to go to step 30. Step 30 stated 'wait for the results of the previous lab report prior to continuing operation'.

Figure 5: Extracts of flow chart of decision-making map for debris on turbomachinery chip detector

The operator found that the personnel from the 'AMO and CAMO were then faced with a situation whereby the guidance required them to wait for the results of a debris analysis that had not taken place'. This step also directed the user to Note 6 (Figure 6) which directed the user to obtain an analysis of the 'last' sample. The operator noted that the use of the word 'last' here was open to interpretation, as this could be interpreted as 'last' being the previous debris or 'last' being the latest debris. It also did not specify that the debris could be 'allowable' or 'non-allowable', as specified in other sections of the manual.

The Australian Transport Safety Bureau recommends that Pratt & Whitney Canada takes safety action to improve the clarity of procedures within the chip detector debris analysis section of the aircraft maintenance manual.
