# Runway incursion involving Boeing 737 VH-XZM resulting in a rejected take-off involving Boeing 737 VH-VZL

Perth Airport, Western Australia, on 28 April 2018

**ATSB Transport Safety Report**  
Aviation Occurrence Investigation  
AO-2018-032  
Final – 1 October 2020

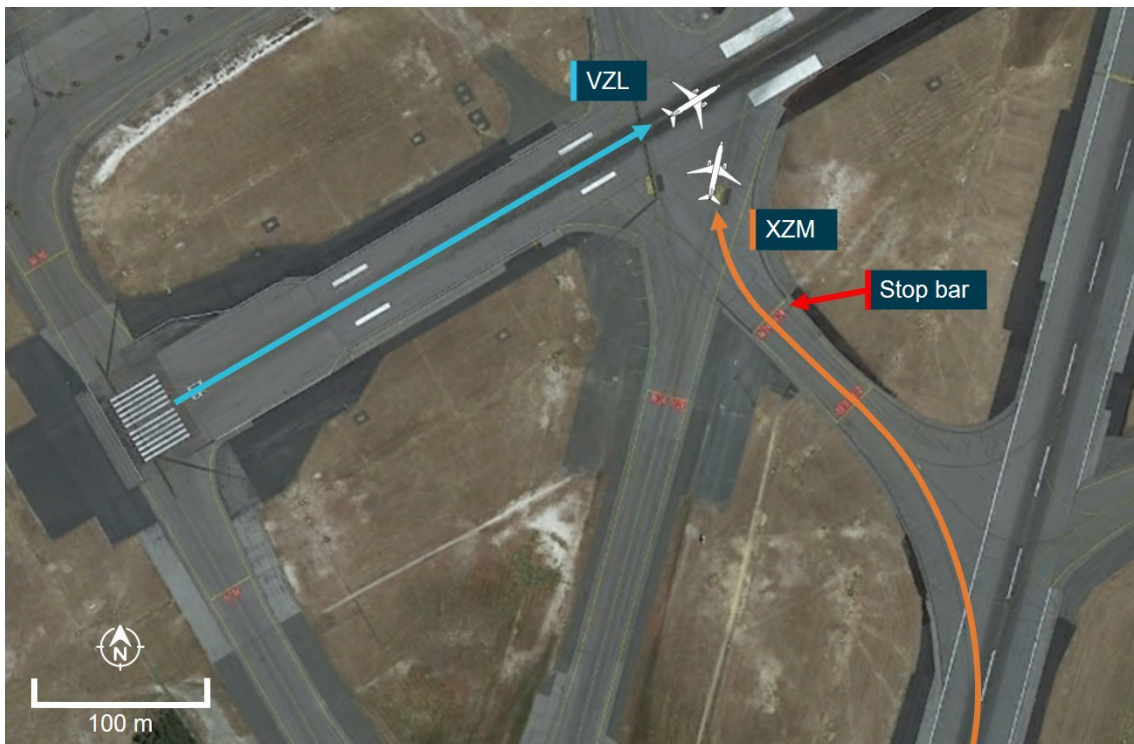
**Figure 1: Overview of the runway incursion**

VH-XZM's incursion into the flight strip of runway 06 resulted in a rejected take-off of another Qantas Boeing 737 aircraft (VH-VZL), which was taking off from runway 06. VH-VZL's wingtip passed about 15 m from the nose of VH-XZM at low speed before stopping.

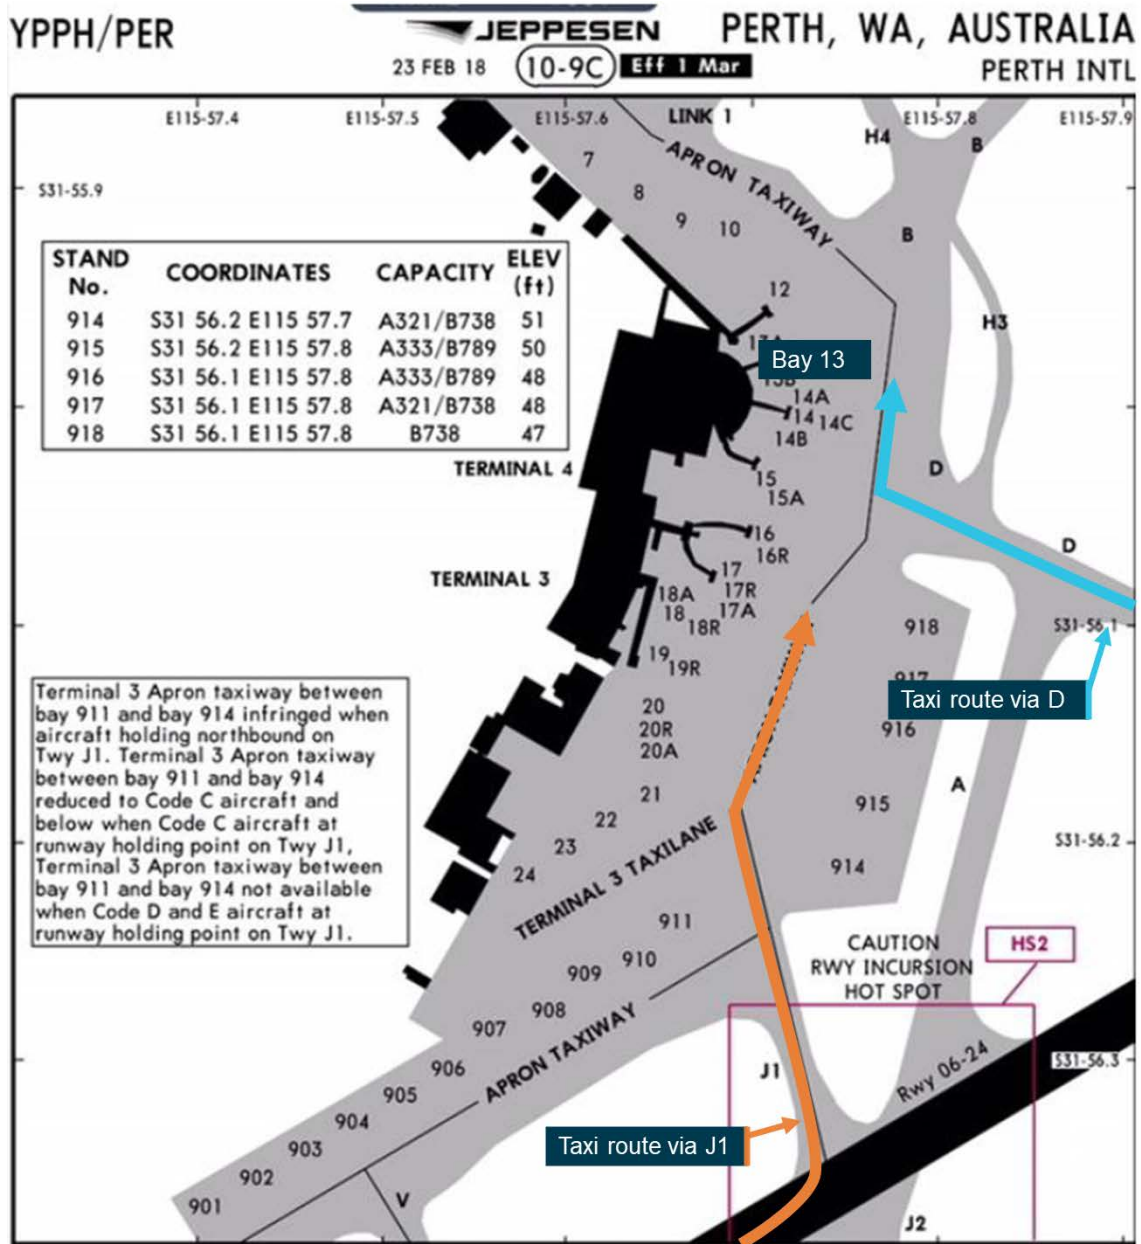
Figure 3: Perth apron chart showing captain’s mental model of taxi routes to bay 13

The captain of VH-XZM developed an incorrect mental model of the exit taxiways off runway 03, believing the aircraft would not have to cross runway 06 after exiting onto either of the potential taxiways (J2 or D). Due to this incorrect mental model, and a combination of workload and distractions at key times, the flight crew did not detect the runway crossing issue until their aircraft had almost reached the edge of runway 06.

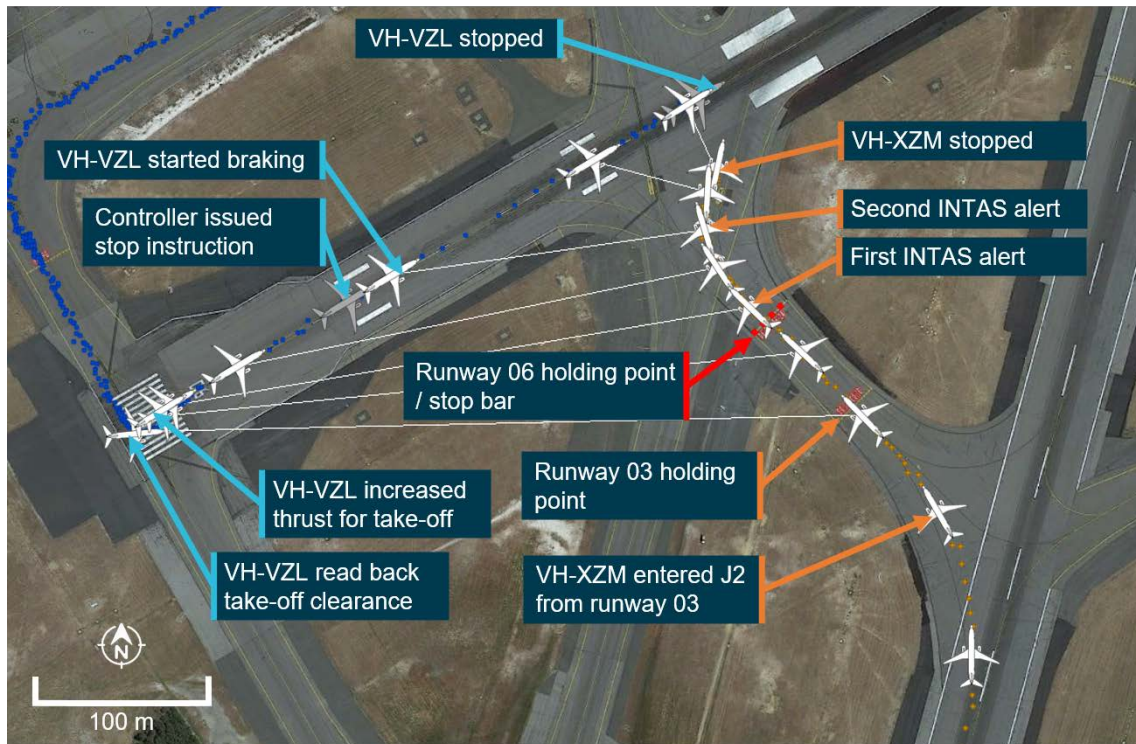
Figure 4: Overview of the runway incursion

At 1441:55, VH-XZM passed over the holding point for runway 03 at a groundspeed of about 22 kt. At about this time, the FO assessed that the captain was still slowing the aircraft at a rate to stop at the runway 06 holding point; the FO was aware that they needed an ATC clearance to cross runway 06 and assumed that the captain would stop.

At 1442:01, the nose of VH-XZM passed the runway 06 holding point (with an illuminated stop bar) at a groundspeed of 17 kt. At 1442:04, in the tower, the integrated tower automation suite (INTAS) made the first of two aural and text alerts on the ADC's workstation. The aural alert comprised a synthetic voice stating 'warning runway zero six stop bar violation'. The alert was

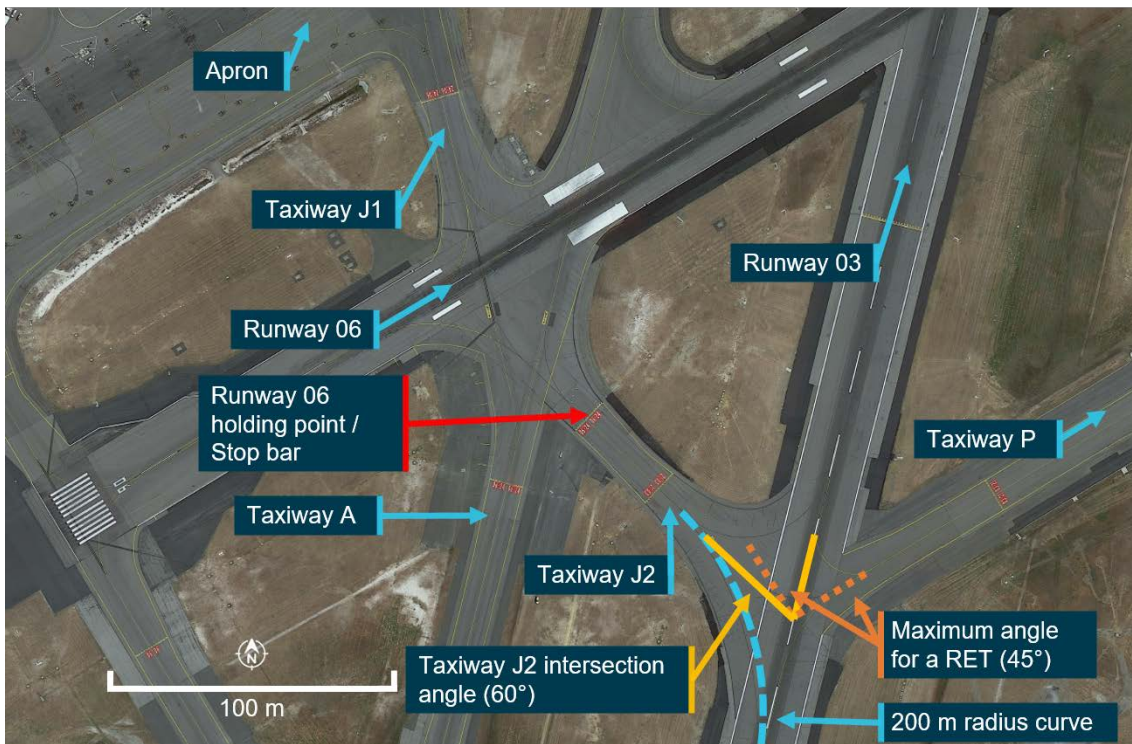
**Figure 6: Taxiway J2 in relation to runways and other taxiways**

Taxiway J2 intersected runway 03 at a 60° angle. The straight distance from the edge of runway 03 to the runway 06 holding point was approximately 176 m, and the distance from the runway 03 holding point and the runway 06 holding point was about 70 m. The distance from the runway 06 holding point to the edge of runway 06 was about 102 m.

Concurrently with the June 2018 TLI, Airservices Australia advocated through the local runway safety team (LRST) for the re-modelling of taxiway J2 to provide a 90° exit from runway 03 in order to mitigate the infrastructure hazard associated with a high speed exit leading directly to a second runway. Perth Airport subsequently advised Airservices Australia, through the LRST, that taxiway J2 would be temporarily closed by NOTAM pending an assessment of mitigation options. Perth Airport later determined that taxiway J2 would be closed permanently and a NOTAM was issued to that effect (see safety action AO-2018-032-NSA-052). Pending Perth Airport's decision to close taxiway J2, the Airservices Australia TLI remained in effect to prevent aircraft exposure to the infrastructure hazard.

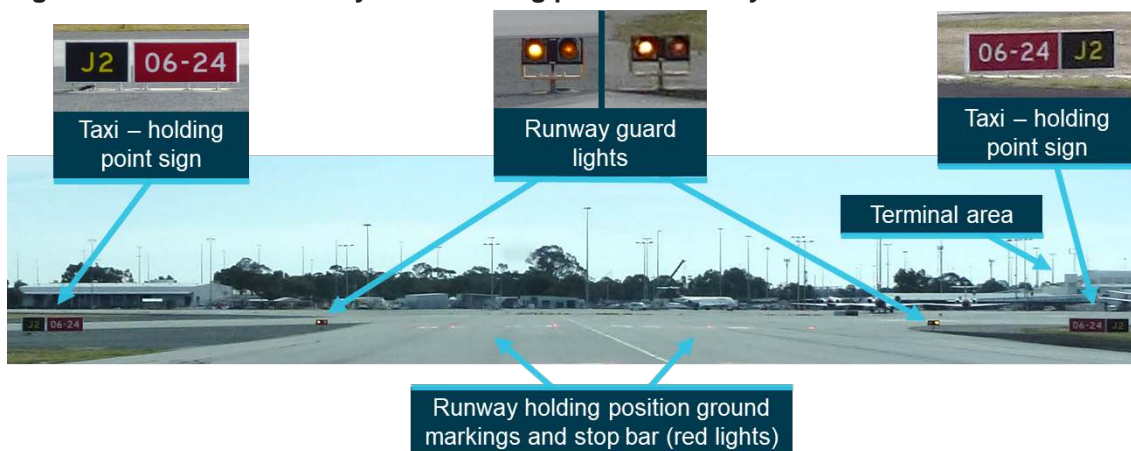
**Figure 7: View of the runway 06/24 holding point on taxiway J2**

For flight crew vacating runway 03 on taxiway J2, the holding point for runway 06/24 was marked with red and white ground markings identifying the runway ahead,<sup>12</sup> taxi-holding point signs and location signs. The runway holding point was also equipped with unidirectional<sup>13</sup> runway guard lights, which flashed continuously, and a stop bar (Figure 7).

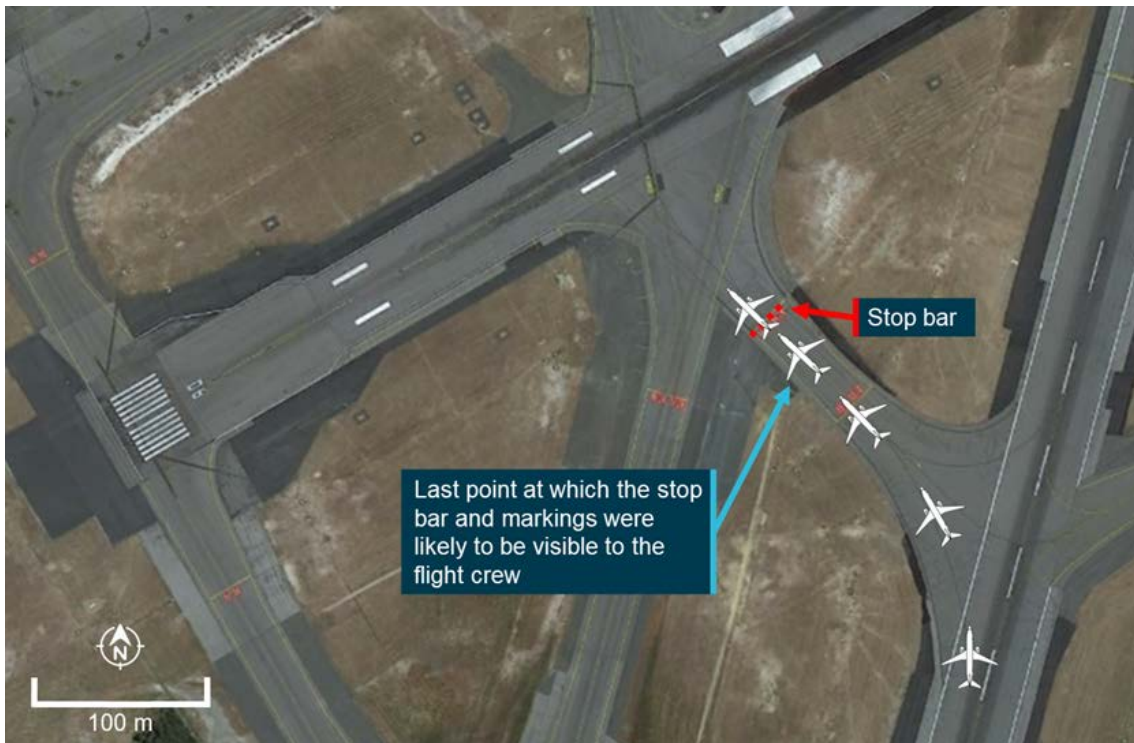
**Figure 9: Last point when stop bar was visible from flight deck of VH-XZM**

When seated in the normal position, the flight crew of a Boeing 737-800 cannot see the ground that is less than 11.5 m ahead of the aircraft's nose (due to the obstruction of the flight deck glareshield). Consequently, the VH-XZM flight crew's last opportunity to see the stop bar on taxiway J2 was at 1442:00, about 5 seconds after completing the turn onto the taxiway and 1 second prior to crossing the stop bar (Figure 9).

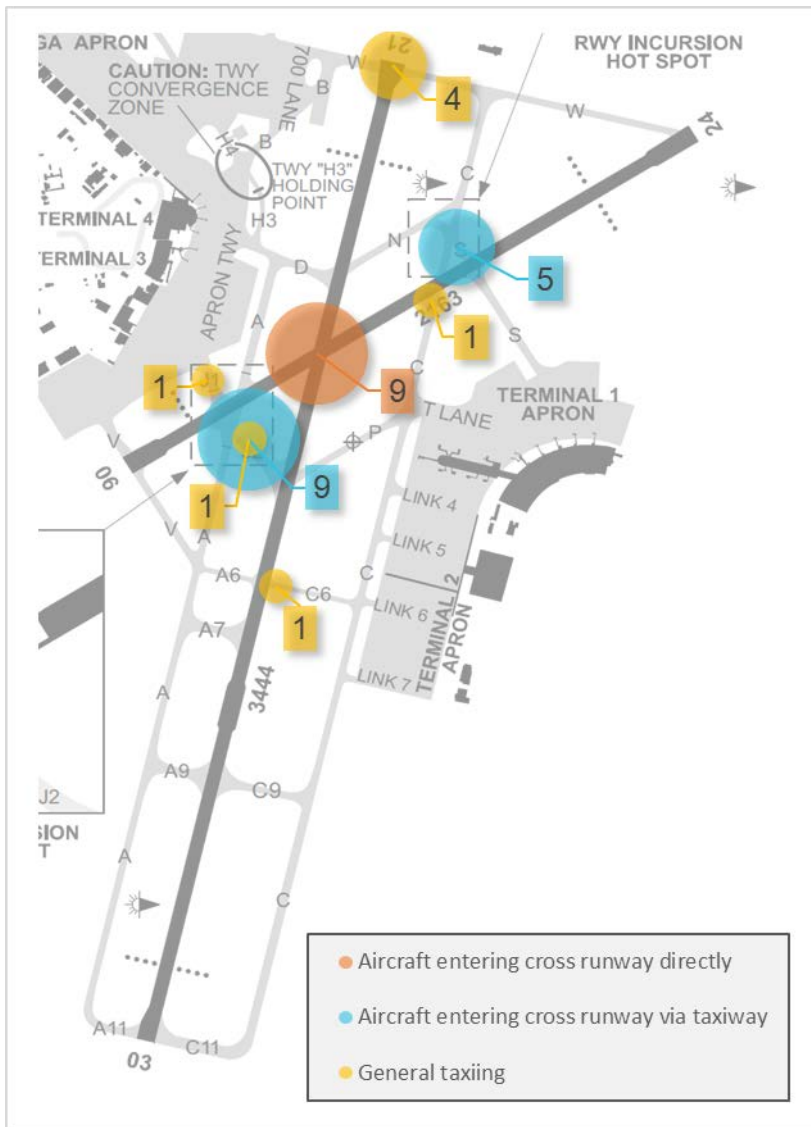
**Figure 10: Selected types of runway incursion at Perth in a 5-year period**

Figure 10 shows the approximate location of incursions in these three groups, with most of the incursions on a cross runway via a taxiway happening near taxiway J2.
