# Uncommanded engine shutdown involving Boeing 787-9, 9V-OJE

46 km north of Perth Airport, Western Australia, on 11 October 2018

**ATSB Transport Safety Report**

AO-2018-069

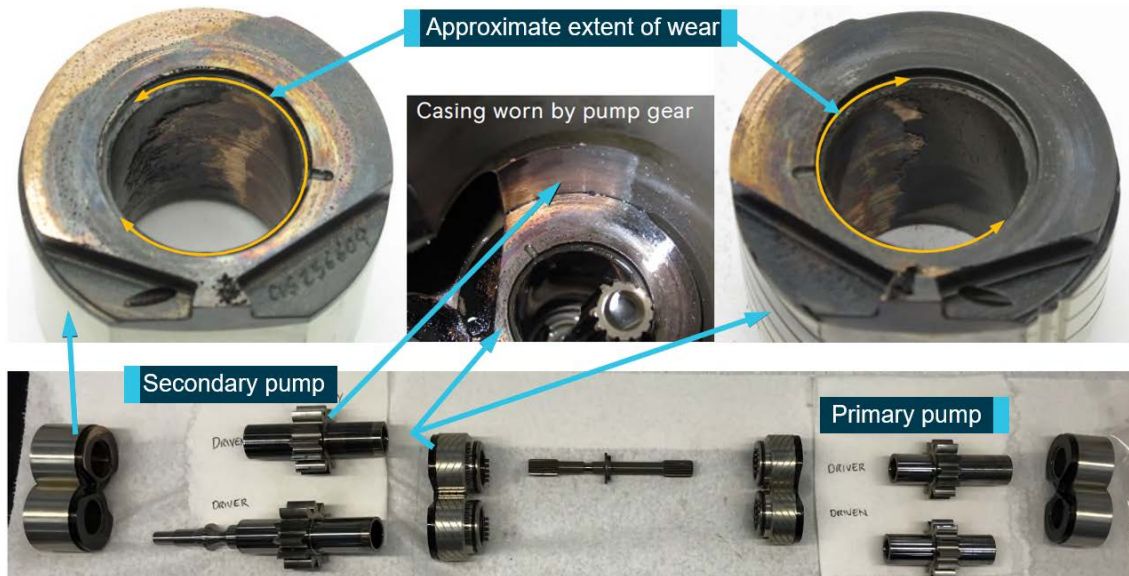
**Figure 2: Worn journal bearings and casing for the secondary HP pump driven gear**

Analysis of the metallic debris revealed that it consisted of material from the fuel pump bearings and the casing. All three stages of the pump (the LP pump, and the two HP pumps) were disassembled and examined by Rolls-Royce in the presence of the United Kingdom Air Accidents Investigation Branch.

The examination found that the debris originated from the secondary HP pump. The bearings for the secondary HP pump driven gear were heavily worn, with evidence of scoring and missing material (Figure 2). Rolls-Royce found that the casing for the driven gear had more wear than would be expected during normal operation, likely due to shaft movement resulting from the damaged journal bearings. No damage was found on other bearings within the secondary HP pump or the other two fuel pumps.

As part of its investigation into the engine failure, Rolls-Royce instructed Scoot to remove the engine's fuel pump in the event of debris being found in the ports during removal of a hydro-mechanical unit. In February 2020, the Fault Isolation Manual was updated to instruct all operators to remove the fuel pump and hydro-mechanical unit in the event of a maintenance message regarding the fuel metering valve not being in the commanded position.
