# Uncontained battery failure involving Sydney Light Rail Vehicle 053

Randwick LRV Depot, New South Wales, on 3 April 2020

**ATSB Transport Safety Report**  
Rail Occurrence Investigation (Defined)  
RO-2020-005  
Final – 3 December 2020

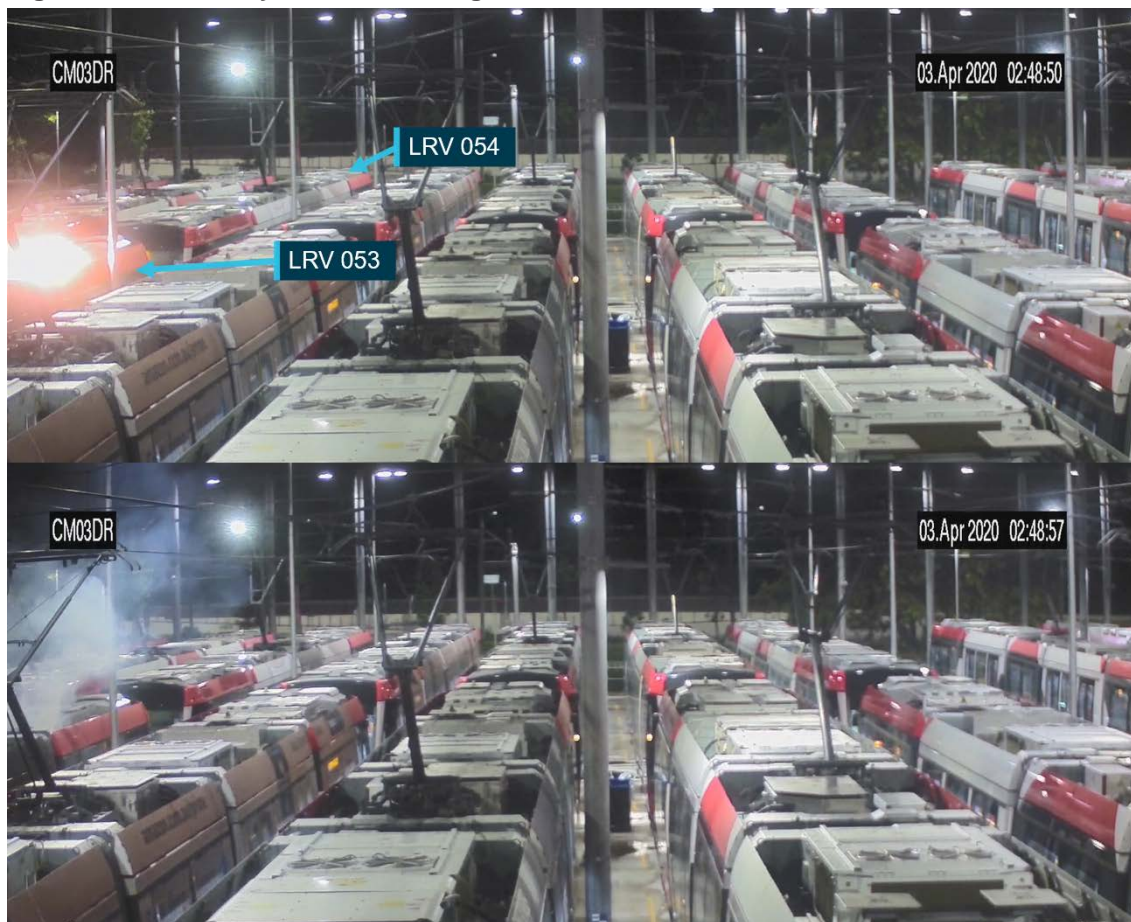
**Figure 1: Randwick yard CCTV footage**

Closed-circuit television (CCTV) cameras in the stabling yard showed a flash coming from the battery enclosure of LRV 053 as the enclosure cover was ejected from the LRV (Figure 1). The cover struck the overhead contact wire, then struck LRV 005 and 058 before falling between the two vehicles (Figure 2). The cover was airborne for approximately 4.12 seconds<sup>2</sup> from being ejected to striking LRV 005. There was substantial damage to the battery enclosure on LRV 053 and minor damage to LRV 005 and 058. There were no reported injuries.

*The figure shows stills taken from the CCTV at 0248:50 with a flash visible and at 0248:57 showing smoke or vapour emanating from the battery enclosure of LRV 053. The ejected panel struck the overhead contact wire and landed to the left of LRV 053 out of view of camera CM03DR.*

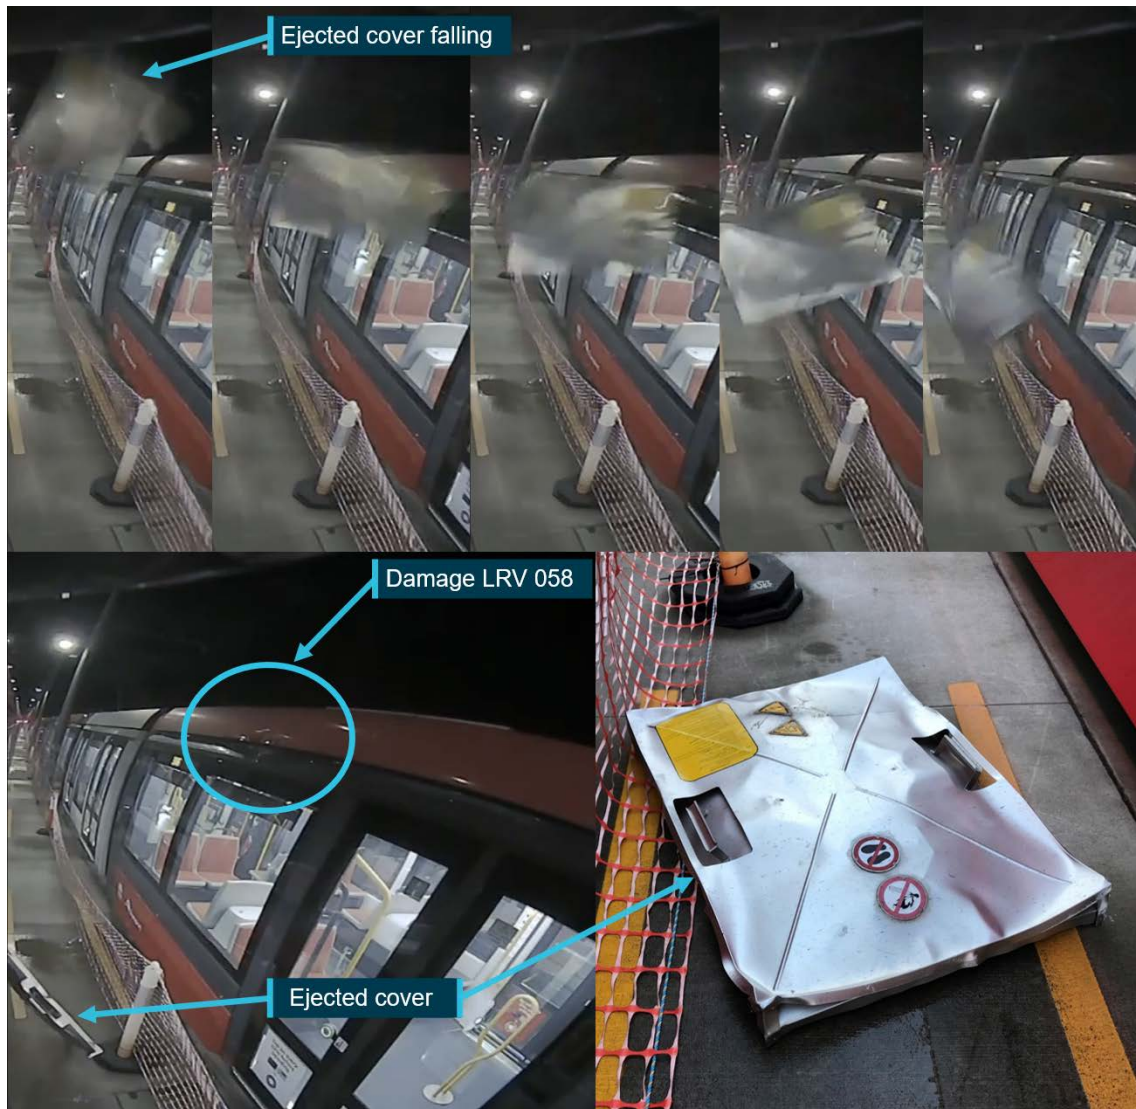
**Figure 2: Battery enclosure cover landing and on the ground**

*The figure shows stills from the external CCTV from LRV 005. The ejected cover from LRV 053 struck LRV 005 and 058 and fell between the two vehicles.*

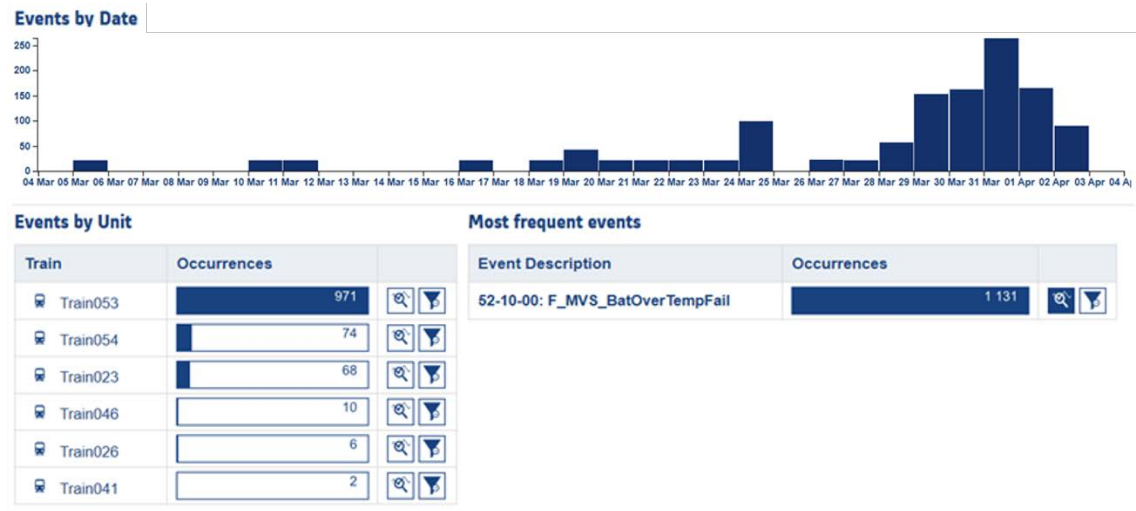
Figure 7: Battery temperature faults

The batteries on LRV 053 recorded frequent over temperature alerts in the 30 days leading up to the occurrence. During this time the batteries were overcharging. Most of the electrolyte probably evolved into hydrogen and oxygen due to overcharging and vented to atmosphere via the filler plugs.

The over temperature faults, charging voltage and current were all recorded, however, there were no systems in place to monitor fault conditions and alerts. Consequently, the ability to identify and monitor potential defects that might escalate and contribute to accidents was limited.

Alstom made changes to the management of train fault data to generate automatic alerts for battery over temperature faults. A new fault code was created within the train control monitoring system to monitor the battery charging temperature and alert the driver if any of the defined thresholds were exceeded.

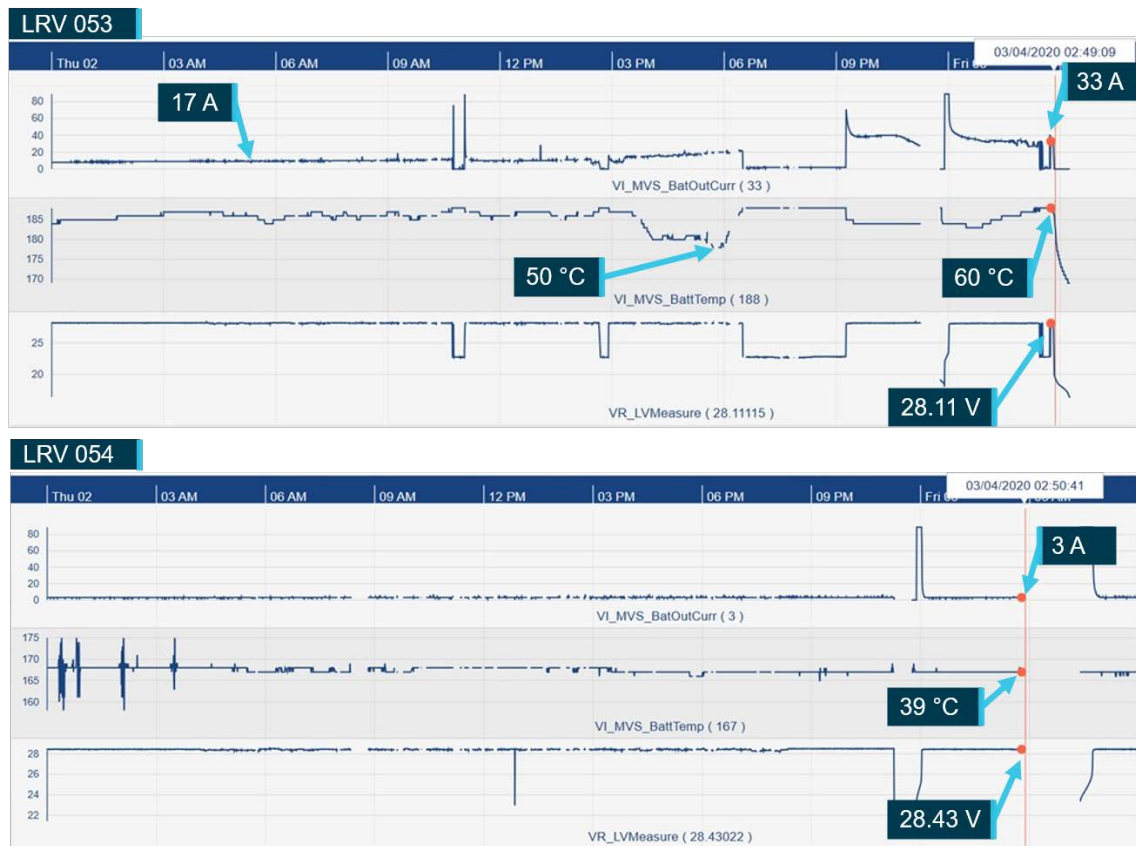
**Figure 8: LRV 053/054 battery charging data from 2 and 3 April 2020**

The batteries on both LRV 053/054 were overcharging in the lead up to the occurrence, while in service and within the stabling yard. The overcharging likely increased the production of hydrogen and oxygen within the battery cells and depleted the electrolyte. The high current recorded on LRV 053 was very likely a result of the battery condition and effects of overcharging.

The image shows the graphical representation of the recorded battery current, temperature and voltage measurements for LRV 053/054 in the 24 hours leading up to the occurrence. Battery temperature was recorded as VI\_MVS\_BattTemp. The value shown for LRV 053 varied between 178 and 188 on 2 April 2020. The actual temperature is derived by subtracting 128 from the values based on the LRV software requirements.

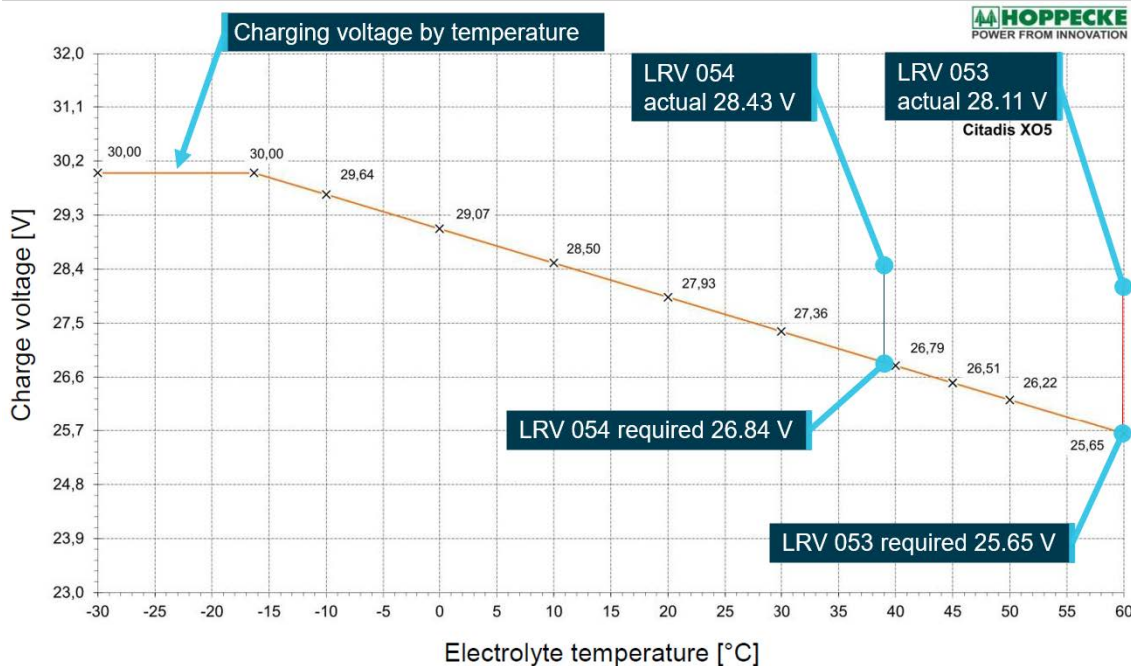
Figure 9: LRV 053/054 charging voltage vs electrolyte temperature

The required temperature compensations is shown in the orange with the corresponding voltage shown above the line. The actual recorded voltage and temperature from LRV 053/054 are shown and compared with the required temperature compensated voltage. Source: Hoppecke (2019). D62109-300-en08\_Manual\_Alstom\_X05\_NAT and Alstom, modified and annotated by OTSI

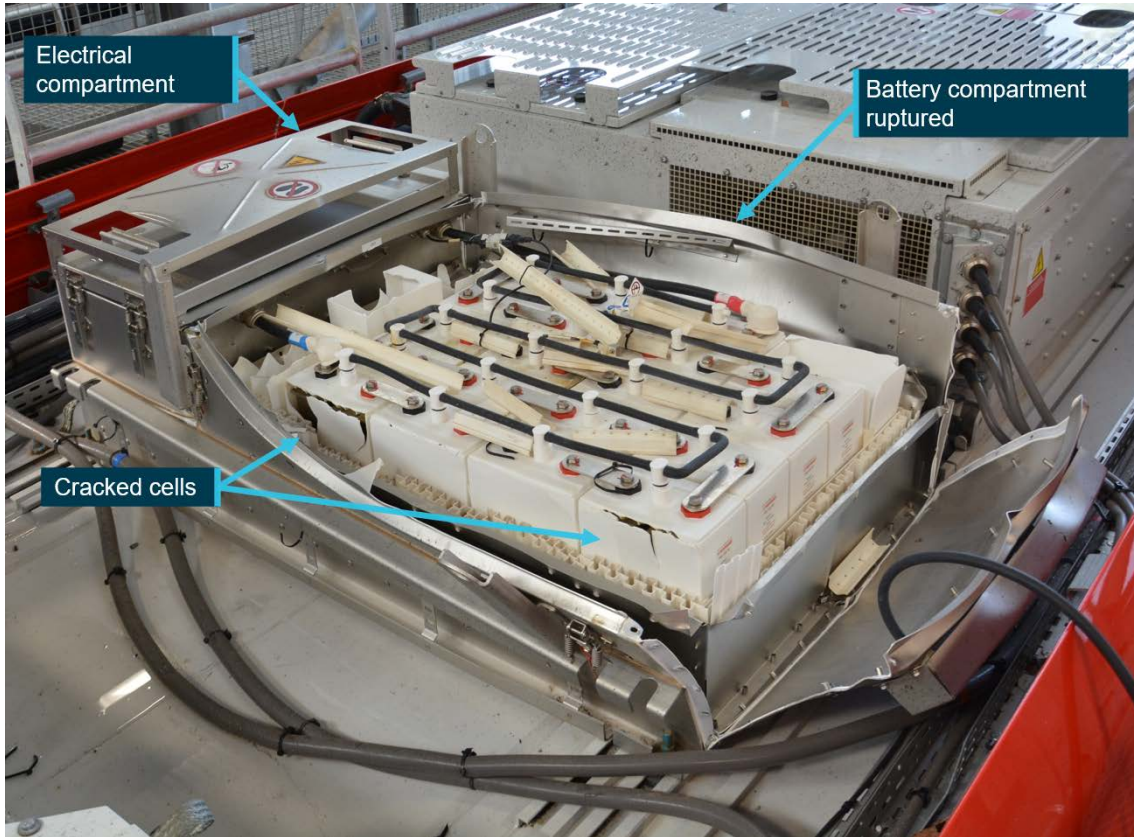
**Figure 10: LRV 053 ruptured battery compartment**

The initial inspection conducted on 3 April 2020 identified the battery compartment had ruptured and there was evidence of heat (browning) between a number of cells. Most the battery filler plugs were lifted and a number of battery cell casing had cracked outwards (Figure 10 and Figure 11). The vents on the ejected cover appeared to be unobstructed.

The battery compartment ruptured due to pressure caused by the deflagration of flammable gases containing hydrogen. The flammable gases were probably released into the enclosure by a combination of the melted battery cells and an internal deflagration within the battery cells.

The battery enclosure on LRV 053 ruptured as a result of forces created by internal pressure when a flammable concentration above the LFL was ignited. The cover and debris were ejected

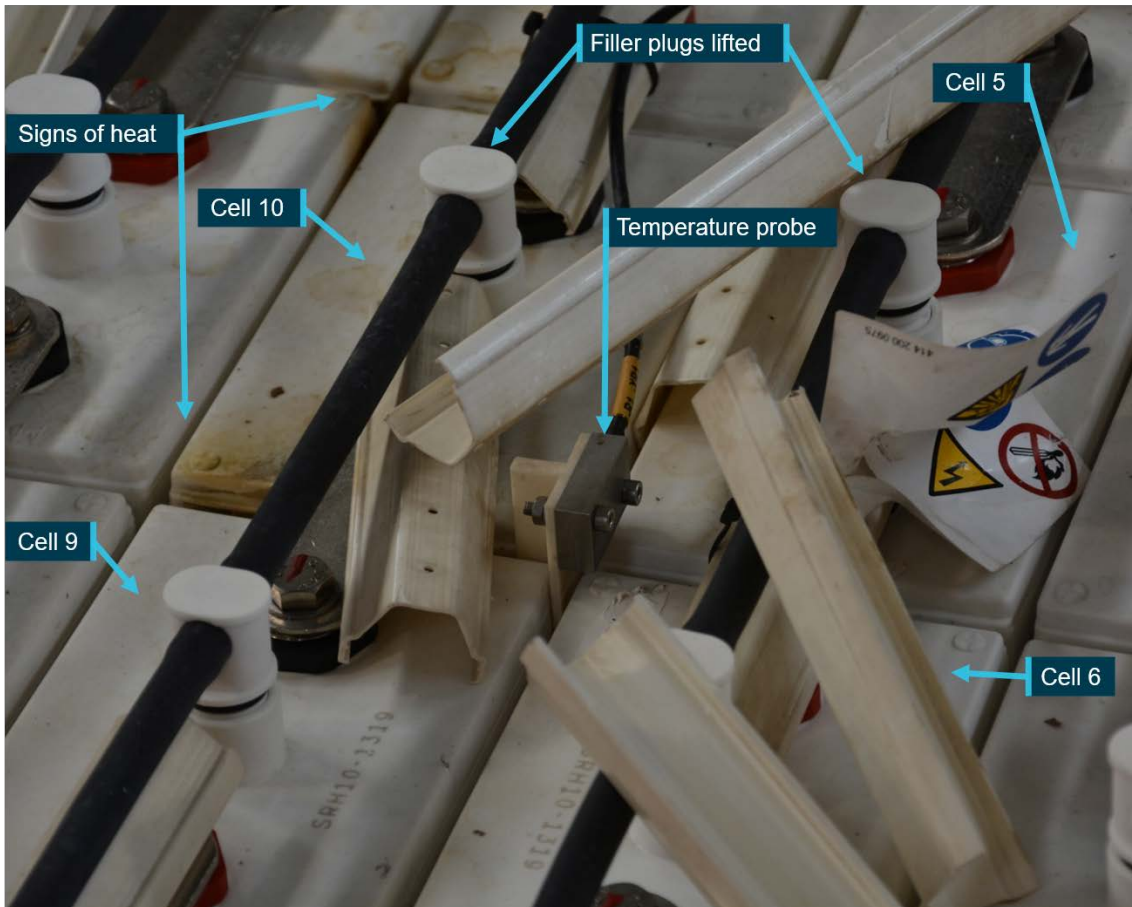
Figure 11: LRV 053 battery cells and temperature probe

The temperature probe was mounted to a post and positioned above batteries 5, 6, 9 and 10. The probe on LRV 053 was found to be sitting up and was not in contact with the top of the battery cells (Figure 11). This was probably the result of the forces created during the occurrence as the temperature probe post allowed the probe to sit on top of the batteries post incident.

The image shows a close up view of signs of heat between battery cells 9 and 10 and between cells 10, 11, 12 and 13. The temperature probe can also be seen to be sitting up and not in direct contact with the top of the battery cells.  
Source: OTSI

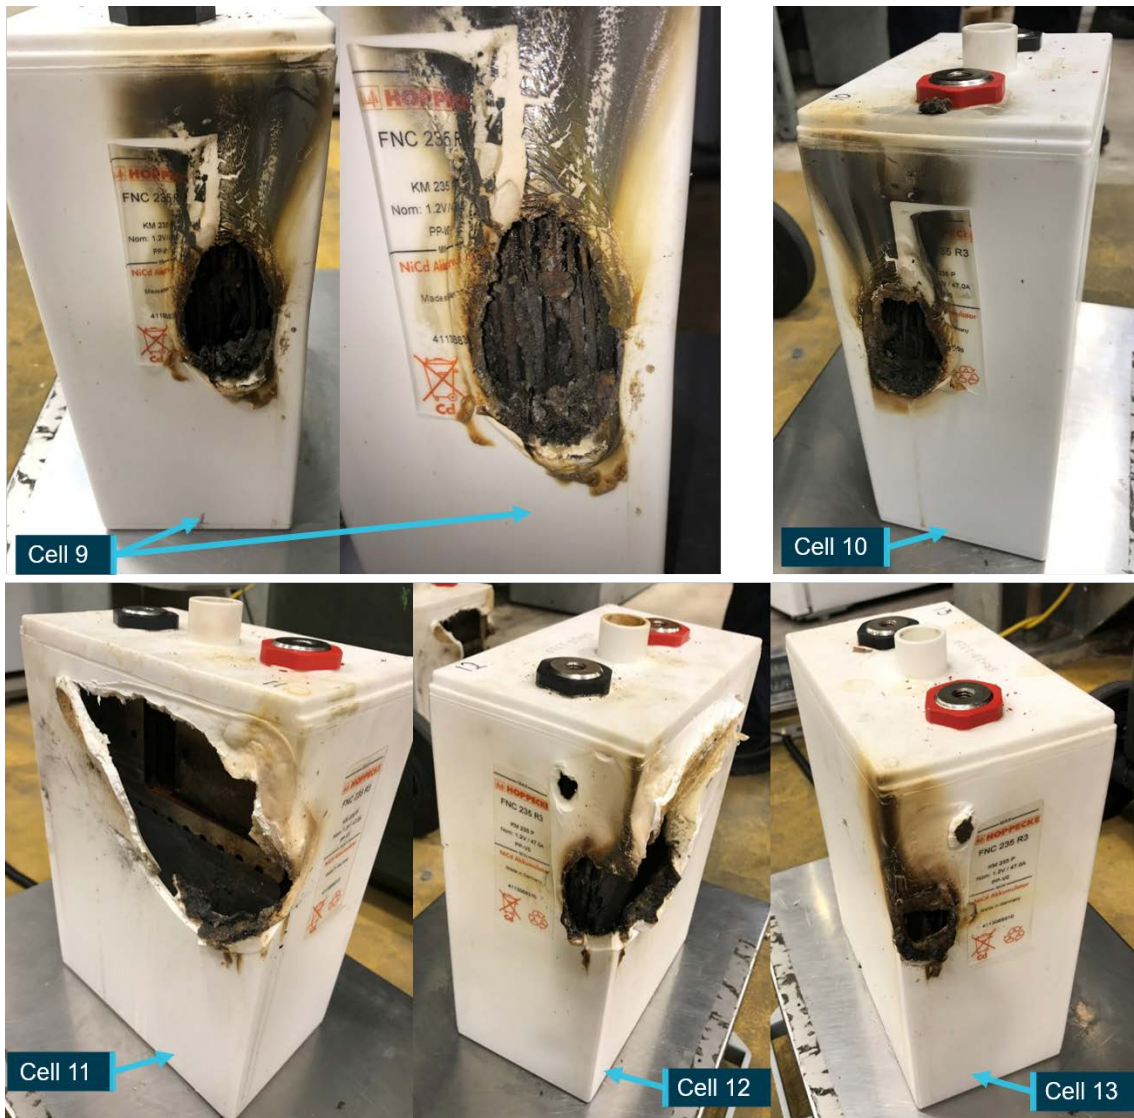
Figure 12: Battery cells 9 to 13

All cells except cell 15 showed signs of damage or the filler plug was lifted. Battery cells 9, 10, 11, 12 and 13 all showed signs of heat with the cell casings melted (Figure 12). Cell 12 had also short circuited. The damage to the cell casings indicates that the actual temperature far exceeded the recorded temperature of 60 °C as the cell casing begin to melt at 120 °C.

The image shows the damage to the cell casings for batteries 9 to 13. Cell casings for batteries 11 and 12 were fused and required mechanical separation to remove from the battery compartment.  
Source: OTSI
