Derailment of freight train 6MP4

near Glenalta, South Australia on 21 April 2018

ATSB Transport Safety Report

RO-2018-009

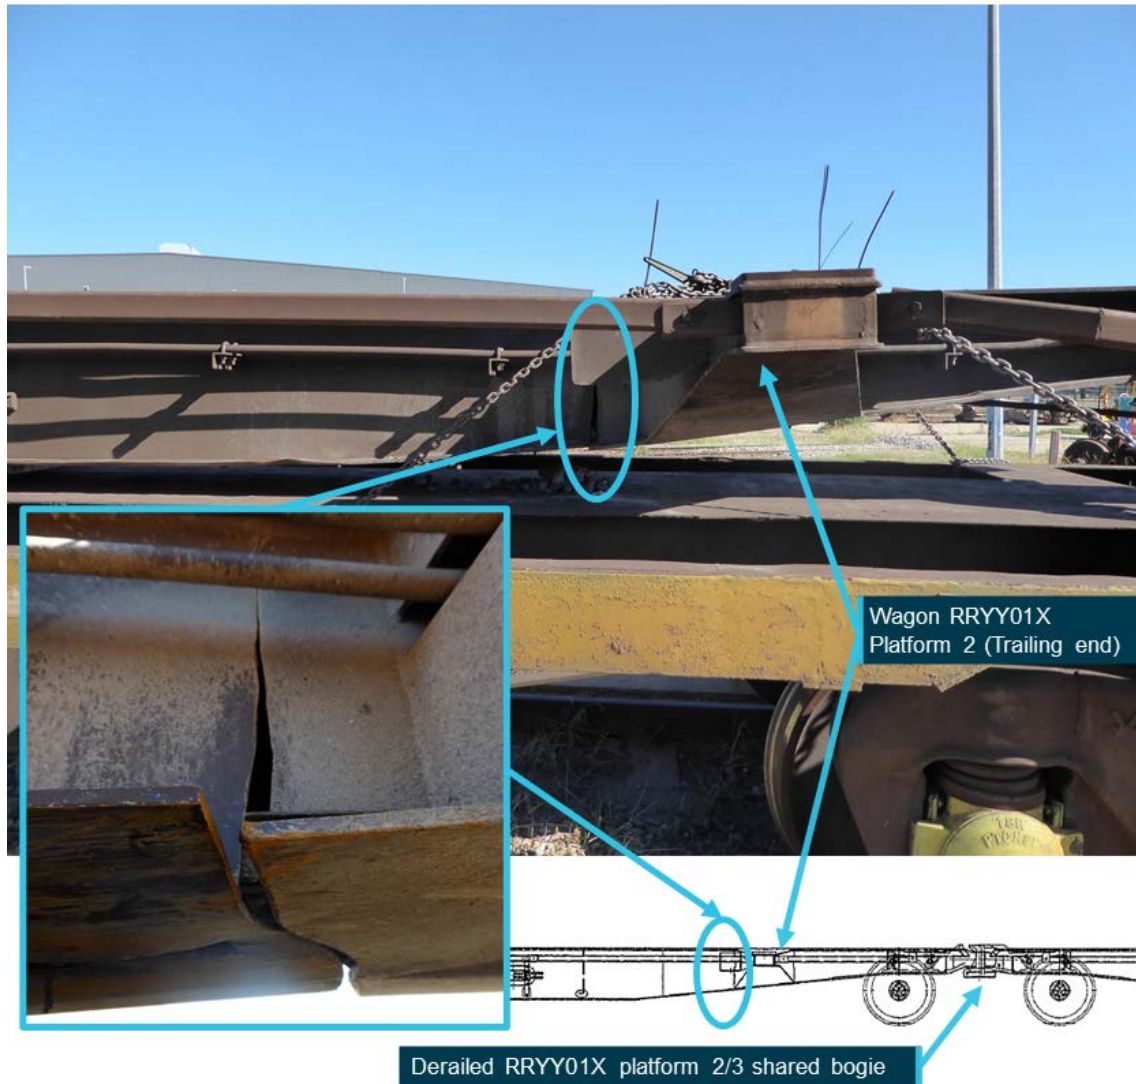
Figure 2: Structural failure in underframe of platform 2 of RRY01X

At some point during the train's descent, the underframe of wagon RRY01X's platform 2 experienced a structural failure, which led to the deck of platform 2 dropping or sagging (Figure 2). This resulted in the deck angle of platform 2 rising towards the coupling to platform 3. The compressive forces acting on the angled deck of the empty platform 2 reduced the weight acting on the trailing axle from the bogie/wheels shared between platform 2 and 3.

Image shows the structural failure in the underframe of wagon RRY01X (platform 2) and its respective location to the derailed shared bogie between platforms 2 and 3.

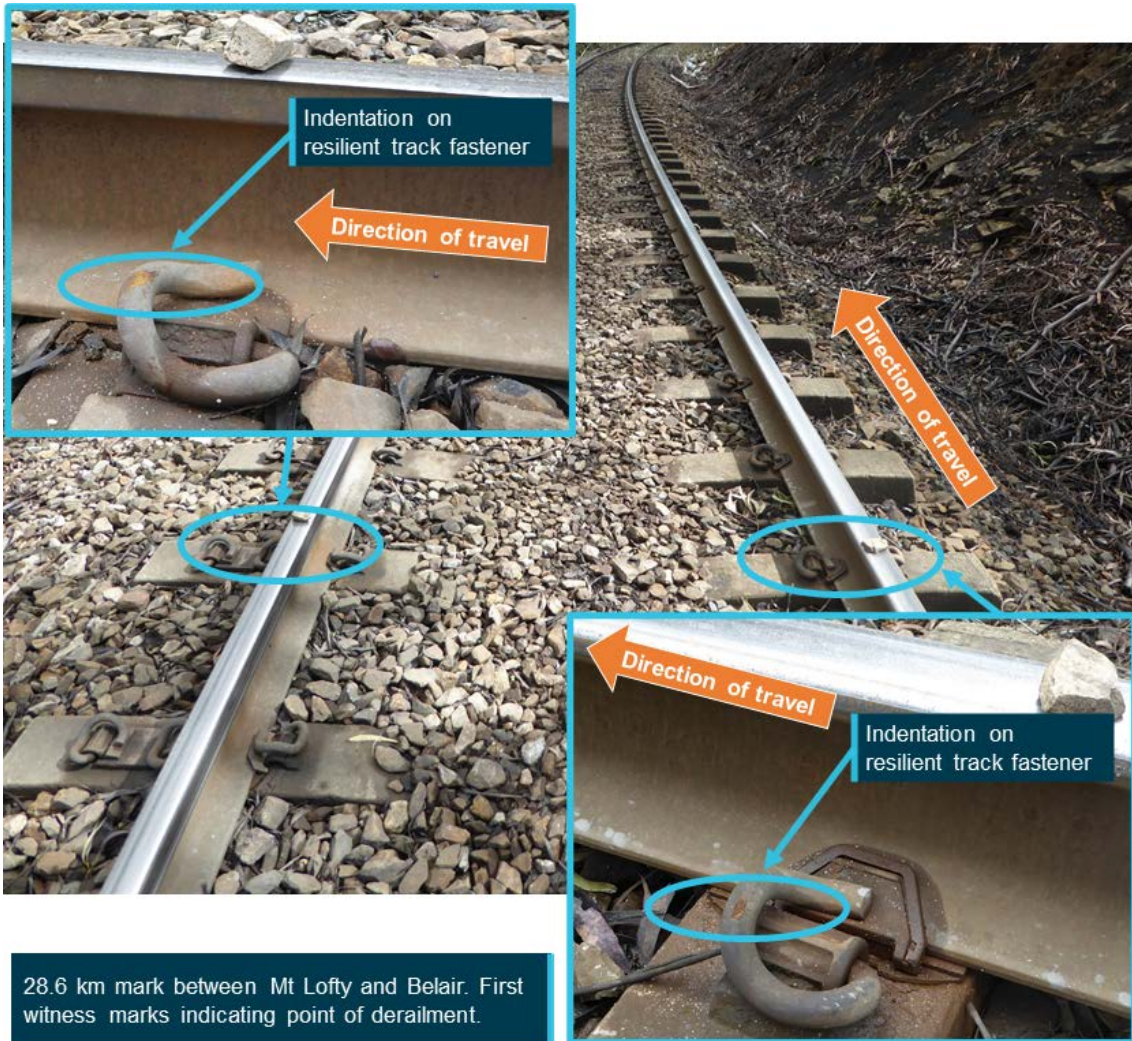
Figure 3: Initial evidence of derailment between Mount Lofty and Belair

The first evidence of derailment was subsequently observed at the 28.6 km mark (about 2.4 km past Mount Lofty station). Wheel witness marks were identified on the exposed upper surface of the resilient track fastenings through a right curve (Figure 3).

Image shows the location of the initial wheel witness marks on the upper surface of the resilient track fastenings at the 28.6 km mark. Source: ATSB

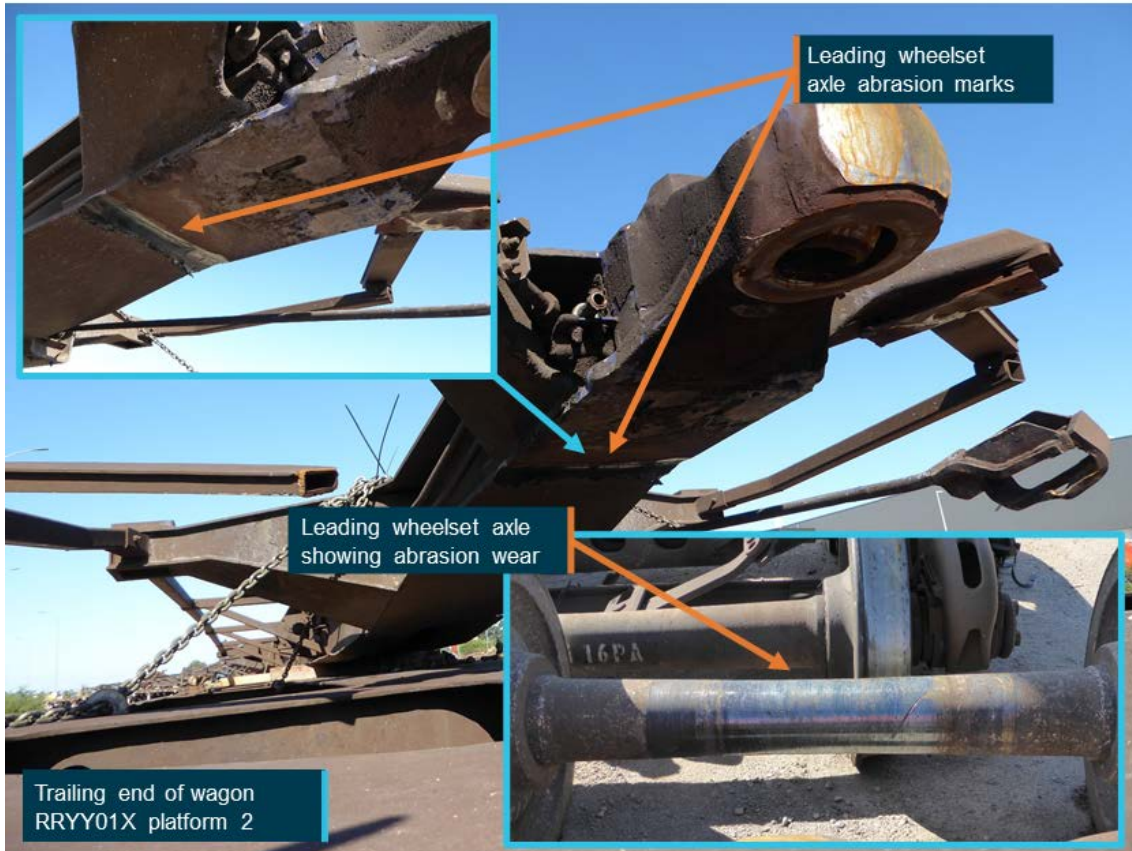
Figure 4: Contact abrasion damage to wheelset axle and platform 2 of 5-pack wagon RRY01X

The combination of a sagging deck and derailed wheels allowed the underframe to start rubbing on the leading axle of the bogie shared between platform 2 and 3 (Figure 4).

Image shows leading wheelset axle abrasion marks from the shared bogie between platform 2 and 3 of 5-pack wagon RRY01X.
Source: ATSB

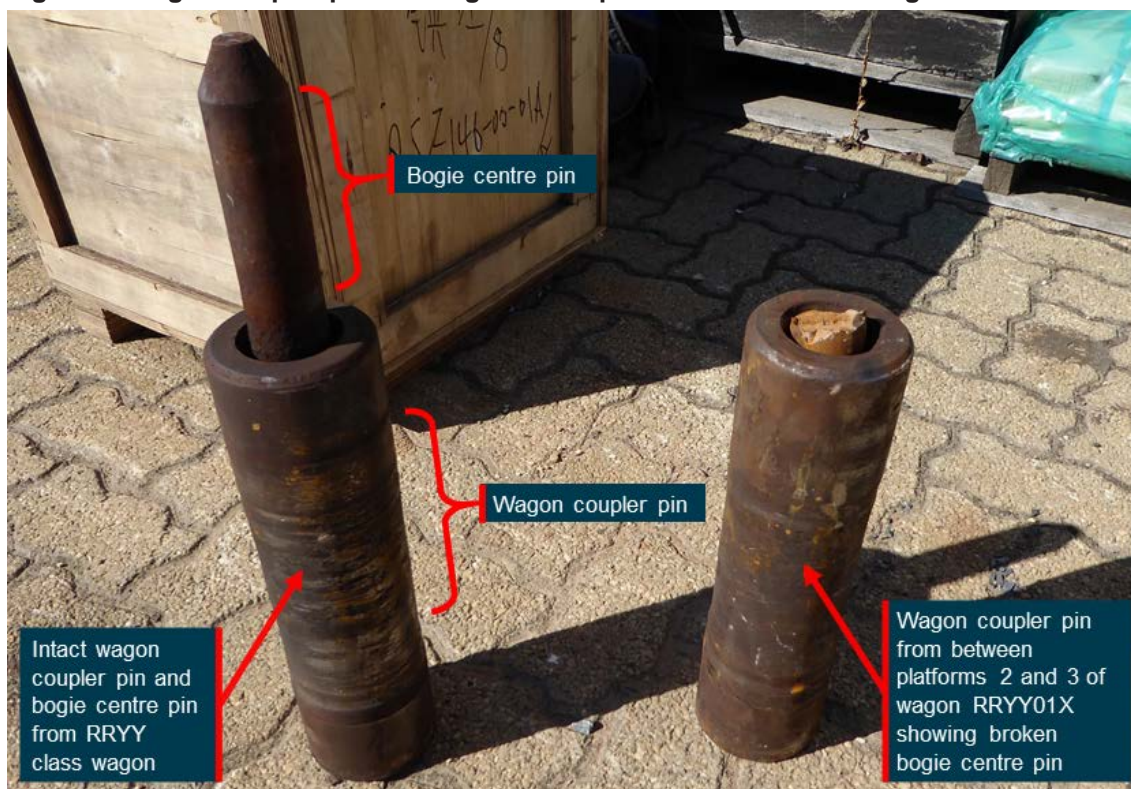
Figure 5: Wagon coupler-pin and bogie centre-pin from RRYY class wagon

The trailing axle continued in a derailed state for a further 1.58 km, making intermittent contact with the ground, track fastenings and sleepers. At about 0005, when passing the 27.02 km point, bogie components collided heavily with a concrete sleeper, dislodging the constant-contact side-bearer pads at this location and breaking the bogie centre-pin (Figure 5).⁵

Image shows an intact combined wagon coupler-pin and bogie centre-pin from a RRYY class wagon, alongside the wagon coupler-pin from wagon RRYY01X with missing bogie centre-pin.
 Source: ATSB

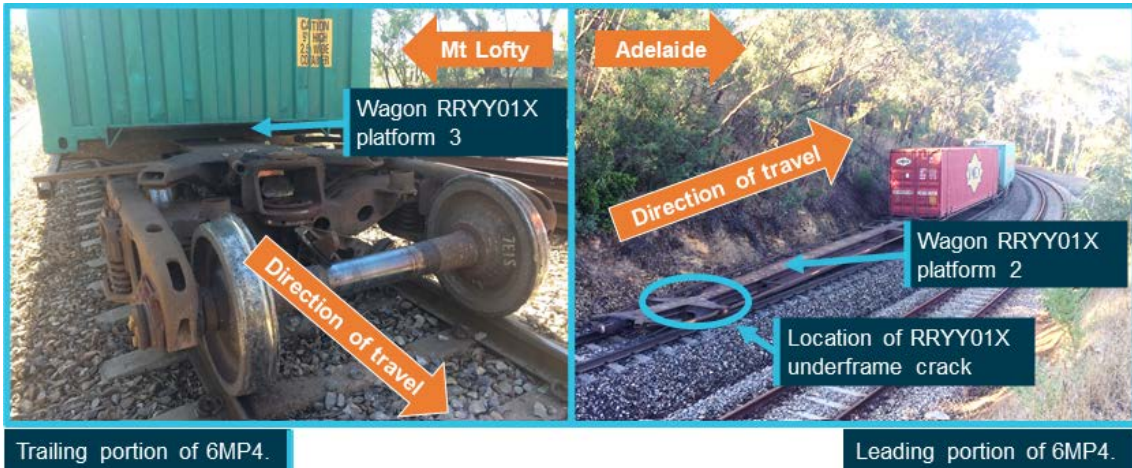
Figure 7: Platform 2 and 3 from 5-pack wagon RRY01X in their stopped locations

The previously derailed bogie was found lodged outside of its normal location under the leading end of RRY01X platform 3, and the trailing end of platform 2 was found on the ground. There was substantial damage to the bogie and two platforms from the 5-pack wagon RRY01X (Figure 7), plus minor damage to rail infrastructure (*Location and infrastructure*). There were no injuries.

Image shows the final position of the bogie involved in derailment with platform 2 and 3, after train 6MP4 came to a stop near Glenalta.
Source: Pacific National annotated by the ATSB

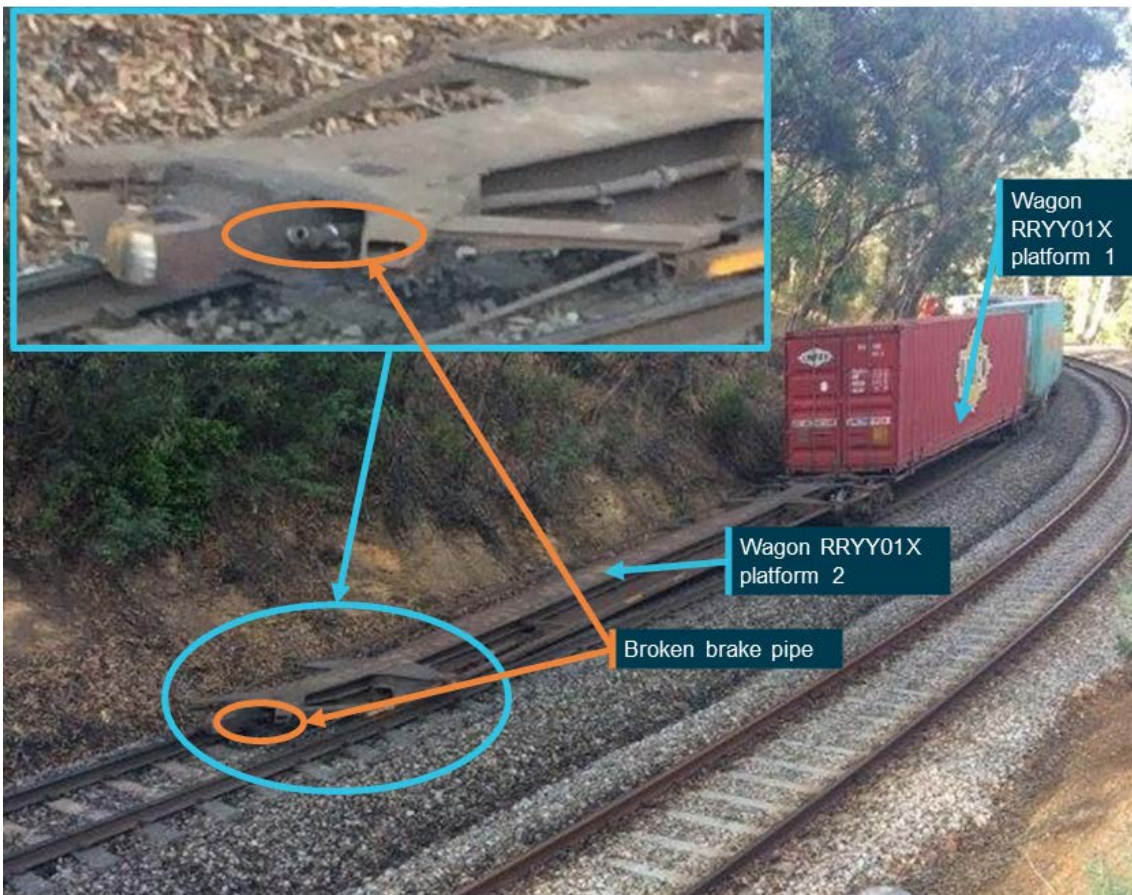
Figure 10: Broken train brake pipe in platform 2 of 5-pack wagon RRY01X

Following the accident, the train's brake pipe connections between platform 2 and 3 of RRY01X were examined. This examination confirmed that the brake pipe had been cleanly broken in the train separation sequence (Figure 10). The brake pipe was not crimped or partially restricted during the train separation, allowing for unrestricted exhausting of brake pipe air.

*Image shows the broken brake pipe on platform 2 of 5-pack wagon RRY01X.
Source: Pacific National and ARTC, annotated by the ATSB*

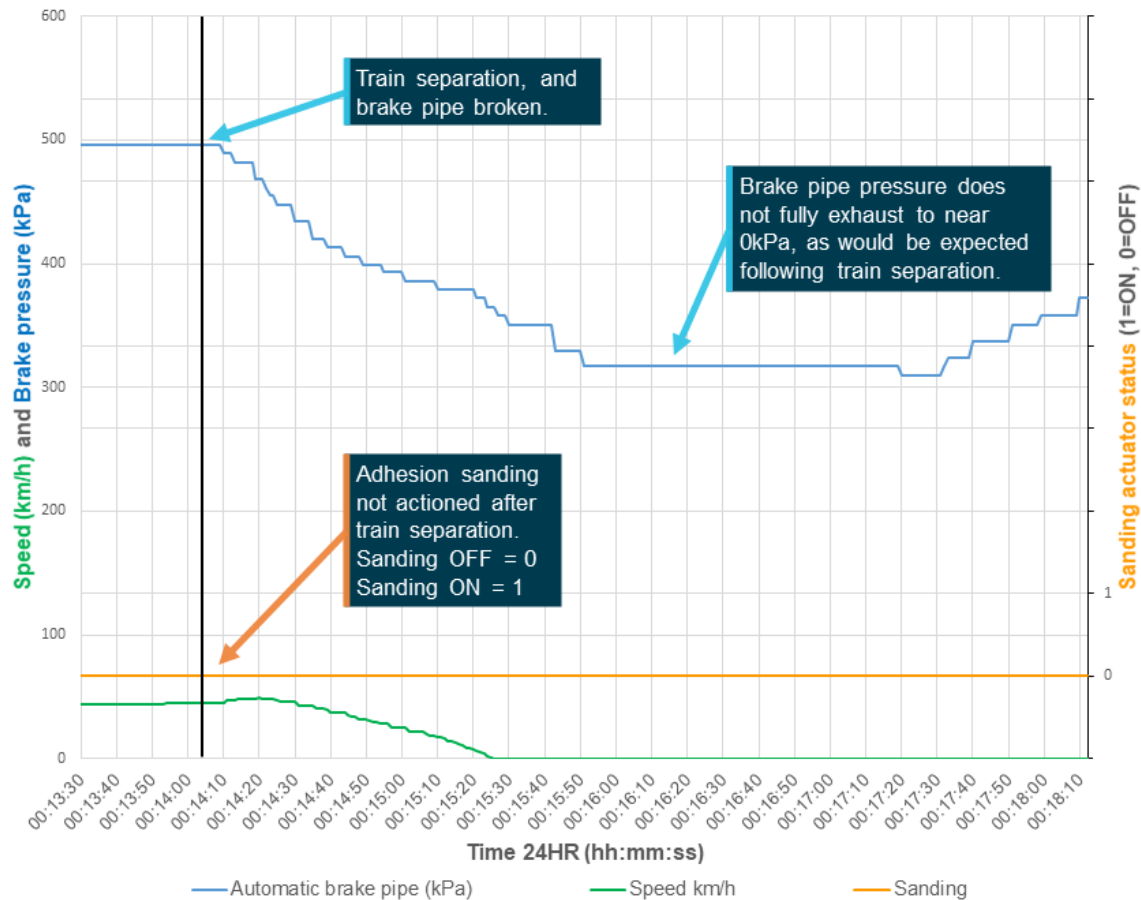
Figure 11: Graph derived from extract of locomotive NR62 event recorder data

- Emergency brake application would normally trigger adhesion sanding in NR class locomotives, but this was not evident after the train separation in this instance (Figure 11).
- Emergency brake application would normally trigger automatic application of a locomotive's brakes. The locomotive brakes did not apply, though in this instance the driver reported bailing or holding off the locomotives' brake after they observed the high brake pipe flow rate.
- Emergency brake application would normally trigger complete evacuation of brake pipe air pressure. In this instance, brake pipe pressure appeared to remain just above 300 kPa (Figure 11).

Image shows recorded locomotive NR62 data of the automatic brake pipe pressure, train speed, and sanding status from the front portion of the separated train. The NR62 recordings from the derailment sequence is not displayed in this graph. Source: Data source Pacific National, graphed by the ATSB

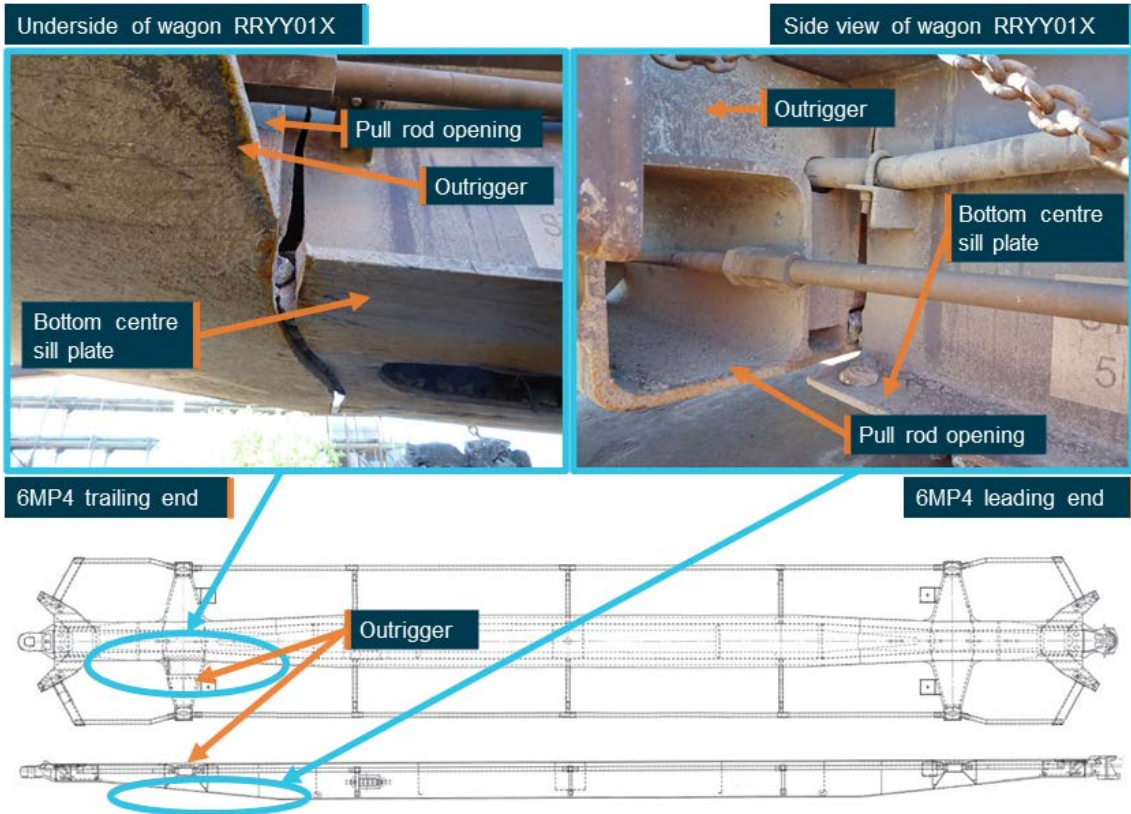
Figure 14: Underframe cracks in platform 2 of 5-pack wagon RRY01X

Platform 2 of wagon RRYY01X was recovered to the Adelaide Freight Terminal, allowing for a more detailed examination of the underframe failure. The failure originated from a crack between the join of the bottom centre sill plate and pull rod boxed opening in the wagon’s container loading outrigger (Figure 14).

*Image shows underframe cracks and their location in platform 2 of 5-pack wagon RRY01X. The underframe cracks and derailed bogie were located at the trailing end of platform 2 of 5-pack wagon RRY01X.
Source: Wagon drawing - Pacific National annotated by the ATSB; photos – ATSB*

After the accident, Pacific National published and distributed a Rolling Stock Notice¹⁵ to its terminal managers, maintenance planners, maintainers, train examiners and engineering representatives. The notice identified the location where the structural cracks within wagon RRY01X had commenced and focussed post-accident inspections onto these specific stress areas of Pacific National's RRY01X class wagon fleet.

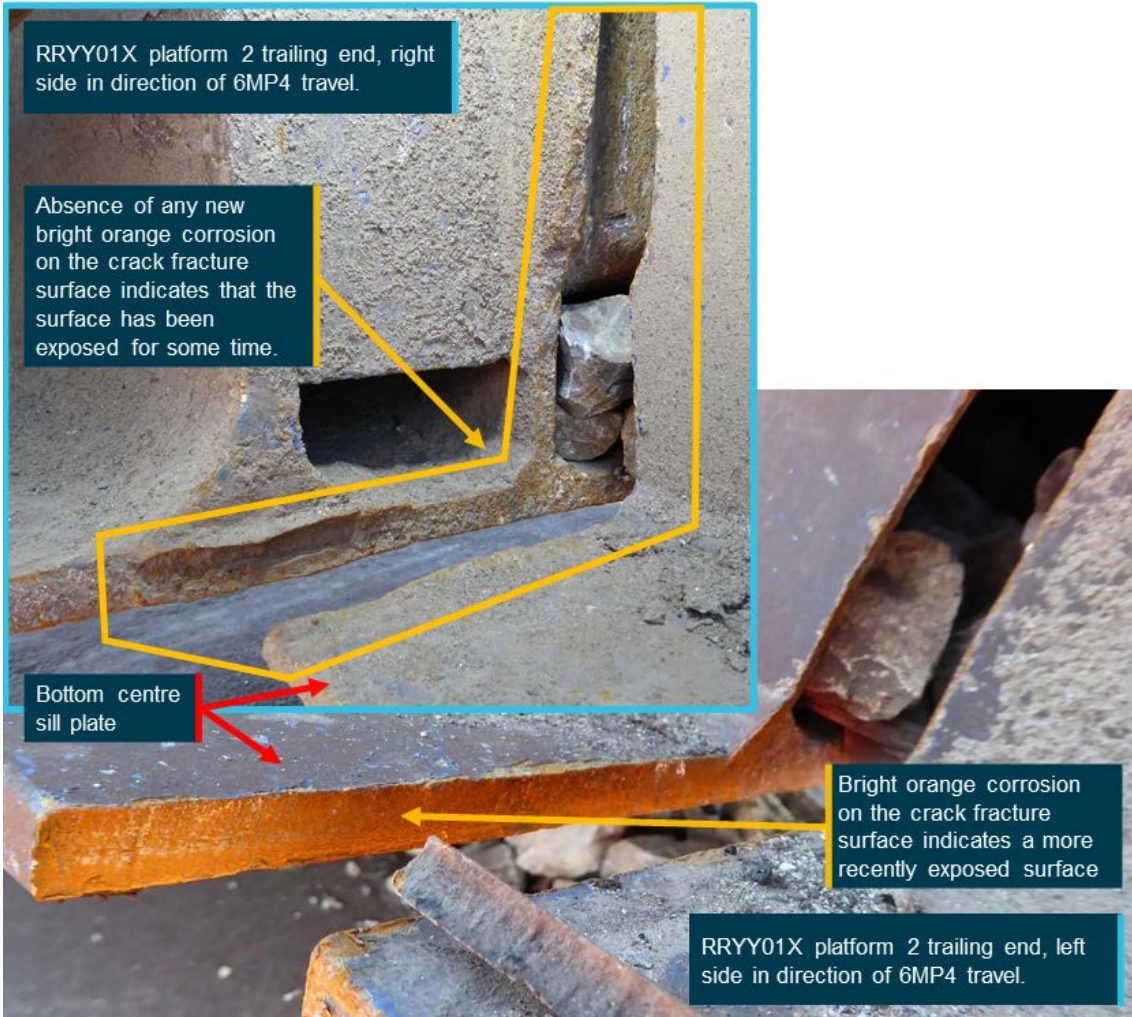
Figure 15: Underframe crack fracture surfaces in platform 2 of 5-pack wagon RRY01X

An examination of the crack surface on platform 2 suggested the initial propagation had occurred over a long period of time. This was followed by a rapid propagation shortly prior to and during the derailment. Although the exact period of time the initial crack was evident could not be determined, the crack surface condition suggested it existed weeks to months before, and most certainly was present prior to 6MP4's departure from Melbourne (Figure 15).

Image recorded on 27 April 2018, 6 days after derailment. Image shows the corrosion differences on the underframe crack fracture surface in platform 2 of 5-pack wagon RRY01X.
Source: ATSB
