Australian Transport Safety Bureau

Engine failure and forced landing involving Cessna 208B, VH-LNH

8 km north-west of Solomon Airport, Western Australia, 16 November 2016

ATSB Transport Safety Report
Aviation Occurrence Investigation
AO-2016-155
Final – 18 December 2020

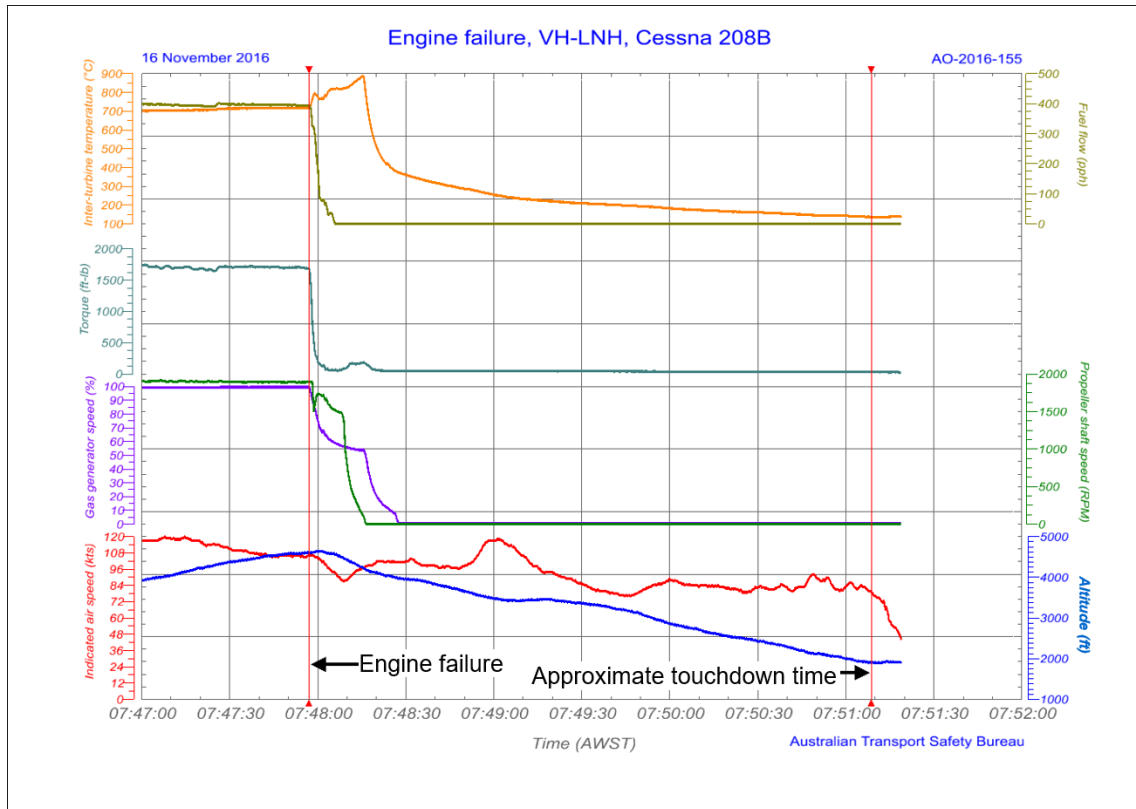
Figure 2: Presentation of the recorded data from the occurrence flight noting that the engine failure occurred at 0747:57 and the touchdown occurred at 07:51:09

The recorded data from the occurrence flight is plotted in Figure 2. Following departure, the aircraft was climbing at an indicated airspeed of 106 kt when at 4,615 ft AMSL and time 0747:47, the engine failed. This was represented in the data by a rapid decline in the measured parameters for torque, propeller shaft speed, fuel flow and gas generator speed. The pilot's report of sudden loud noises from the engine were consistent with the abrupt variation in the recorded parameters.

Eight seconds after the initial reduction in engine parameters, torque and fuel flow had reduced to zero, correlating with the pilot's recollection of the events immediately following the failure. At 0750:17, the aircraft had descended to 4,200 ft AMSL and the recorded propeller speed had reduced to zero. After the failure, the inter-turbine temperature rapidly increased from 715 °C, peaking at 887 °C, before steadily declining as the failed engine cooled. Twenty-nine seconds after the engine failed, the gas generator speed had reduced from 99.5 per cent to zero. Changes to the indicated airspeed and altitude identified that touchdown on the mine road occurred at 0751:09 at an airspeed of approximately 80 kt.

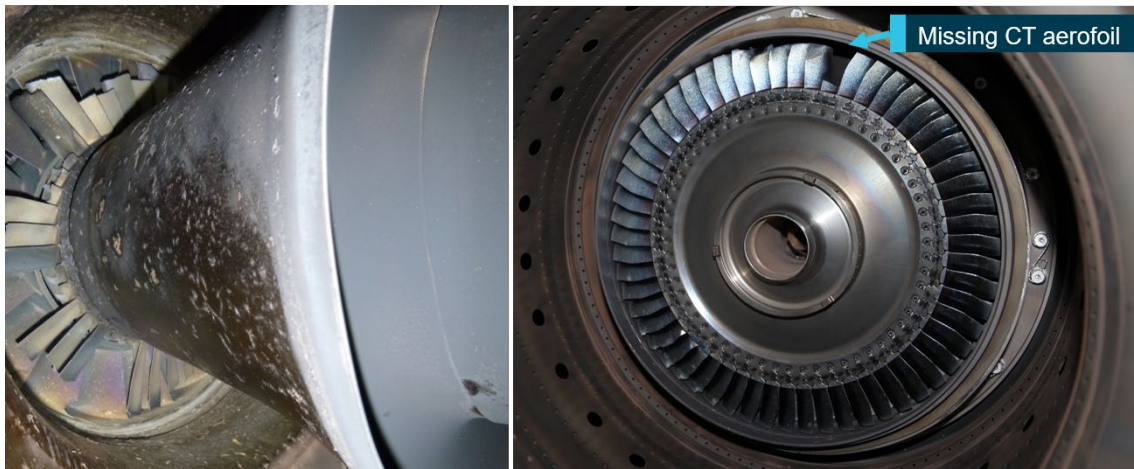
Figure 6: Composite image displaying the observed damage to the power turbine (left) and compressor turbine (right) displaying the missing aerofoil section.

Following the forced landing, the aircraft was relocated from the mine road to Solomon Airport. An initial on-wing inspection through the exhaust duct of the engine revealed considerable damage to the power turbine (Figure 6). Several power turbine blades were missing, having fractured at places varying from the blade root to the tip. Aviair personnel subsequently removed the engine and transported it to an approved facility for controlled disassembly and examination.

The power turbine had sustained the most severe damage, with several blades having fractured due to overstress at varying heights between the blade root and the tip due to contact with upstream¹⁰ debris (Figure 6). The upstream face of the power turbine inlet guide vane had sustained significant hard-body impact damage, most likely from metallic debris released from the compressor turbine. The power turbine was seized and not able to rotate freely. The propeller shaft was also unable to be rotated.

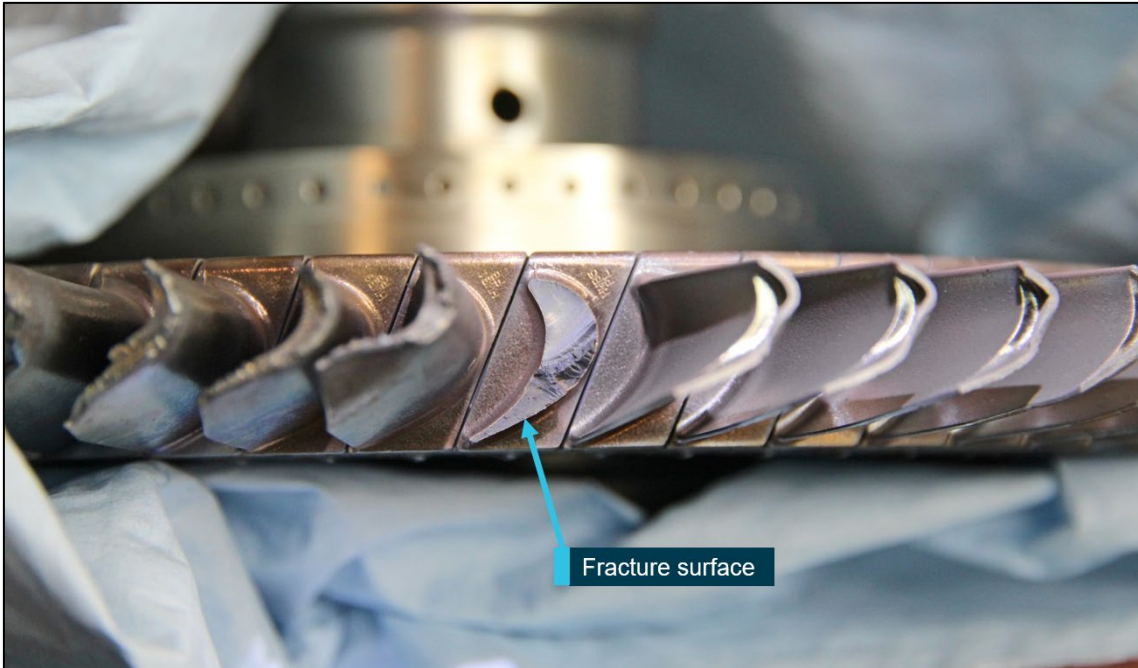
Figure 7: The fractured CT blade

Examination of the compressor turbine (CT) identified that a single CT blade had fractured close to the blade root (Figure 7 and 8). Multiple blades had sustained bending from impact damage with the liberated aerofoil section. One of the adjacent blades displayed a clear imprint from contact with the liberated aerofoil section (Figure 9). The fracture surface of the failed blade was largely flat and located at the root, close to the platform. Characteristic 'beach mark' features were present that extended to approximately 50 per cent of the overall fracture surface, indicating that a fatigue crack had progressed through that portion of the blade. The remainder of the fracture was jagged and angular and representative of a sudden overstress fracture.

Fractured blade manufacturing identifiers; part number 3079351-01, serial number HWB5PL, vendor supplier 702055
Image source: ATSB

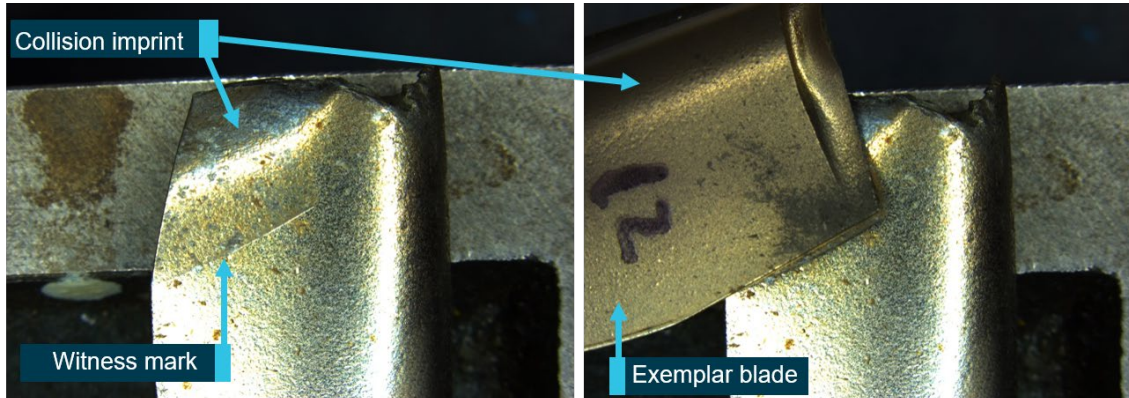
Figure 9: Composite view of a CT blade adjacent to the one that had fractured showing the collision imprint from the liberated aerofoil section

An exemplar blade (right image) from the disc has been used to illustrate the collision of the liberated aerofoil section from the fractured blade.
Image source: ATSB

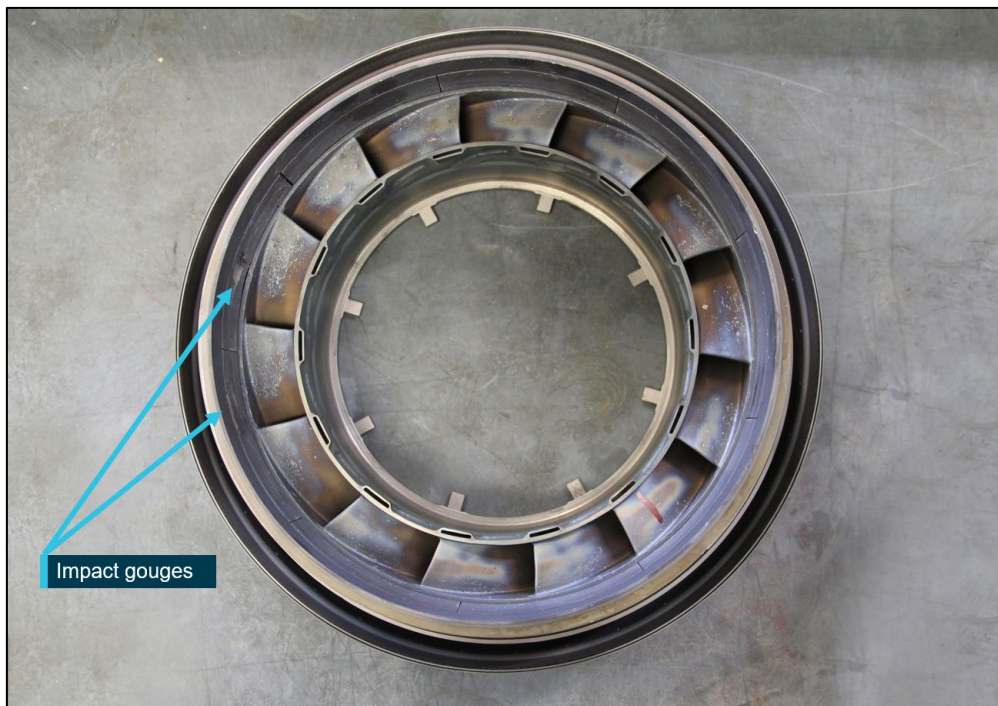
Figure 10: Compressor turbine vane ring assembly, view of the downstream face with gouge damage (labelled)

The CT vane ring fitted to the engine was also examined (Figure 10). The vanes had sustained abrasion and minor impact damage. The shroud segments had sustained two major gouges from the engine failure. The following manufacturing part numbers were identified:

CT vane ring manufacturing identifiers: (part number) 3029051, (serial number) 931E, (work order) WO 0452R16, (flow class) CL 6.25, (major repair specification) STI 72-50-254, (repair authority) STI 02-0356
Image source: ATSB

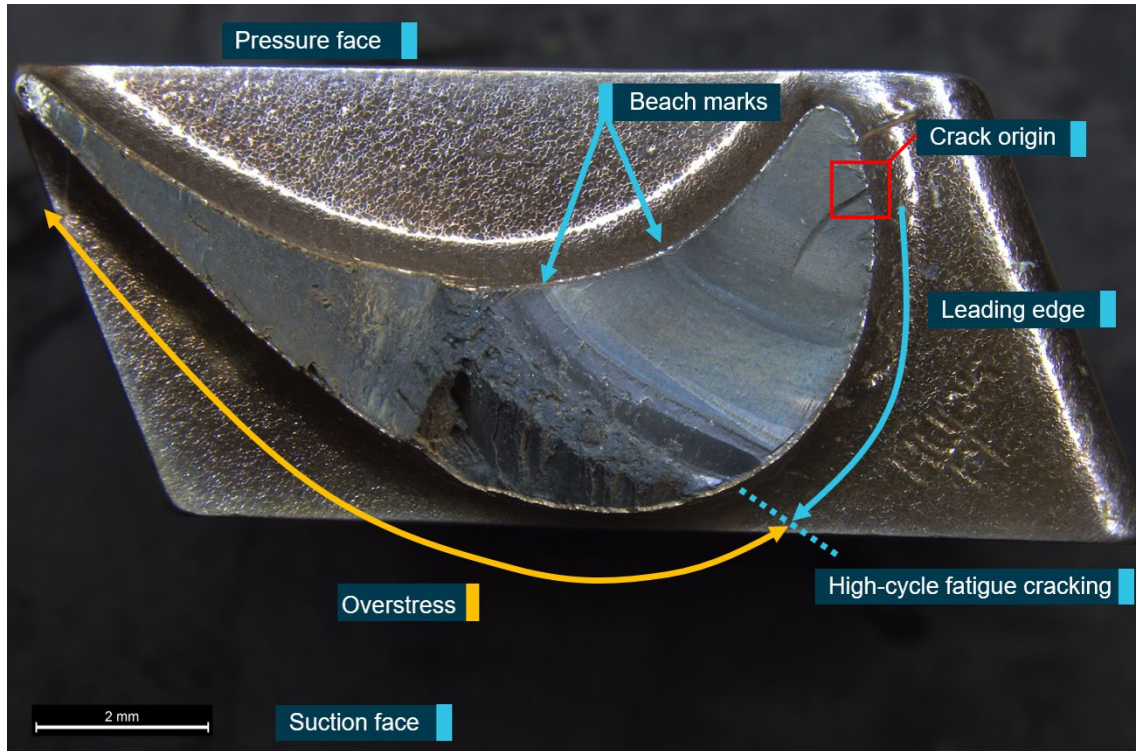
Figure 11: High-magnification optical image of the fractured blade showing that cracking initiated at the leading edge on the suction face, progressing through approximately 50 per cent of the cross-section prior to overstress fracture and release of the aerofoil

The PWC metallurgical investigation confirmed that the engine failure was initiated by the fracture of a single compressor turbine (CT) blade. Fracture and release of the CT blade aerofoil section into the gas path led to many of the surrounding CT blades sustaining tip-bending and abrasion from rubbing against the CT shroud segments. Major downstream damage to the power turbine resulted from the blade release. Other CT blades exhibited secondary damage in the form of random nicks, cracks, bending and indentations from repeated impact against the liberated debris.

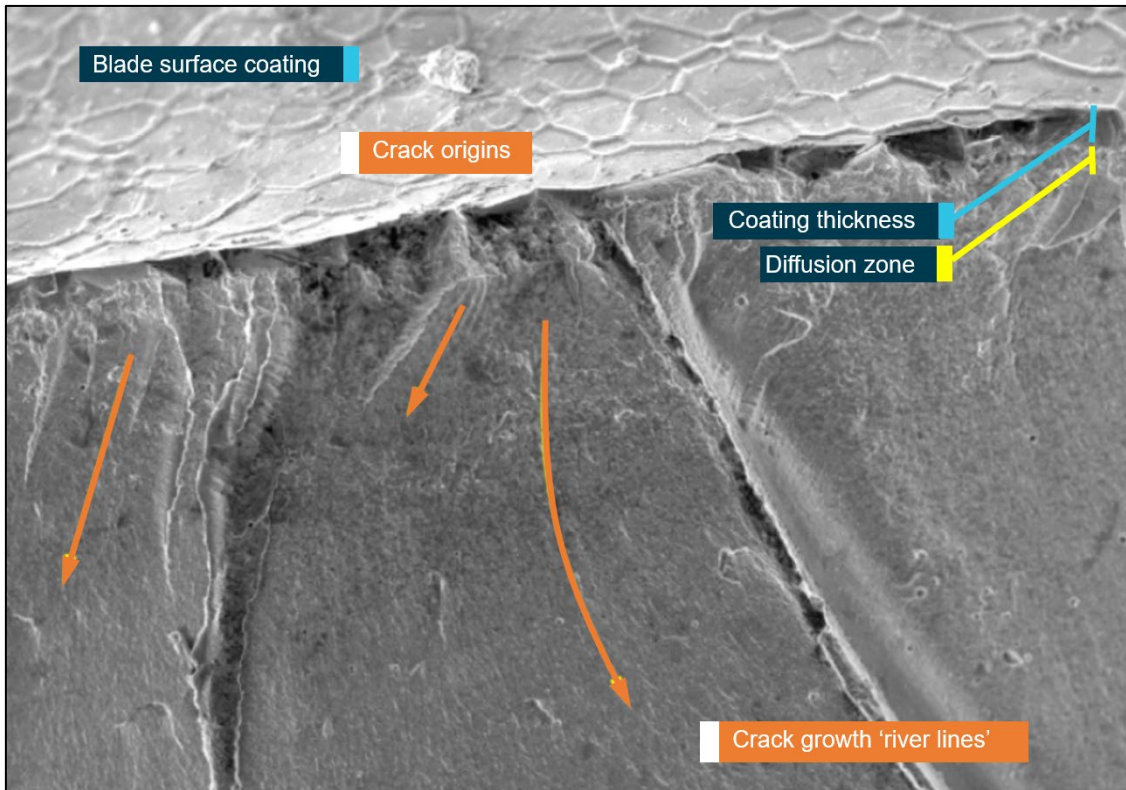
Figure 12: High-magnification SEM image of the crack origin at the leading edge showing the direction of propagation ‘river lines’ and other features associated with the blade coating

The SEM examination did not identify any defective features within the nickel-base alloy or coating material that might otherwise have led to the cracking.

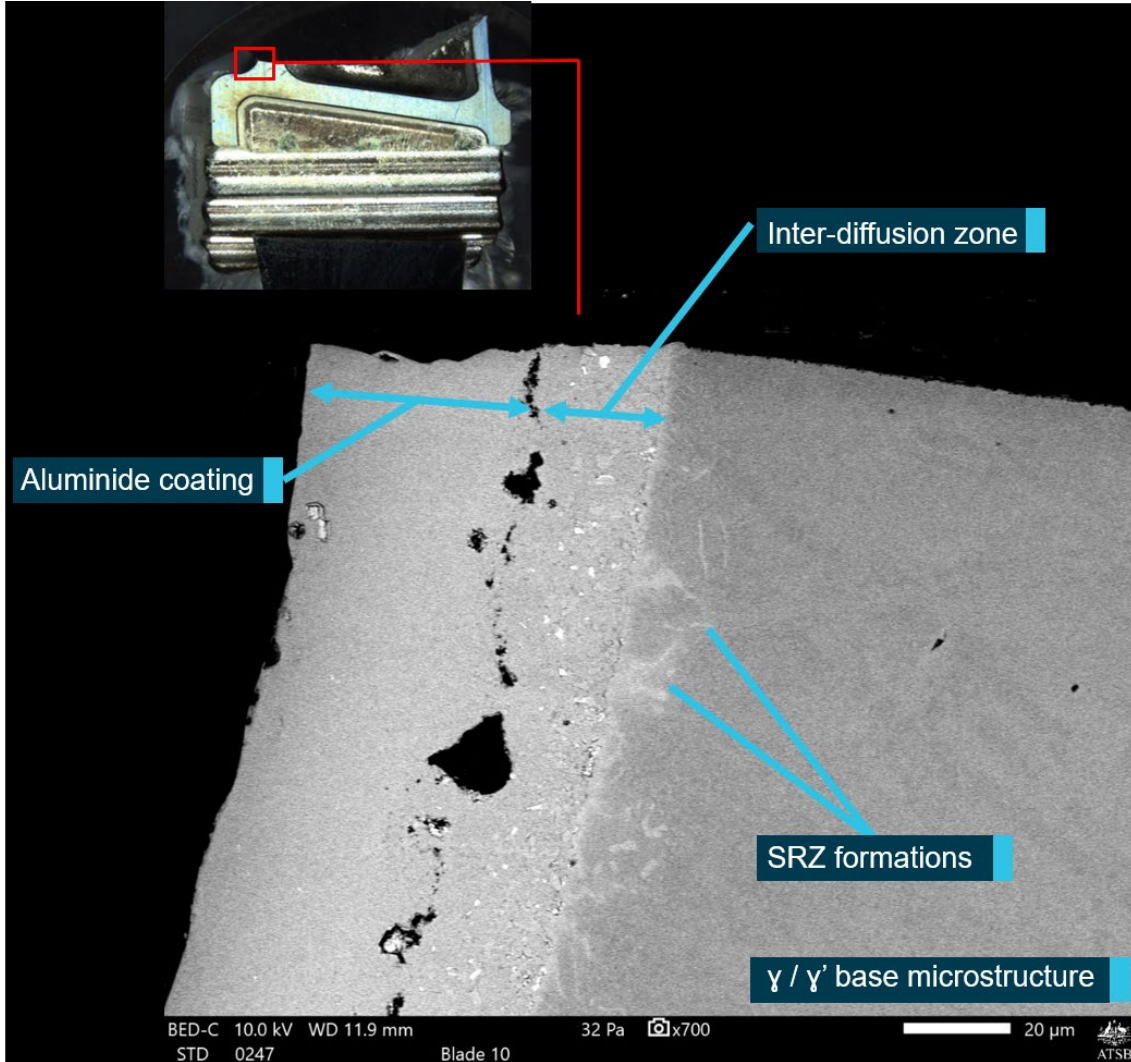
Figure 13: Composite optical and SEM micrograph of the remnant fractured CT blade

blade coating, the patches were unlikely to have affected the crack initiation. After examining the CT blades and disc from the occurrence engine, and reviewing the PWC metallurgical report, the ATSB agreed with PWC’s findings in respect of the fractured CT blade.

The main SEM image is a cross-section through the crack origin. The primary microstructural features are described. Some alteration of the microstructure was observed with the formation of secondary reaction zone (SRZ) between the gamma / gamma -prime (γ / γ') base microstructure and the blade coating.
Image source: ATSB

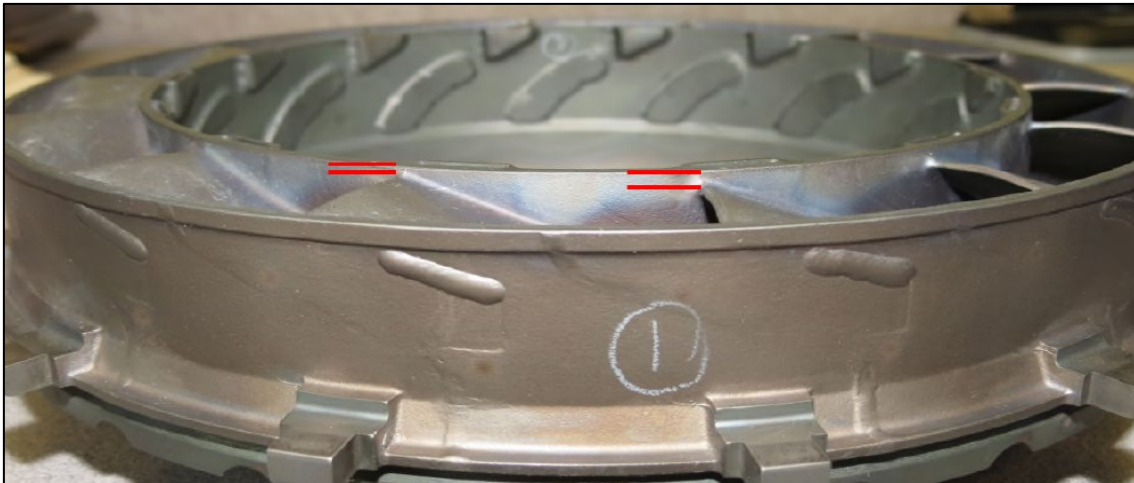
Figure 14: Trailing edge positioning variations against the inner shroud from the STI-repaired CT vane ring, highlighting a non-conformance

Appendix A contains comparison plots from PWC of the measured values for vane chord length, trailing edge thickness and vane stagger angles of the STI-repaired CT vane ring against the PWC design. Also contained within appendix A are plots of the vane stagger angle of other STI-repaired compressor turbine vane rings from PT6A-114A engines that had sustained CT blade fracture.

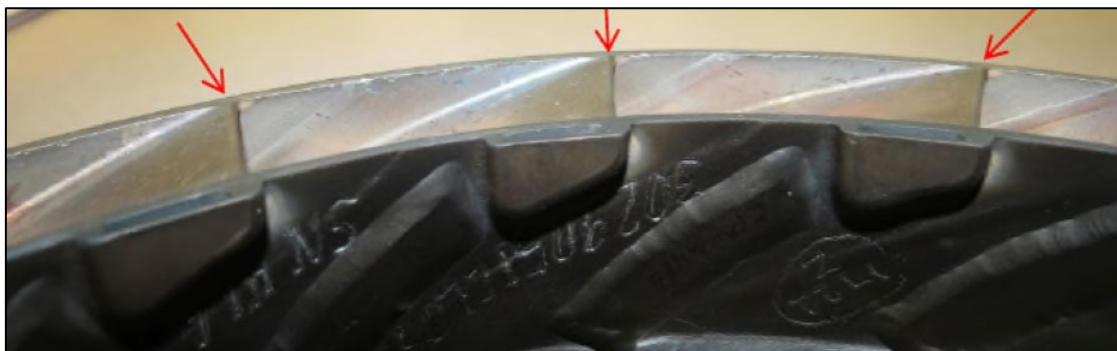
Figure 16: Example of trailing edge positioning against the outer shroud from a PWC-manufactured CT vane ring

Notable differences in vane positioning exist when compared with the STI-repaired item from the occurrence engine.
Image source: Pratt & Whitney Canada
