# Wagon out of gauge on freight train 2BW4

Main North rail line, New South Wales, on 16 June 2020

**ATSB Transport Safety Report**

RO-2020-009

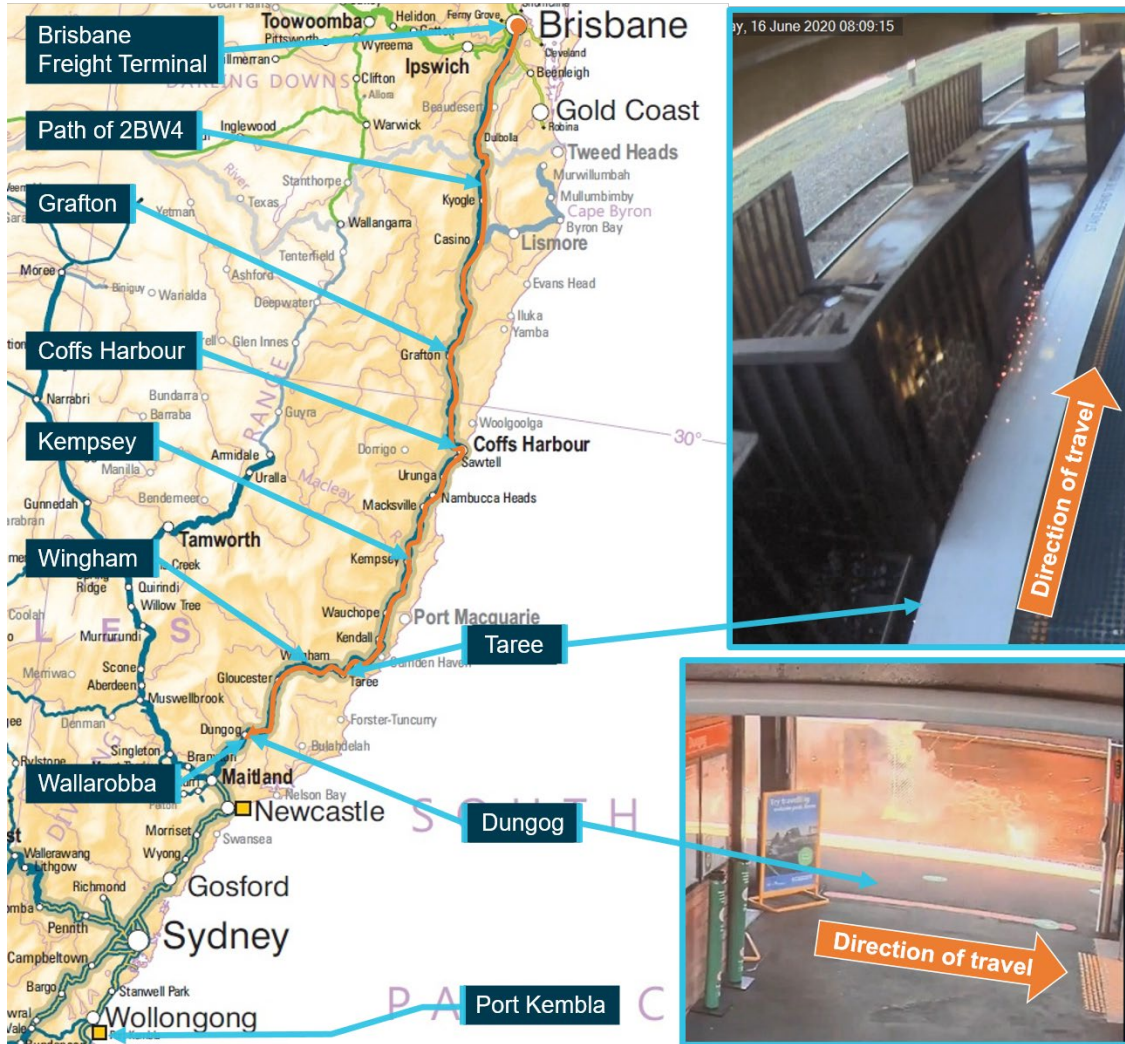
**Figure 1: Train path 2BW4 and platform footage of wagon RKOX4055Y**

Minor damage was found on Grafton, Coffs Harbour, Taree, Wingham and Dungog platforms believed to be a result of contact with the detached wagon RKOX4055Y. Closed-circuit television (CCTV) footage from Coffs Harbour, Taree and Dungog showed this wagon contact the platforms with dust, smoke and sparks visible (Figure 1).

Map showing the path of train 2BW4 and platform locations. Footage from Taree and Dungog platforms inset showing wagon RKOX4055Y contacting the platforms.

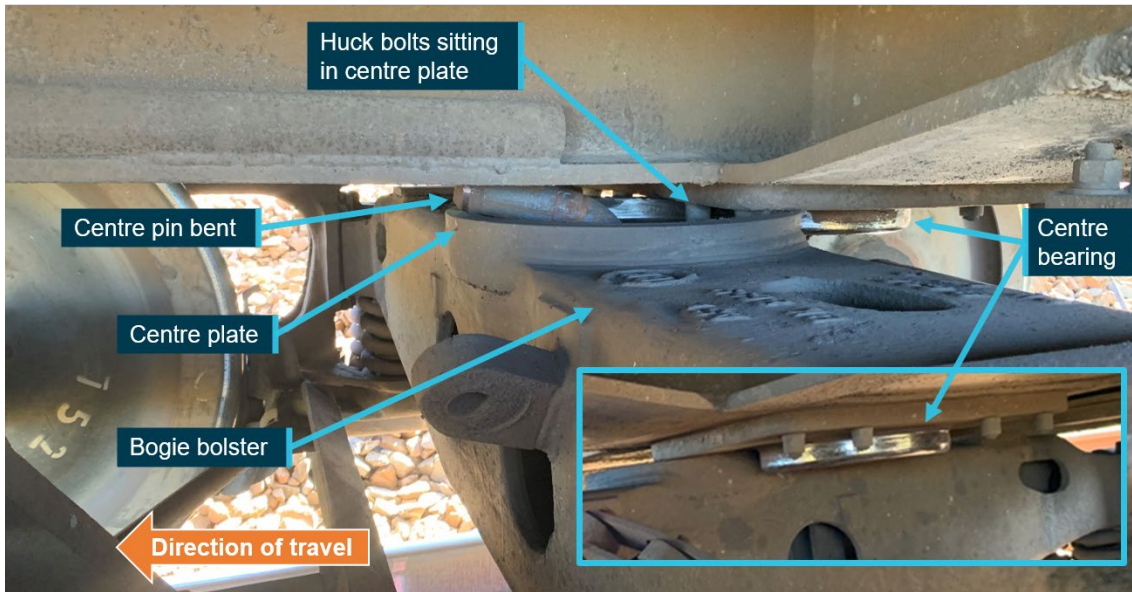
**Figure 2: RKOX4055Y A-end bogie detached**

The train crew inspected the train and identified that the wagon body on the 35th wagon (RKOX4055Y) was detached and resting on the bogie bolster at the A-end of the wagon. The bogie had shifted towards the middle of the wagon with the centre bearing sitting forward of the

centre plate (Figure 2). It was the trailing bogie on the wagon. Two huck bolts<sup>5</sup> from the centre bearing mount were sitting within centre plate, limiting further movement of the bogie.

*Image showing the bogie as found with inset image showing the centre bearing from the opposite side.  
Source: Pacific National, modified and annotated by OTSI*

In this instance, the wagon body was partially restrained by the huck bolts resting within the centre plate. The A-end of wagon RKOX4055Y travelled intermittently out of gauge for approximately 739 km in a trailing direction, likely reducing the consequences of this occurrence. On each occasion the wagon body contacted an obstruction such as a platform, the wagon body glanced rather than catching the obstruction.

- Communicated the occurrence and contributing factors to the BFT terminal operators and maintenance personnel and reinforced the requirement for underframe inspections prior to trains departing the terminal.
- Required BFT terminal operators and shunting personnel to undertake an underframe inspection on each wagon before shunting from the BlueScope Steel Coopers Plains facility.
- Reviewed the safety engagement schedule to include engagements relating to full train examinations at BFT.
- Reviewed the verification of competency (VOC) assessments at BFT for full train examinations by driver trainers and train crew including inspection of the wagon body and bogie interface.

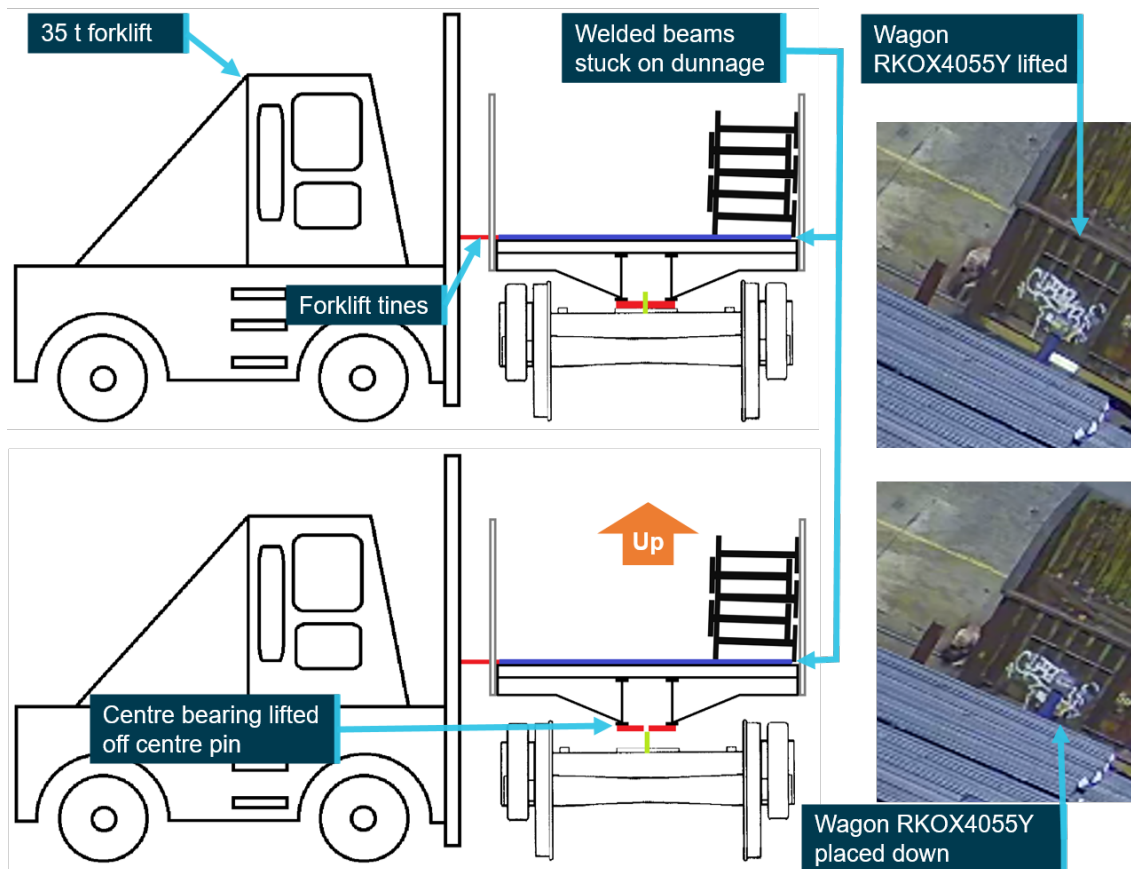
**Figure 3: Unloading wagon RKOX4055Y**

Wagon RKOX4055Y was unloaded from one side and the forklift operator had difficulty unloading the beams. The BSS unloading procedure did not address loads that became stuck. The operators attempted to free the load using two forklifts, as the last stack of beams (approximately 15 t) became stuck between the dunnage and the side wall of the wagon. While attempting to lift the beams, the A-end of the wagon was likely lifted off the centre pin (Figure 3). Footage from the BSS Coopers Plains facility showed the corner of wagon RKOX4055Y lift before being placed down again. Neither forklift operator identified the likely lift off event and dislodged wagon body.

The upper diagram shows the unloading of wagon RKOX4055Y with the welded beams stuck between the dunnage (blue) and the wagon side walls. The lower diagram shows the wagon body and centre bearing lift off the centre pin (green) during attempts to lift the beams. Screenshots from CCTV footage showing the corner of RKOX4055Y lifted before being placed down. Source: Pacific National footage, diagrams and annotation by OTSI

Unloading welded beams from one side likely increased the risk of a wagon lift off event, in particular, if the last stack of beams become stuck. At that point, the mass of the load is at the lightest and the capacity of a single forklift (35 t) could lift the wagon body and load.

- The requirement to unload welded beams from both sides was reinforced with terminal personnel.
- Unloading procedure (SOP QLD-PR-T-008) was reviewed to ensure appropriate controls are in place and to highlight the risk of a wagon lift off event.
- Lift off events were included into BlueScope Steels incident management system as a reportable incident.

Pacific National also advised that an engineering review is currently underway to review the design of the RKOX wagons to prevent welded beams becoming stuck between the dunnage and wagon side wall.
