# Level crossing collision between freight train 5KQ7 and a road coach

Norlane, Victoria, on 2 April 2020

**ATSB Transport Safety Report**

RO-2020-004

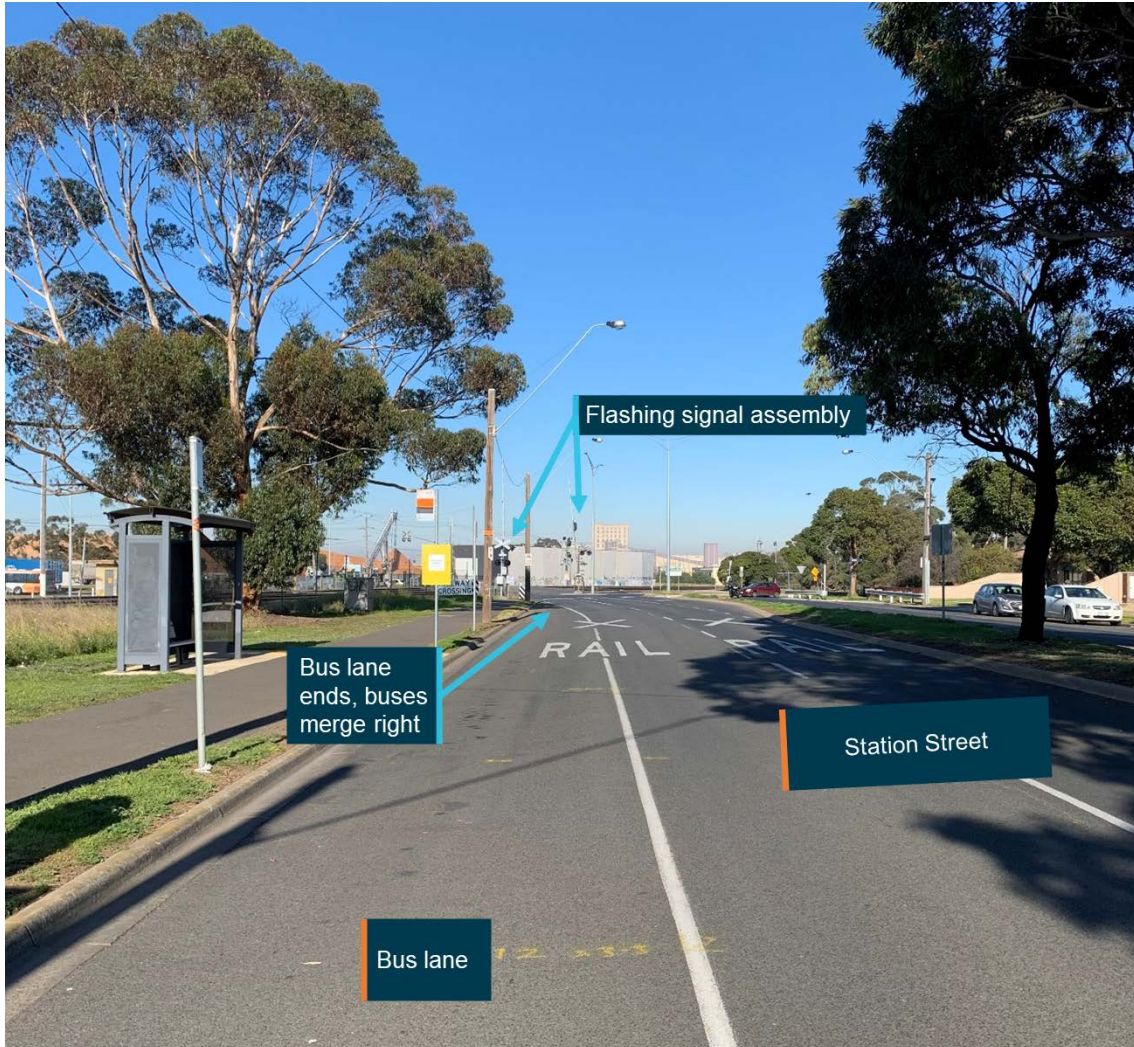
**Figure 2: View of the level crossing from the North Shore Station bus stop**

At about 1049, the road coach was stopped at North Shore Railway Station bus stop on Station Street. The level crossing was 70 m ahead and was visible from the bus stop. The flashing lights installation<sup>5</sup> in the centre of the road was also visible (Figure 2).<sup>6</sup>

<sup>6</sup> From the coach stop, the left-hand (or 'near') side signal assembly was partly obscured by vegetation and roadside infrastructure.

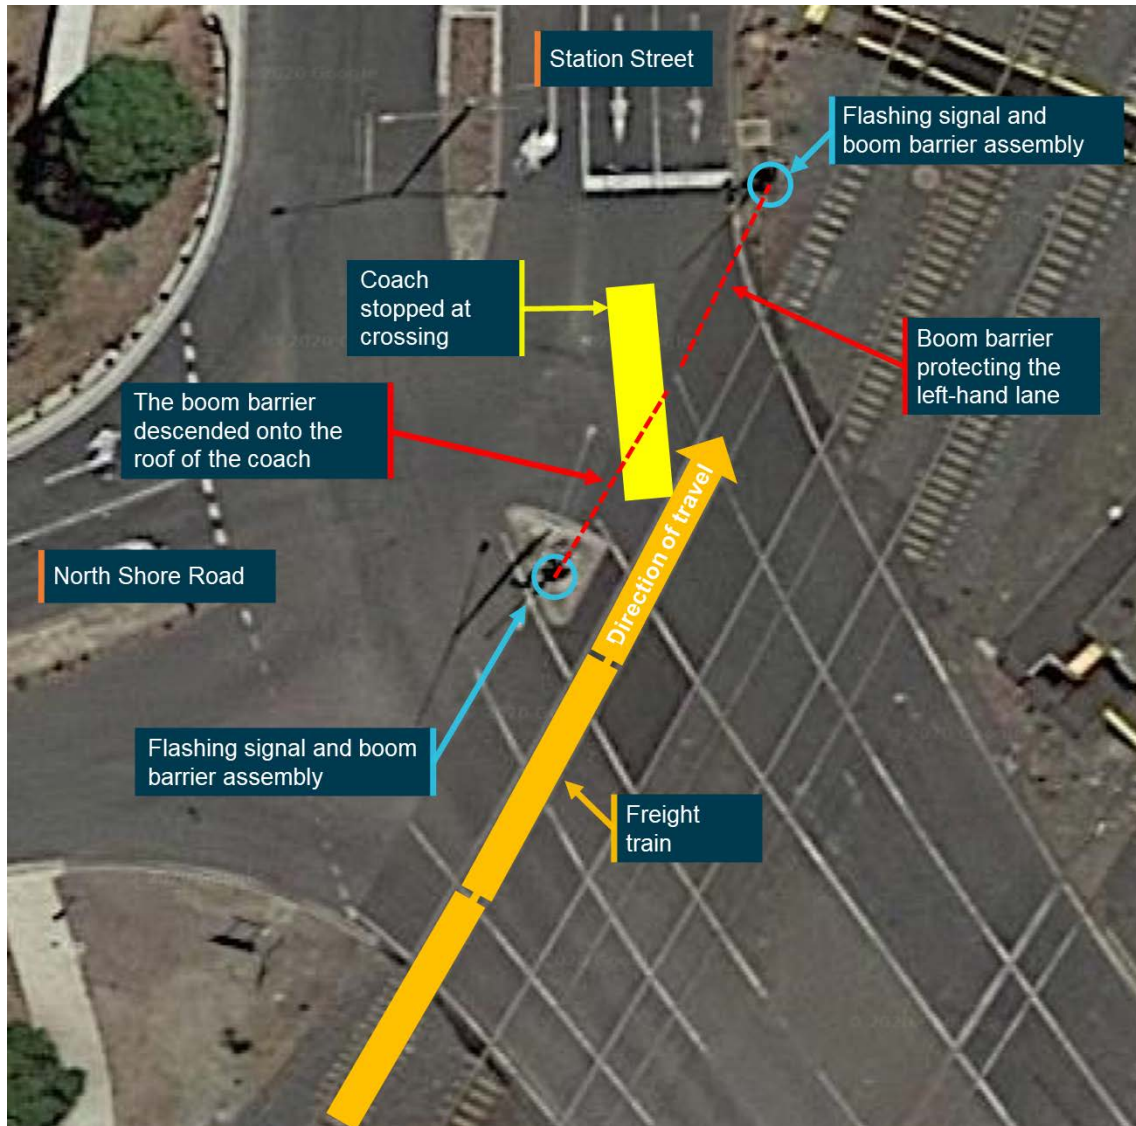
**Figure 4: The estimated position of the coach on the crossing and the approaching train**

On approaching the crossing, the driver slowed the coach in preparation to cross. The driver reported that the coach had just crossed the level crossing stop line road marking when they heard the level crossing warning bells and stopped the coach. In the stopped position, the coach was foul of the first track (Figure 4).

About 39 seconds after the crossing warning had activated, the leading locomotive entered the crossing travelling at a speed of about 50 km/h. The train then collided with the front left-hand quarter of the coach.

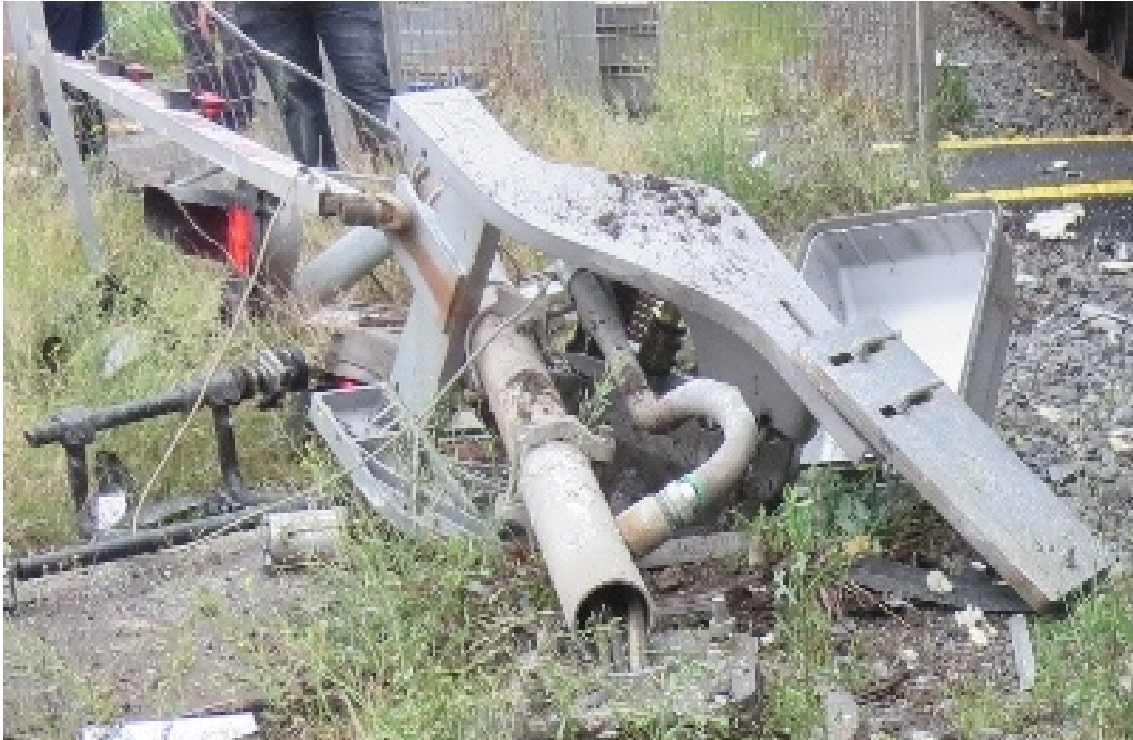
**Figure 5: Damaged flashing signal and boom barrier assembly**

The front section of the coach was substantially damaged and the locomotive sustained minor front-end damage and a shattered windscreen (front cover).

The impact pushed the coach into the near side flashing light assembly and boom barrier causing substantial damage to infrastructure (Figure 5).

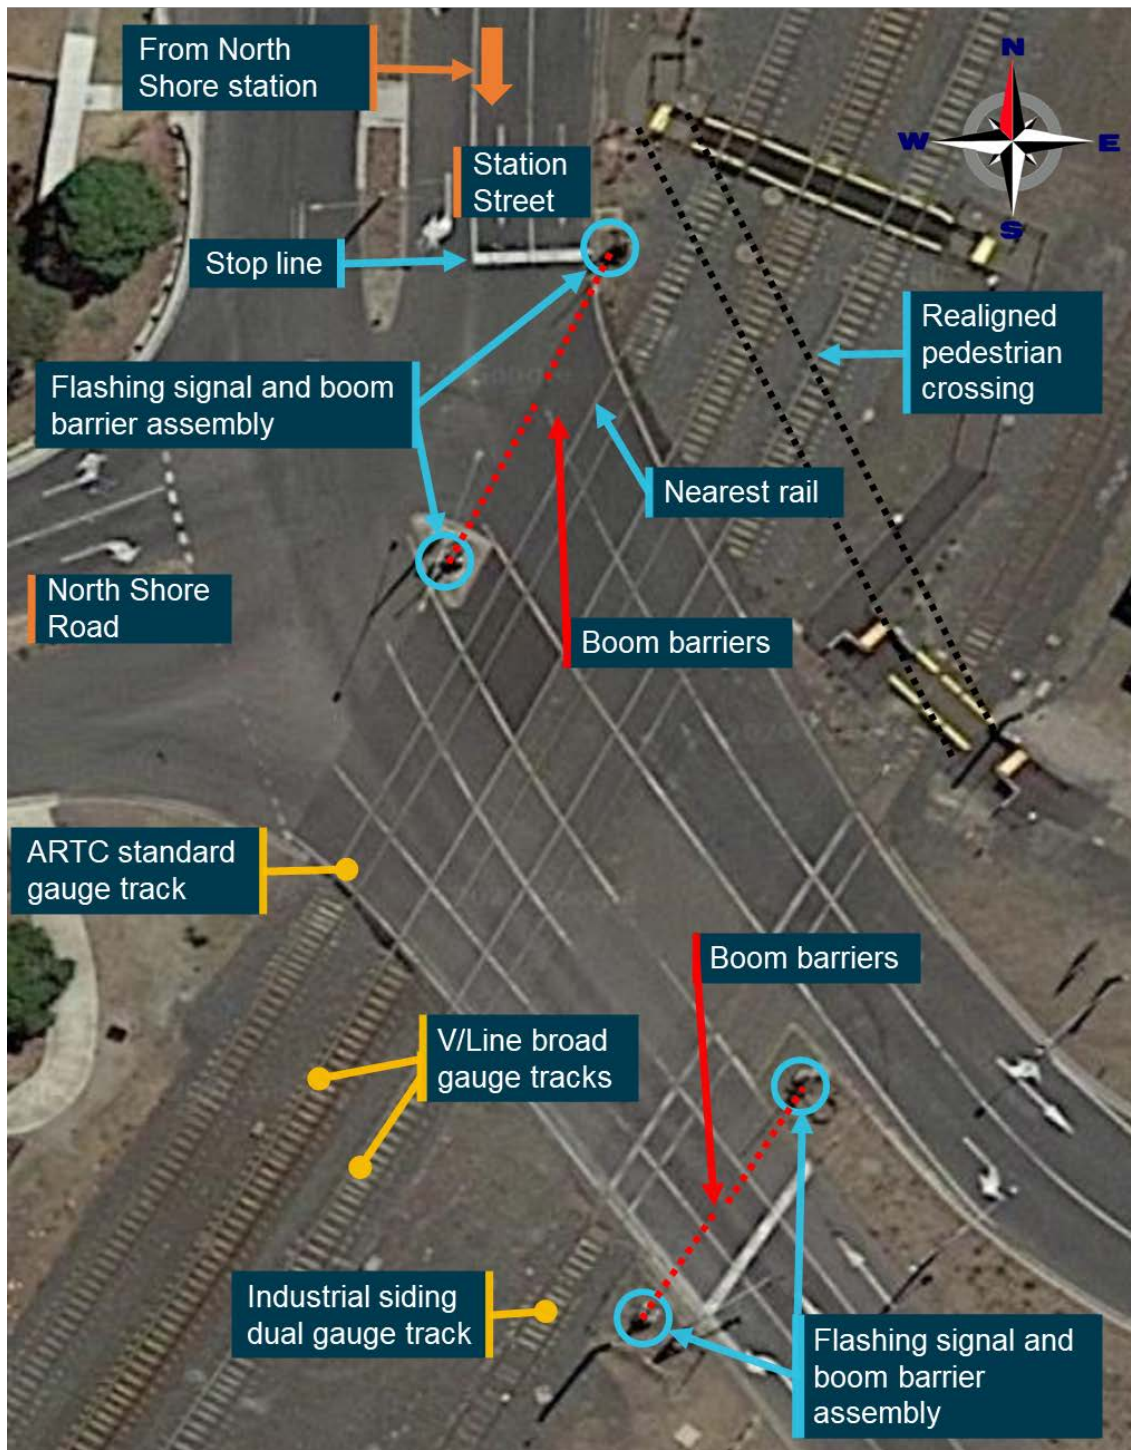
Figure 6: Aerial view of the Station Street level crossing and its key features

At this crossing, four bi-directional rail tracks crossed five lanes of road traffic. The western-most track on which the coach impinged was a standard-gauge track managed by the Australian Rail Track Corporation (ARTC). The middle two tracks were main line broad-gauge tracks managed by V/Line and the track furthest from the coach was a dual-gauge track leading to an industrial siding.

A CCTV camera provided partial surveillance of the crossing. However, in this instance, the point at which the coach stopped was outside the camera's field-of-view.

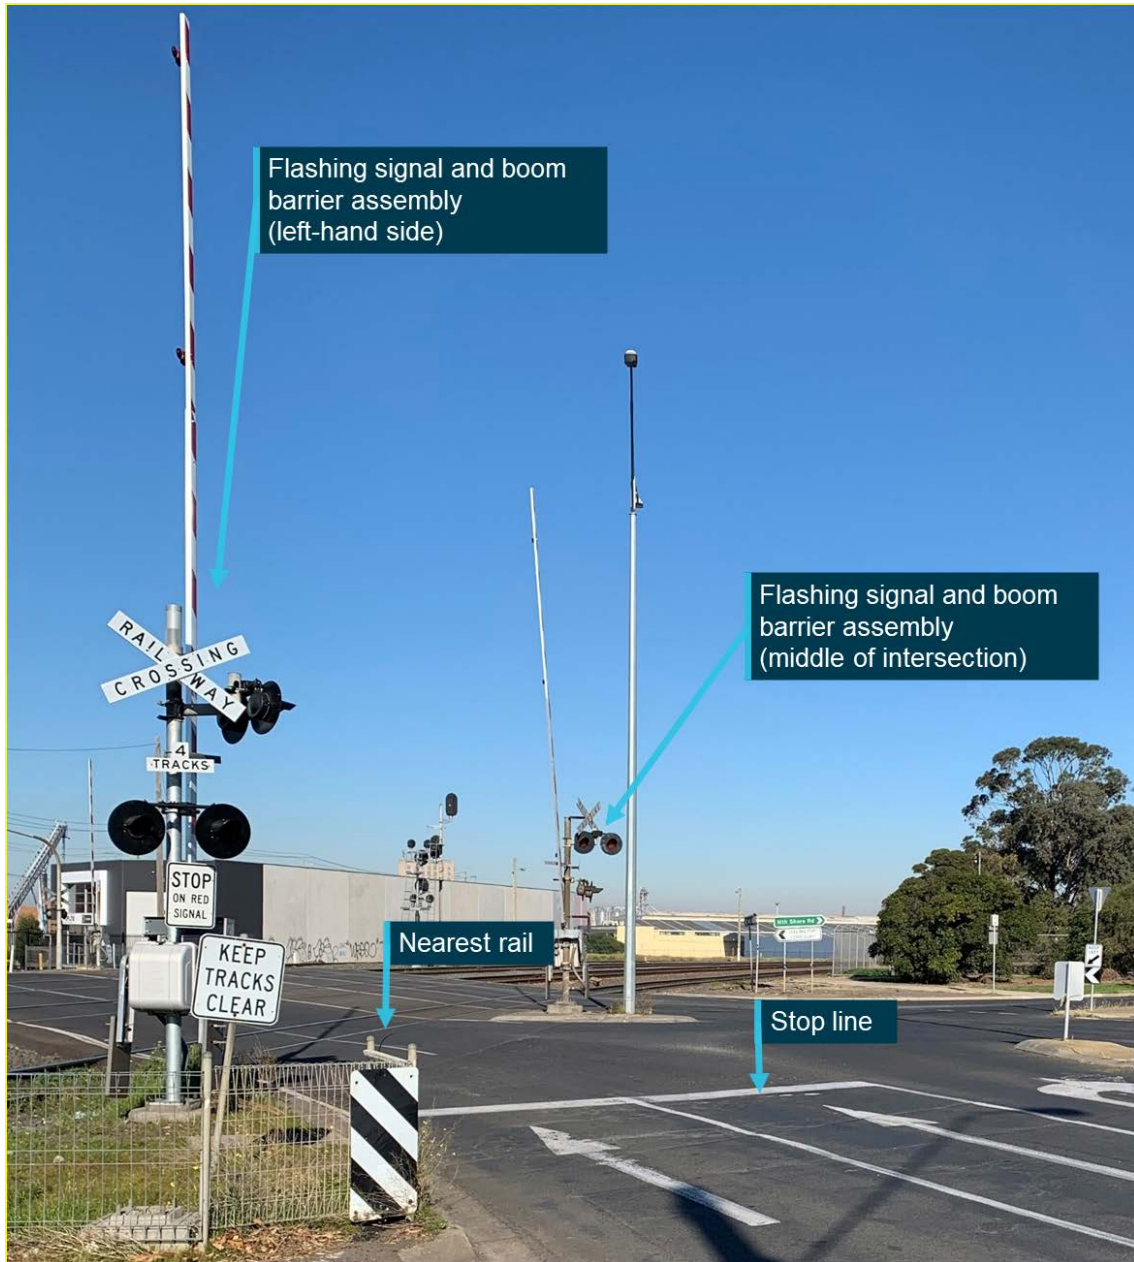
**Figure 7: Road approach to level crossing including signage and protection equipment flashing light and boom barrier assembly**

Approaching the crossing, the road and crossing configuration meant that traffic was required to pass the road intersection with North Shore Road and then veer to the left to enter the crossing. Drivers of road vehicles would have a view of the stop line road marking, crossing signage and both the left-hand<sup>9</sup> and the central<sup>10</sup> flashing light assemblies (Figure 7).

Post-occurrence inspection of the level crossing found that the stop line marking was approximately 1.8 metres from the boom barrier<sup>14</sup> when measured along the inner edge (or near side) of the street; AS1742.7 requires a minimum of 3 m.

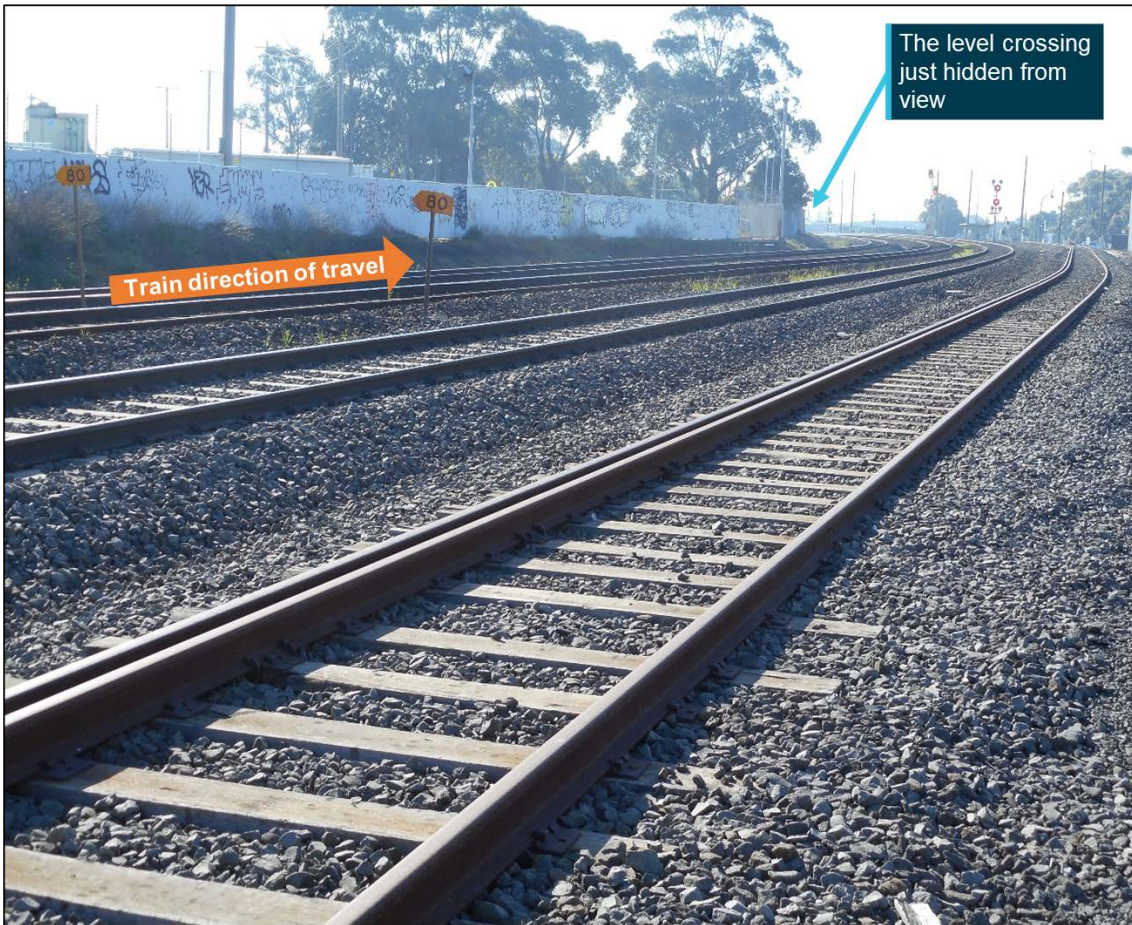
Figure 8: The rail approach to the Station Street level crossing

The rail approach to the level crossing (travelling towards Melbourne) was on a left-hand curve with a radius of about 550 m. The curve commenced about 200 m prior to the crossing and was preceded by a curve board indicating a permitted speed of 80 km/h. The train was travelling at 53 km/h prior to the emergency brake application and was therefore significantly below this speed.

Due to the track curvature and the visual obstructions along the left-hand side of the rail corridor, the train crew could not observe the crossing until clear of the obstructions (Figure 8). It is estimated that the coach was not in the view of the locomotive drivers until the train was within about 100 m of the crossing.

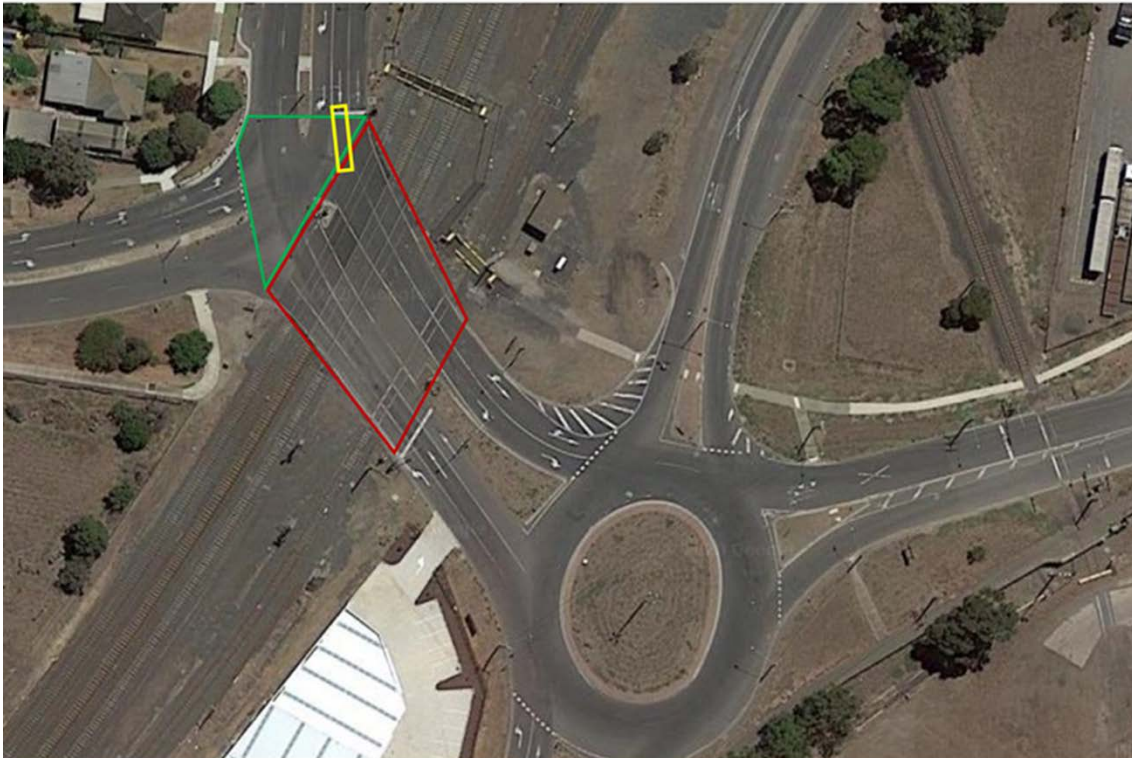
**Figure 12: Road intersection and level crossing layout**

The crossing itself was four tracks wide (40 m). This is greater than most crossings and may have influenced the decision of the driver not to proceed. The geometry of the crossing also meant it may not have been immediately apparent to the driver that the left-front corner of the coach had fouled the track.

While there were no identified queueing issues that may have triggered applying yellow box markings,<sup>22</sup> such markings at this complex crossing may have assisted with identification by the driver of the crossing limits and the hazardous zone.
