# Safeworking irregularity involving crew of freight train 4WM2

Near Waterfall, New South Wales, on 21 August 2019

**ATSB Transport Safety Report**

RO-2019-016

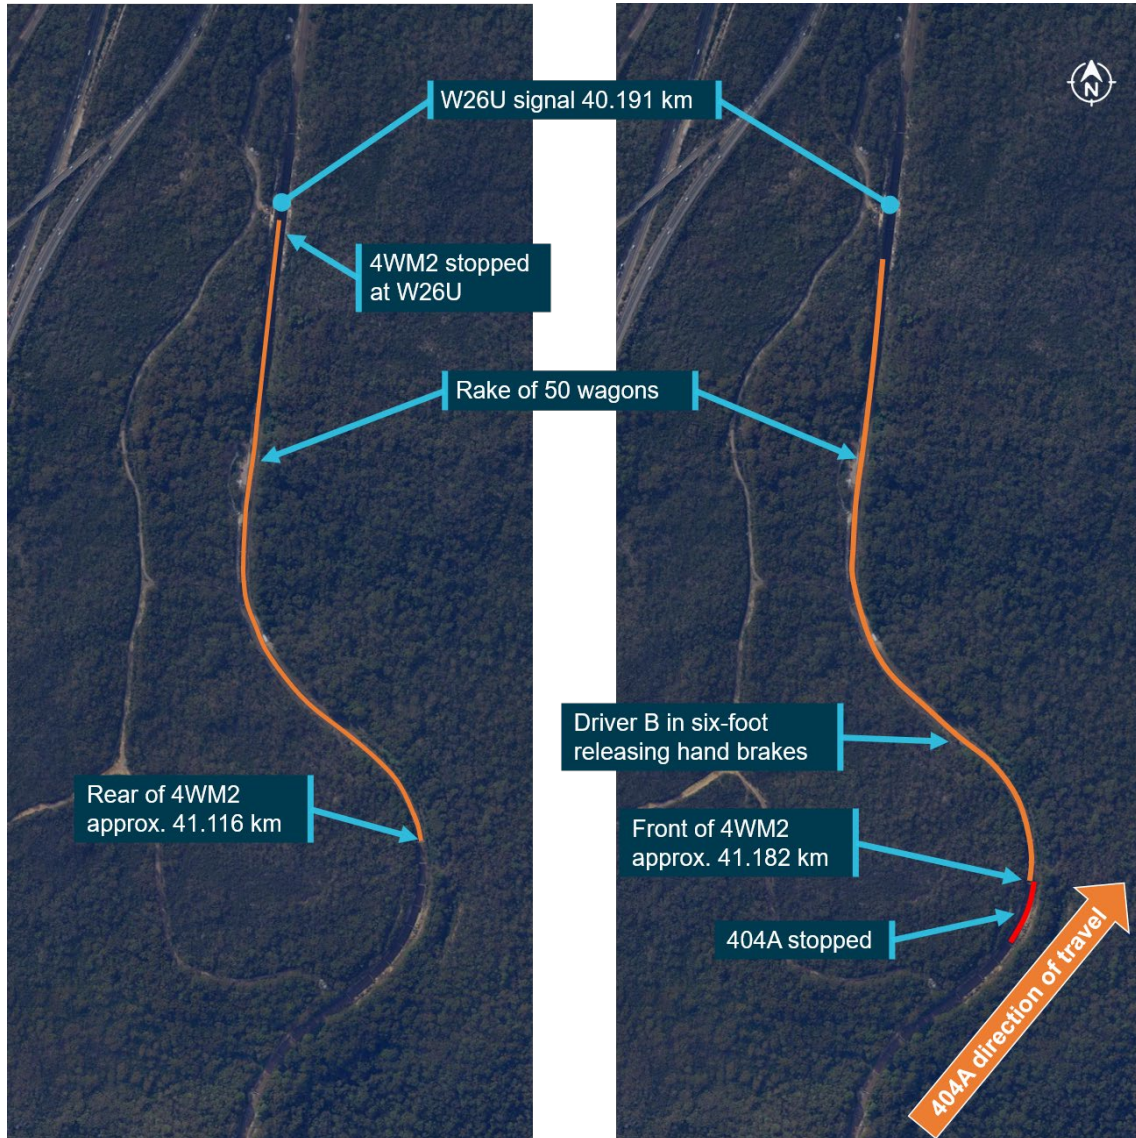
**Figure 2: Position of 4WM2 before and after remarshalling**

The crew of 4WM2 were advised to remarshal the train while stationary at signal W26U, located in a steep cutting at 40.191 km.<sup>11</sup> The train length of 925 m positioned the rear of the consist at approximately 41.116 km (Figure 2).

Following the remarshalling, the lead locomotive was positioned at approximately 41.182 km on the Up Illawarra. Driver B had walked approximately 300 m along the consist when contacted to advise that train 404A had been stopped.

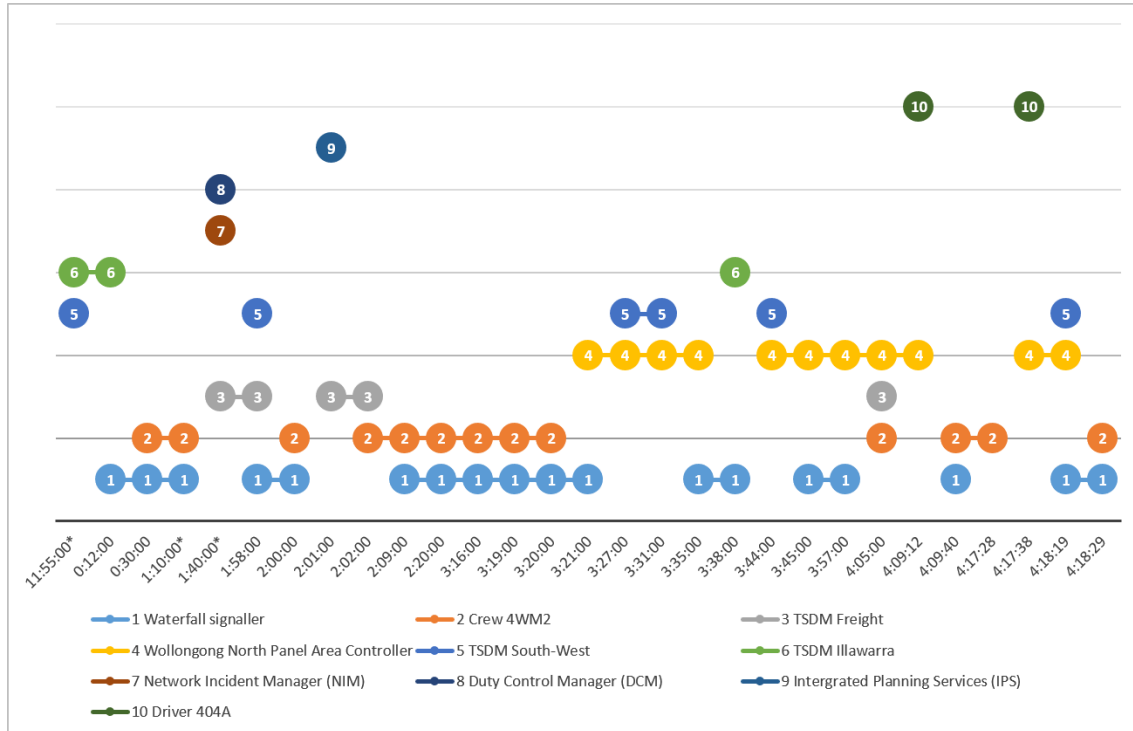
**Figure 3: Communication timeline**

The communications relating to the decisions and movement of 4WM2 were assessed to understand the events leading up to the occurrence (Figure 3). It was found that while recorded network communication devices were available, not all communications, decisions or directions relating to 4WM2 were made utilising recorded communication devices as required by NGE 204.

The TSDM Illawarra advised the WS at 0012 to hold train 4WM2 at the Waterfall accept signal (W26U) due to the track fault in the adjoining network. The TSDM discussed that 4WM2 would be too long for the goods loop or refuge loop at Waterfall and that the train may need to ‘run around [remarshal] on the Up main’. The TSDM suggested the train might be held for less than an hour.

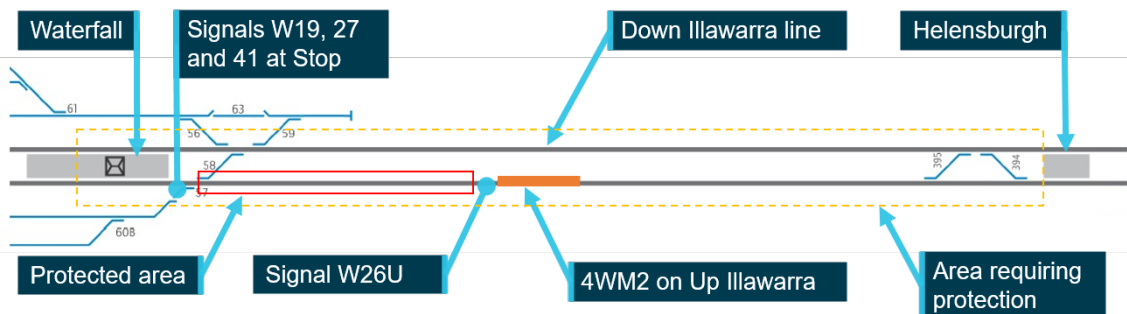
**Figure 4: Safeworking protection diagram**

The protection applied by the WS protected the train on the Up Illawarra main line in the Down direction (Figure 4).
