# Landing gear damage involving Airbus A320, VH-VFL

Near Sydney, New South Wales, on 5 March 2020

**ATSB Transport Safety Report**

AO-2020-018

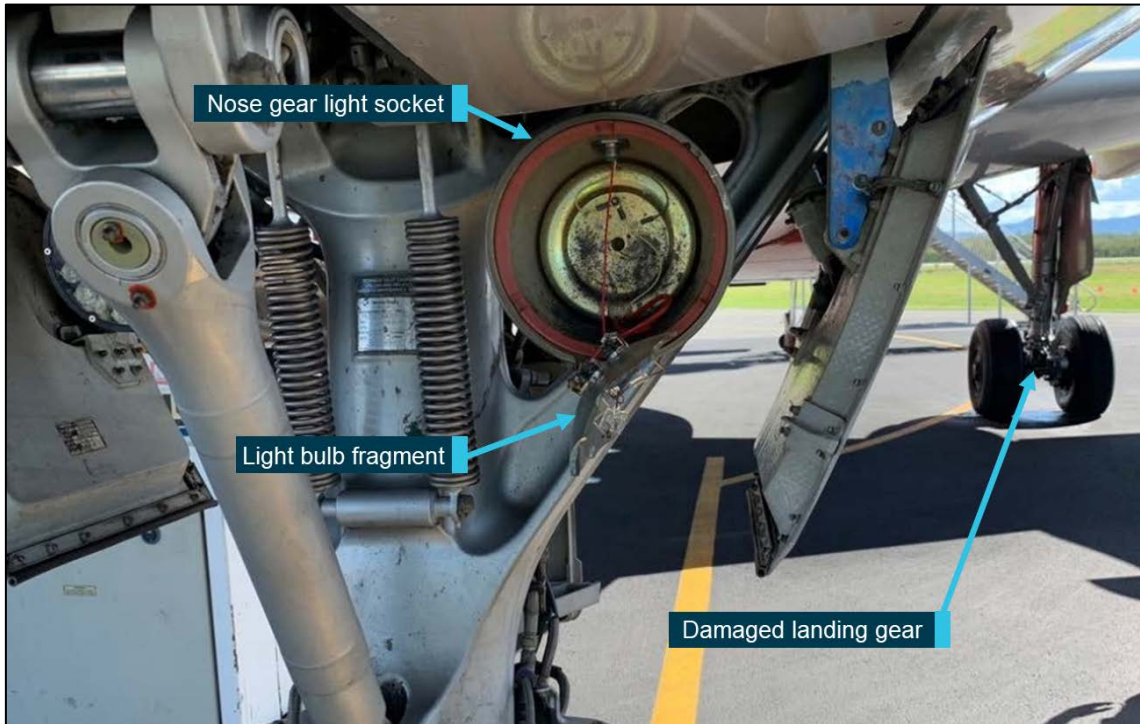
**Figure 1: Damaged nose gear landing light**

Figure 1 shows the damage to the nose gear landing light at the time of the post-flight walk around. Most of the lamp was missing, with a small fragment still attached to the socket. In the background of the image, the damaged left MLG can be seen. The broken nose gear landing light was inspected by the manufacturer, but there was no comment made regarding possible reasons for the damage.

The polycarbonate cover on the nose gear landing light would likely have prevented it from disintegrating due to thermal stress, such as from a blown bulb. Therefore, the damage to the light indicated by the recovered bulb fragments was probably the result of an impact. The bulb fragmented despite the presence of the polycarbonate cover, indicating that the light was struck with considerable force. Given their proximity to each other and the nature of the damage, the punctured hydraulic line and deformed metal wiring conduit were also considered to be the result of an impact.

The source of the impact to the nose gear landing light could not be determined. It is possible the aircraft struck a bird or an RPA during departure from Sydney, or foreign object debris during its take-off roll. It should be noted, however, that no debris was found during runway inspections at Sydney Airport and there was no visible biological evidence of a wildlife strike.

- On departure from Sydney, the nose gear landing light was probably struck and damaged by an unknown object. Consequently, part of the nose gear landing light lens likely impacted and damaged the main landing gear.

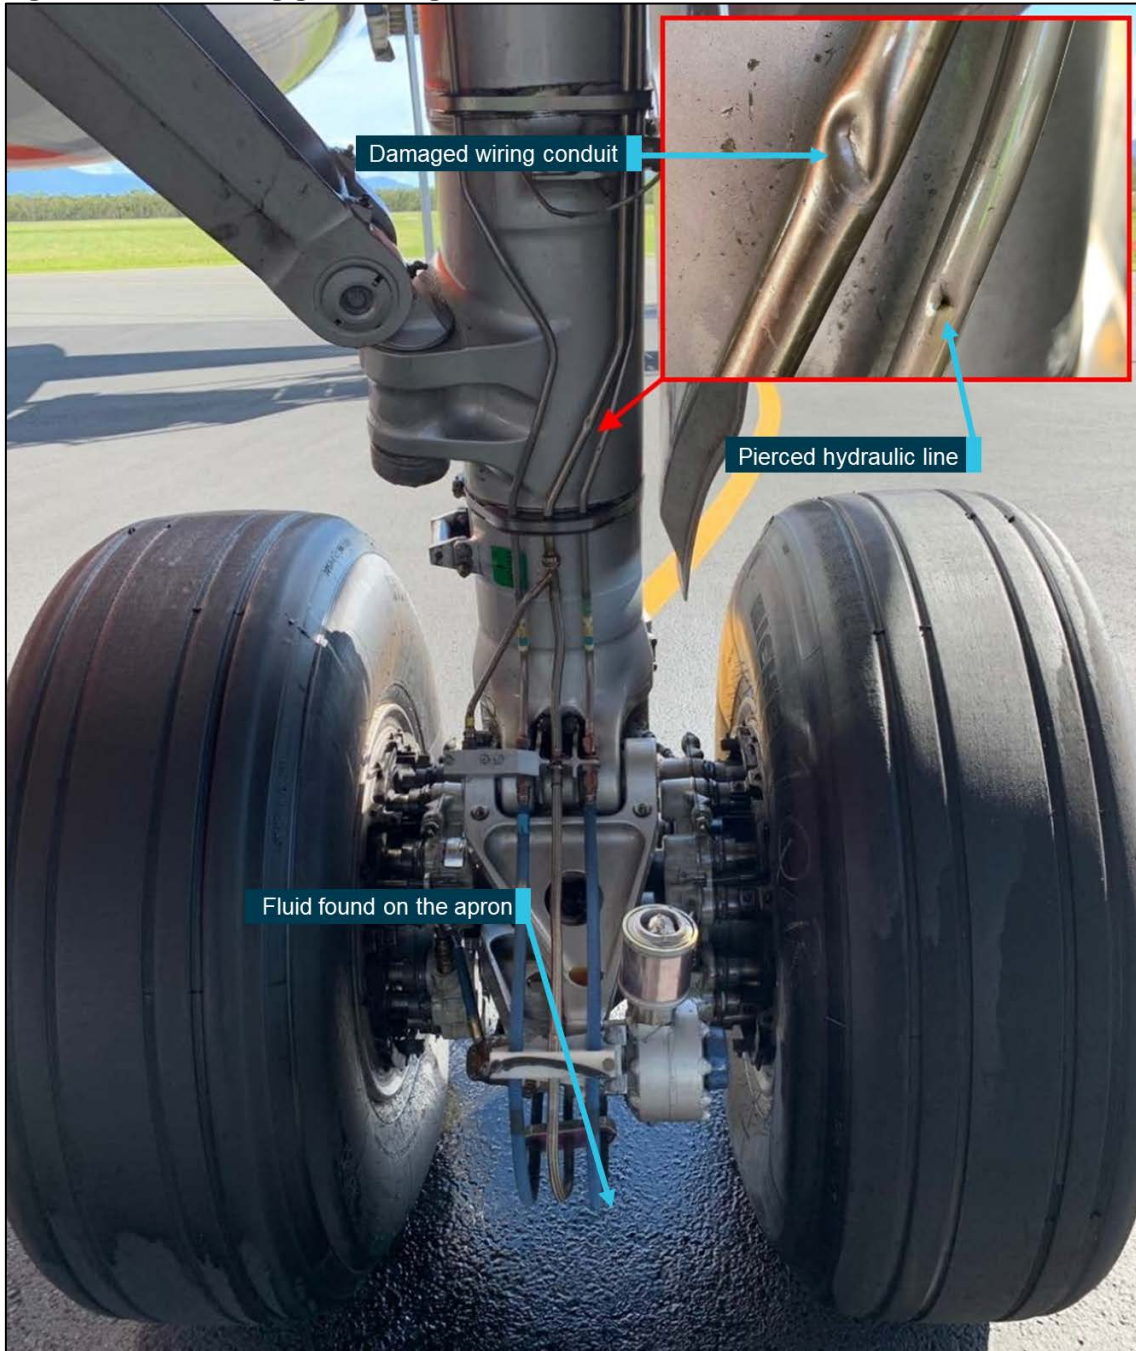
**Figure 2: Main landing gear damage**

Figure 2 shows the damage found on the left-hand MLG wiring conduit and the adjacent brake hydraulic line. Fluid can be seen on the apron as well as the tyres. A subsequent inspection of the aircraft found more fluid in the wheel well of the left main landing gear.

The pierced hydraulic line was sent to the ATSB for examination. The line was confirmed to be a titanium-aluminium alloy, per the manufacturer's specifications. The damage observed was consistent with a concentrated external force resulting in the puncture.

Examination of the damaged hydraulic line identified traces of what was most likely glass. The most probable source of the damage to the hydraulic line and wiring conduit was the glass lens of the nose gear landing light. Other potential sources of damage, such as ground support equipment or foreign object debris could not be ruled out, however there was no evidence found to support these.

Both impacts most likely occurred during the flight between Sydney and Proserpine, since no damage was reported following the previous flight, or during pre-flight inspections in Sydney. Fluid found in the main landing gear (MLG) wheel well likely came from the punctured hydraulic line. The fluid was probably discharged into the well when the crew raised the landing gear during departure from Sydney, as the line would have been pressurised, and the gear was not retracted

again prior to the damage being found. It is therefore likely that the MLG damage occurred during departure from Sydney, rather than via a remotely piloted aircraft (RPA) while on descent into Proserpine, since damage on descent would not explain the fluid found in the wheel well. As such, the noise heard by the cabin crew member was probably unrelated to the occurrence.

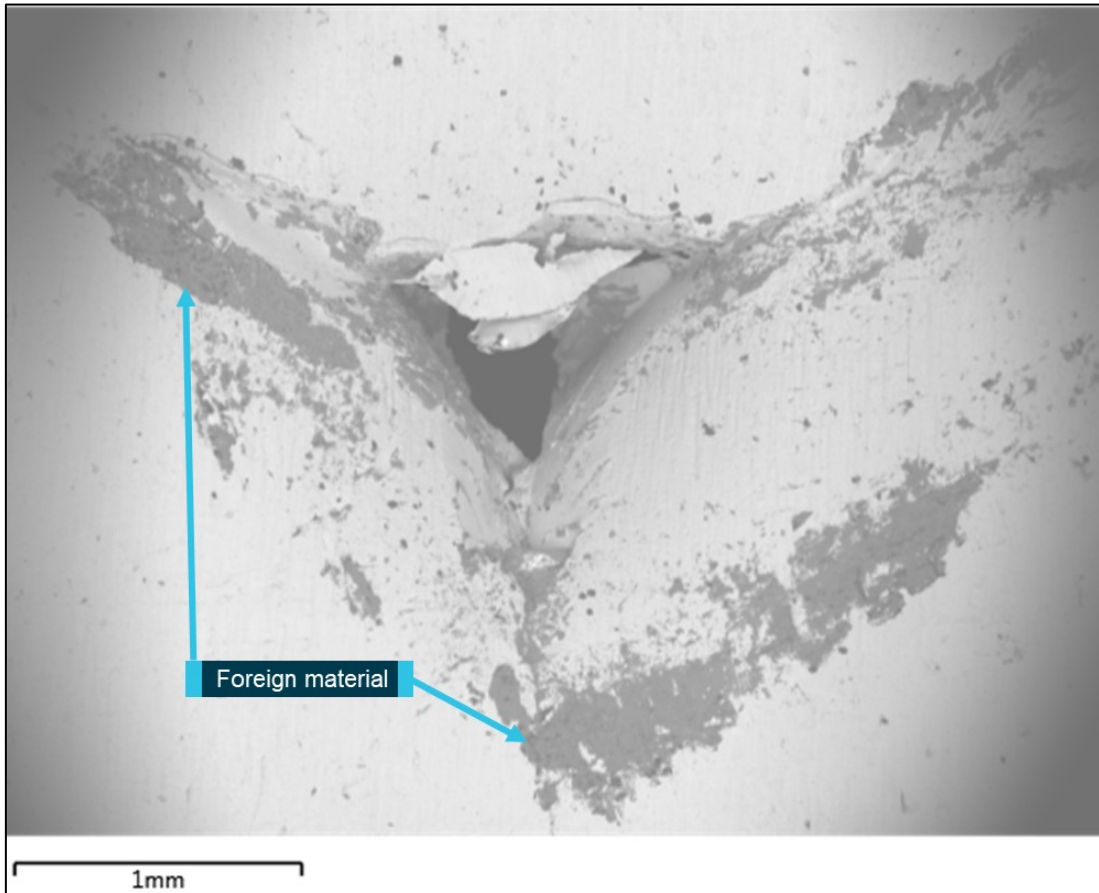
**Figure 4: Backscattered electron image of the hydraulic line damage**

Scanning electron microscopy, including backscattered electron imagery<sup>2</sup> and energy-dispersive X-ray spectroscopy<sup>3</sup> was conducted on the damaged section of line. Figure 4 shows a foreign material identified around the damaged area.

*The darker regions indicate a foreign material is present, consisting of lighter elements than the titanium-aluminium line.*  
 Source: ATSB

Energy dispersive X-ray spectroscopy identified the foreign material as a combination of silicon and oxygen. At higher magnifications, the foreign material appeared to have a granular, crystalline structure. The structure and composition of the foreign material indicated that it was most likely silica, otherwise known as silicon dioxide. Silica is the primary ingredient in most forms of glass.
