# Runway incursion involving Bombardier Dash-8-402, VH-LQJ

Gladstone Airport, Queensland, 17 March 2020

**ATSB Transport Safety Report**

AO-2020-019

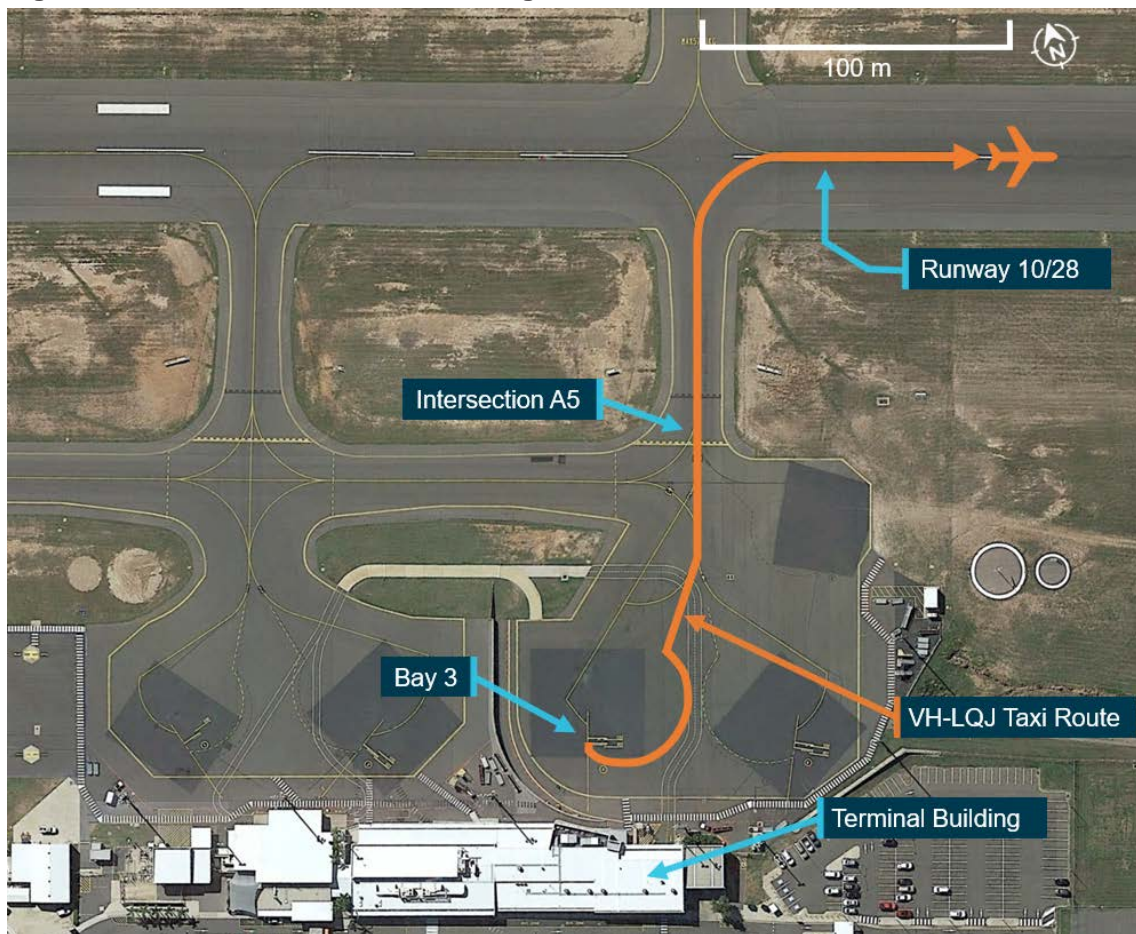
**Figure 1: Overview of VH-LQJ taxi routing**

The weather at the time was reported as being a wind from 201 degrees magnetic at 6 knots, no cloud, and a visibility of 43 km. As the wind did not favour either runway, the flight crew of LQJ elected to use runway 28 to avoid departing towards the rising sun. This required a short taxi from bay 3 to the A5 intersection, and a right turn to enter and backtrack runway 28 (Figure 1 and Figure 2).
