# Loss of control and collision with terrain involving Cessna 441, VH-XMJ

4 km west of Renmark Airport, South Australia on 30 May 2017

**ATSB Transport Safety Report**  
Aviation Occurrence Investigation  
AO-2017-057  
Final – 30 April 2020

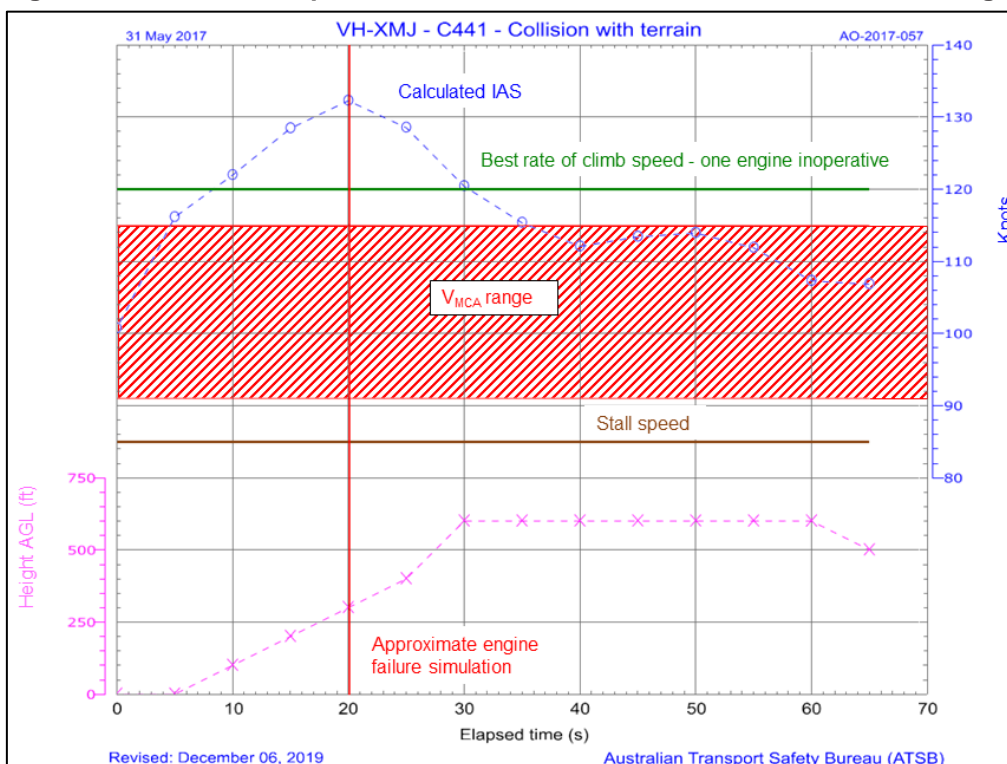
**Figure 13: Indicated airspeed and altitude variation over the final minute of flight**

The data showed a steady increase in airspeed up to about 132 kt, followed by loss of airspeed, brief stabilisation around 110-115 kt, then a further decrease to about 107 kt before the data ended. The maximum recorded airspeed was about 10 kt higher than published OEI best rate of climb speed  $V_{YSE}$  (120 kt, see the section titled *Asymmetric performance*) and occurred at a height of about 300 ft above ground level.

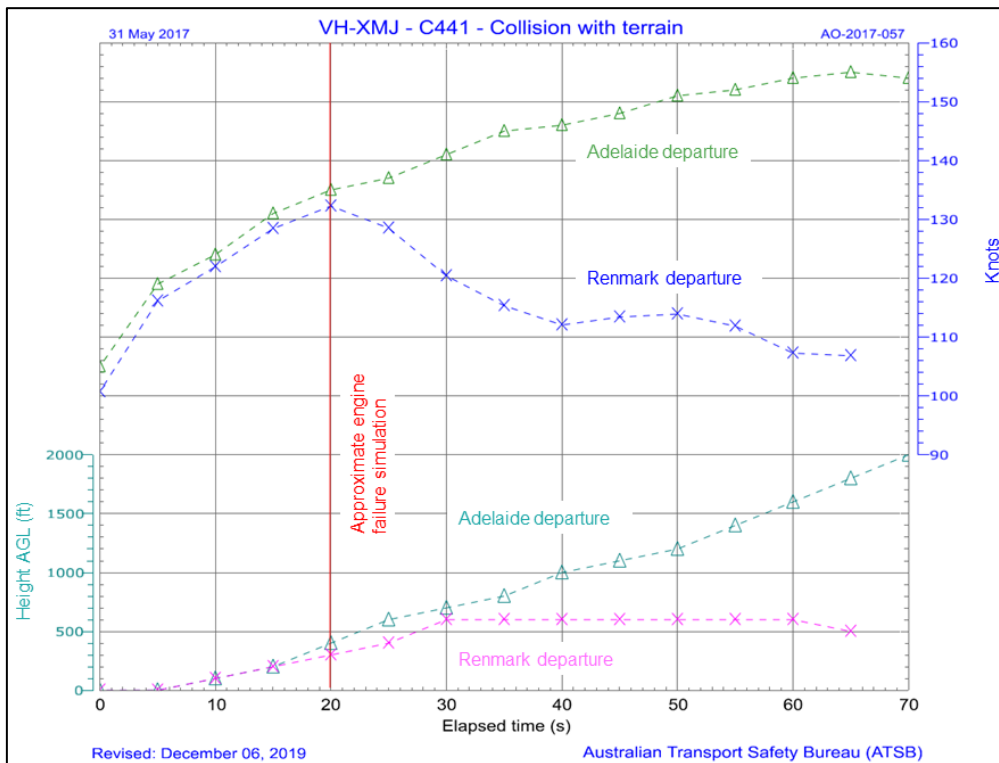
**Figure 14: Departure profile comparison**

Figure 14 illustrates the difference in the calculated IAS and height (above ground level) profiles between the departure from Renmark Airport and the earlier departure from Adelaide Airport.

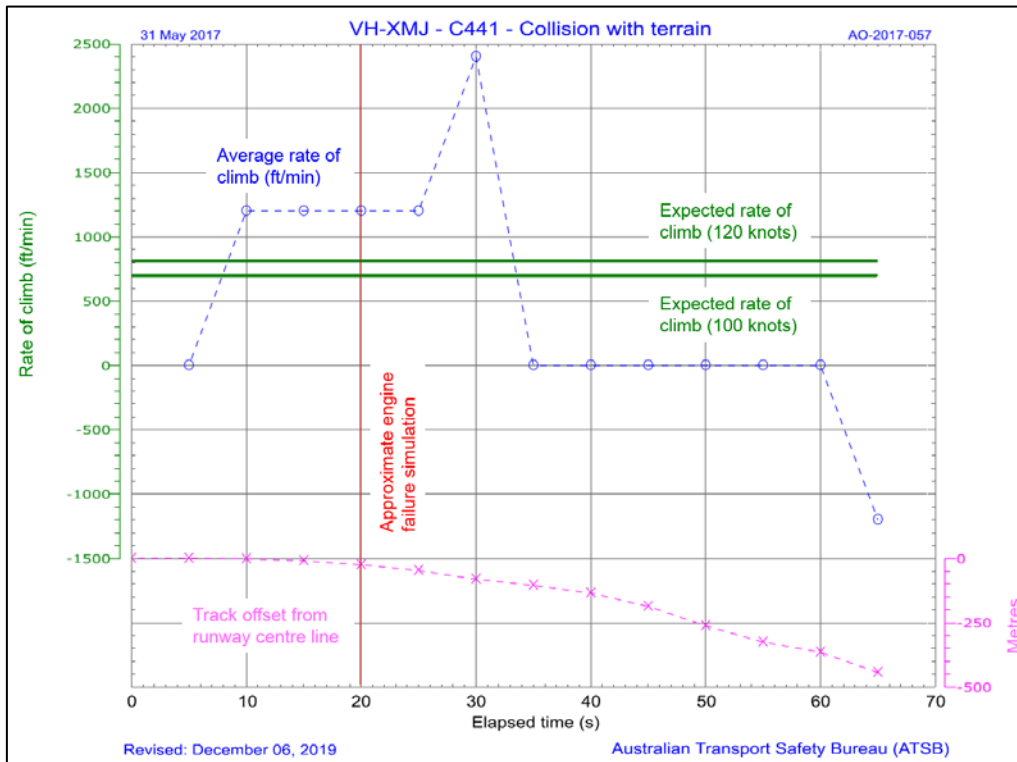
Figure 15: Rate of climb and track variation over the final minute of flight

In addition to the airspeed variation, the aircraft's rate of climb was derived from the GPS altitude data and is shown, together with the aircraft's track deviation from the runway heading in Figure 15. The data indicated that the aircraft initially climbed at greater than the expected OEI rate of climb before levelling and maintaining approximately level flight for 30 seconds until the data ended. A review of the airspeed over the same time period identified that it reduced during the peak increase in the rate of climb, suggesting that the aircraft was pitched up to reduce airspeed.

Analysis of the track variation identified that the aircraft deviated to the right of the runway centreline during the final minute of the flight. That movement was consistent with both the prevailing left crosswind component during the departure and a reduction in power on the right engine.

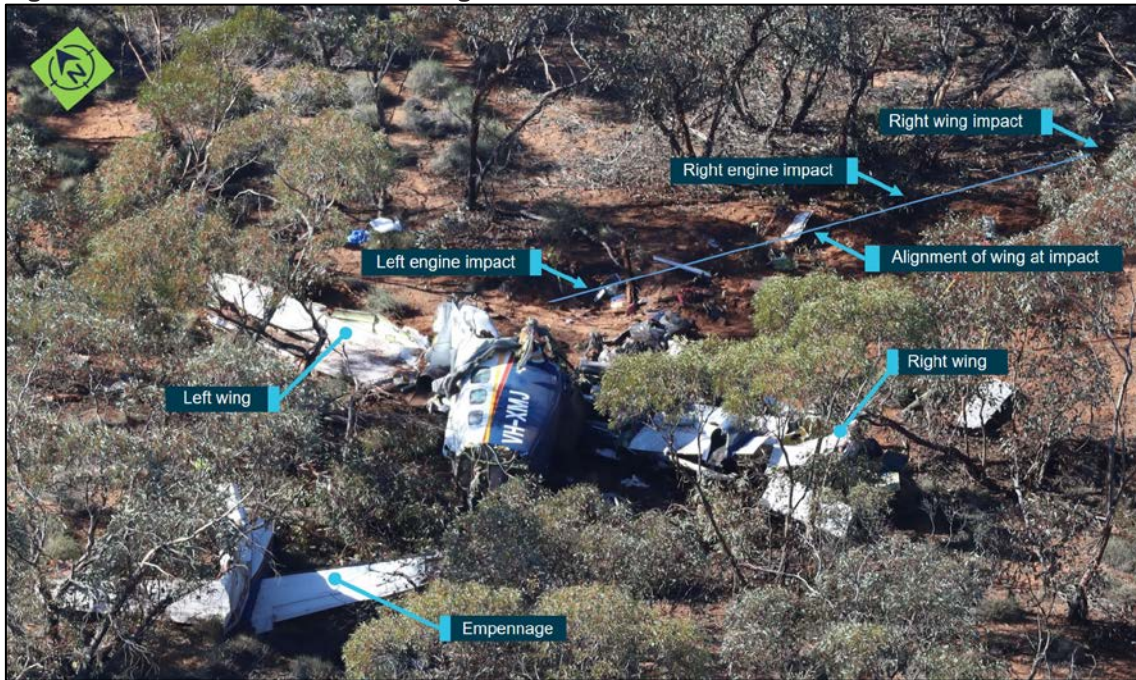
**Figure 19: Accident site and wreckage of VH-XMJ**

The aircraft was destroyed as a result of the ground collision. There was no subsequent fire, however, damage to the aircraft precluded a complete examination of a number of the aircraft systems. On-site examination of the wreckage and later examination of recovered components did not identify any pre-impact faults that could have contributed to the accident.
