Signal ME45 passed at danger involving suburban passenger train TP43 and near collision with another suburban passenger train

Bowen Hills, Queensland, on 10 January 2018

Rail Occurrence Investigation (Systemic)

RO-2018-002

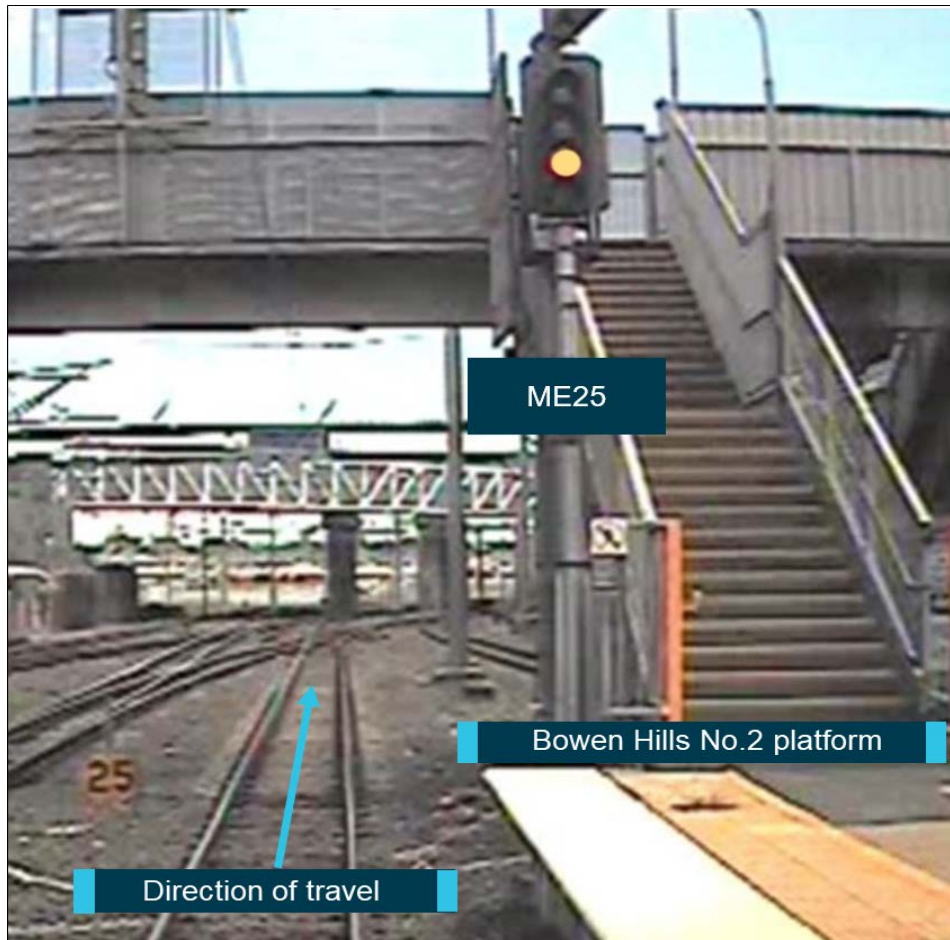
Figure 1: Signal ME25 showing a yellow aspect as TP43 arrived at Bowen Hills

Just prior to the arrival of the train at Bowen Hills, the incoming driver² was waiting on the platform. This driver noticed that the departure signal (ME25) at the northern end of No.2 platform was displaying a yellow aspect (Figure 1). To a driver, a yellow aspect is an indication to proceed with caution and expect the next signal to be displaying a red aspect. In this case, the next signal was ME45, located about 390 m beyond the platform.

The image taken from the front-of-train camera as TP43 stopped at Bowen Hills No.2 platform. The signal displayed a yellow aspect, which the driver recalled seeing prior to the arrival of the train.
 Source: Queensland Rail annotated by the ATSB

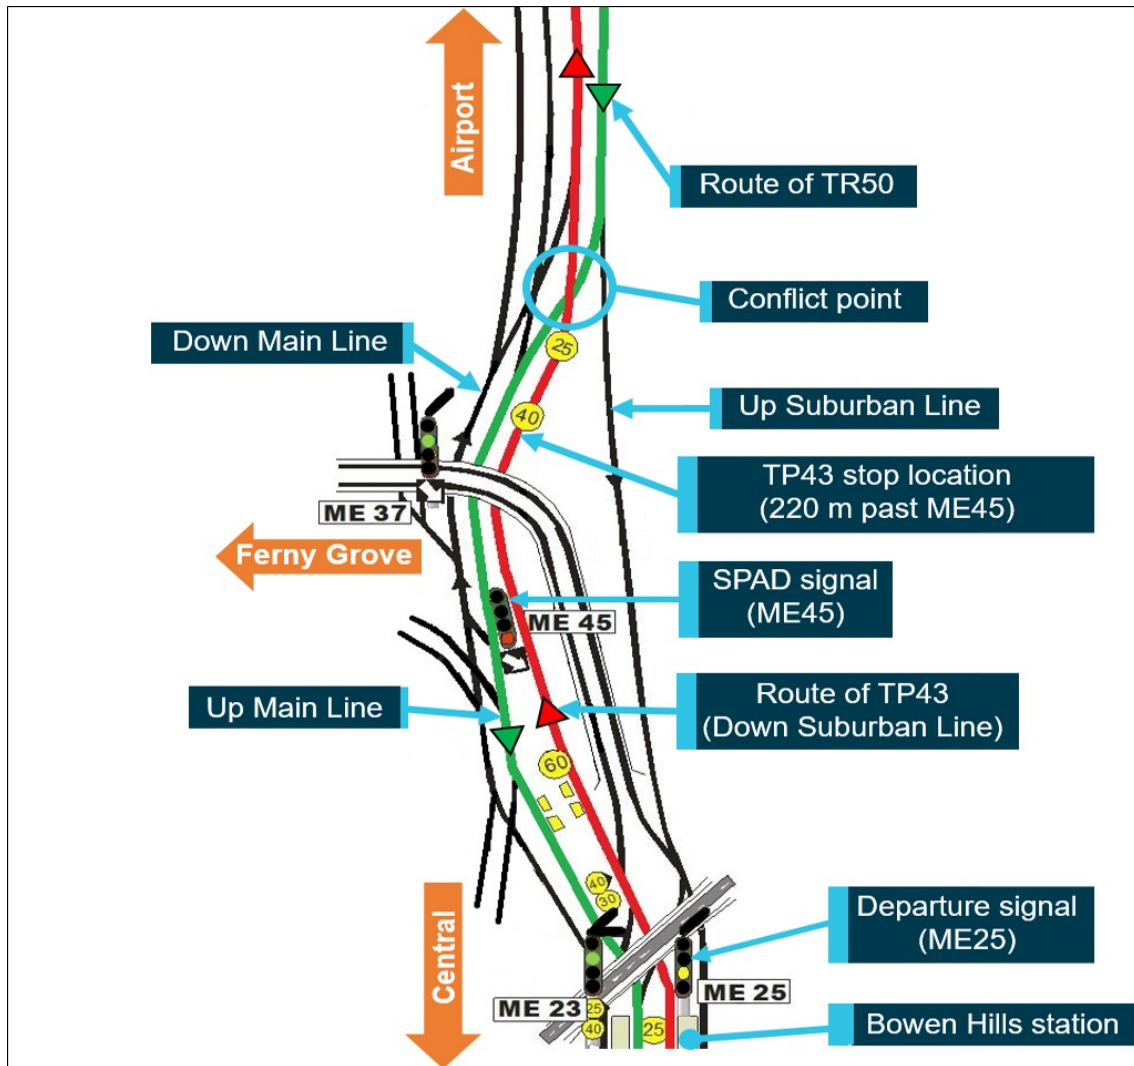
Figure 2: Location of signal ME25, signal ME45 and related information

The image shows the route of TP43 (in red) on the down suburban line and the colour light aspects displayed in signals ME25 (yellow) and ME45 (red). It also shows the relevant speed boards (yellow circles) and the potential conflict point with train TR50 on the up main line (in green).
 Source: Queensland Rail, annotated by the ATSB

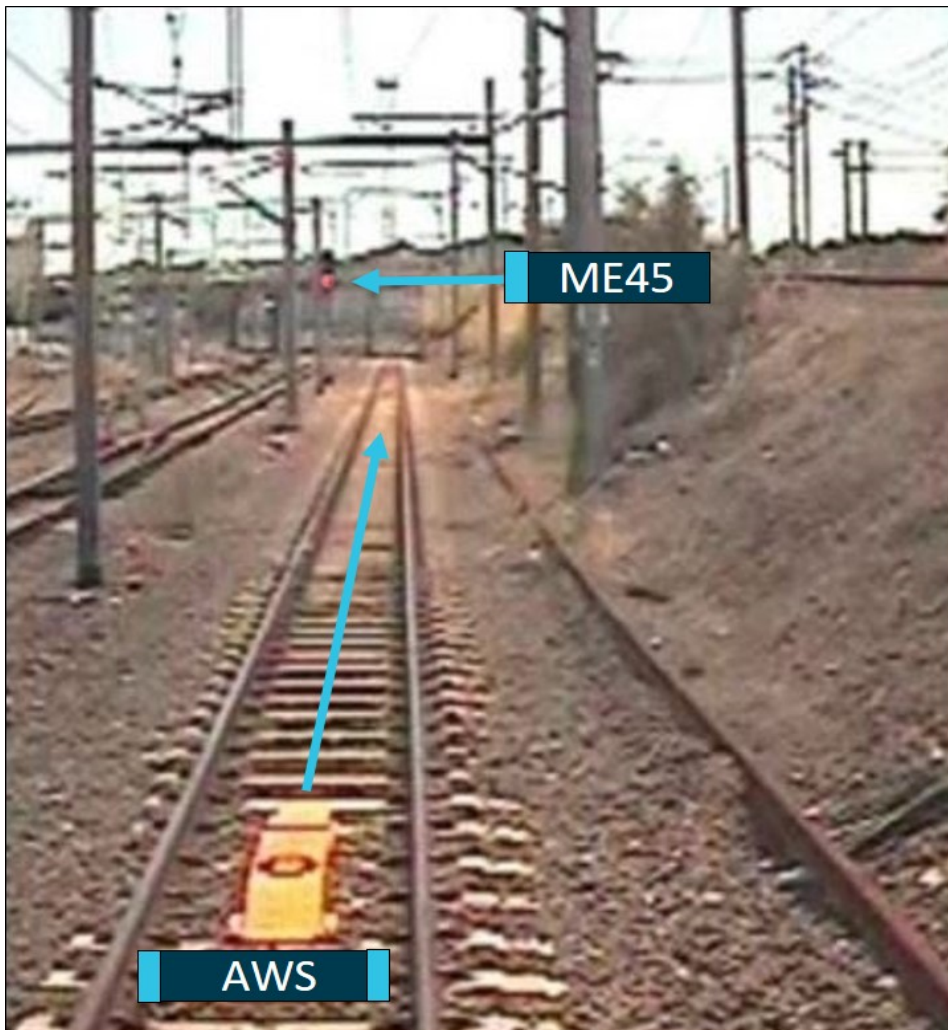
Figure 3: AWS magnet and signal ME45 displaying a red (stop) aspect

At 1038:04, the leading car of the train passed over the automatic warning system⁷ (AWS) magnet for signal ME45, which was located 79.5 m prior to the signal (Figure 3). The in-cab AWS equipment generated an audible and visual alarm, to warn the driver the train was approaching a restricted signal (in this case a stop indication in signal ME45).

The front-of-train image from TP43 shows the AWS magnet, and signal ME45, which was displaying red aspect (stop) indication. The AWS magnet was located 79.5 m from signal ME45.
Source: Queensland Rail, annotated by the ATSB
